Diagnostic and Repair Plan

FSC 13-24-5902 Missing HV cable clamps

Version 1, Online

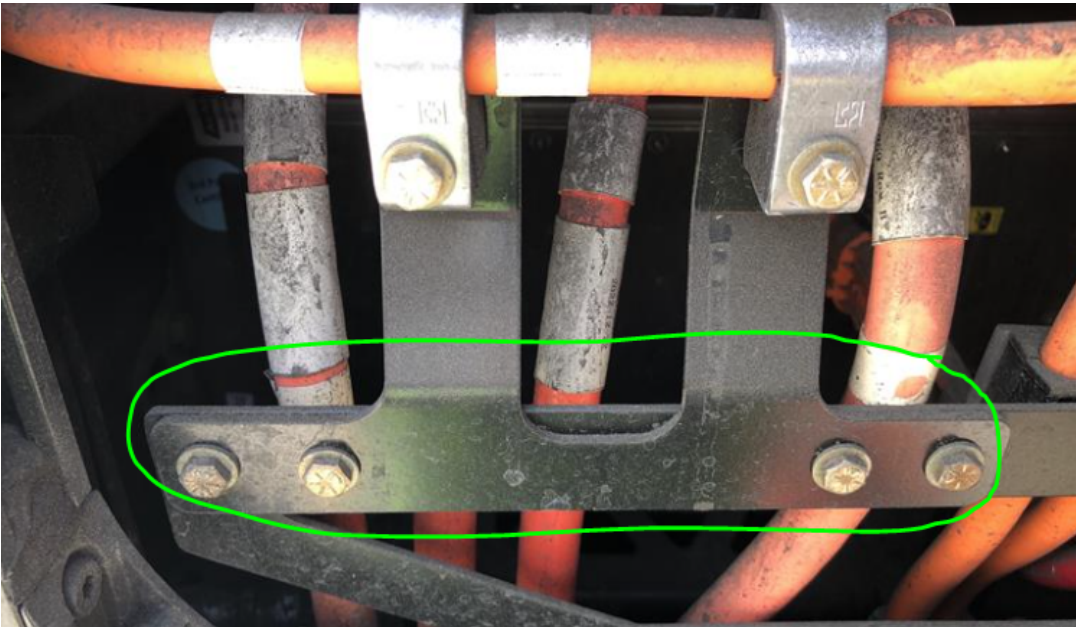
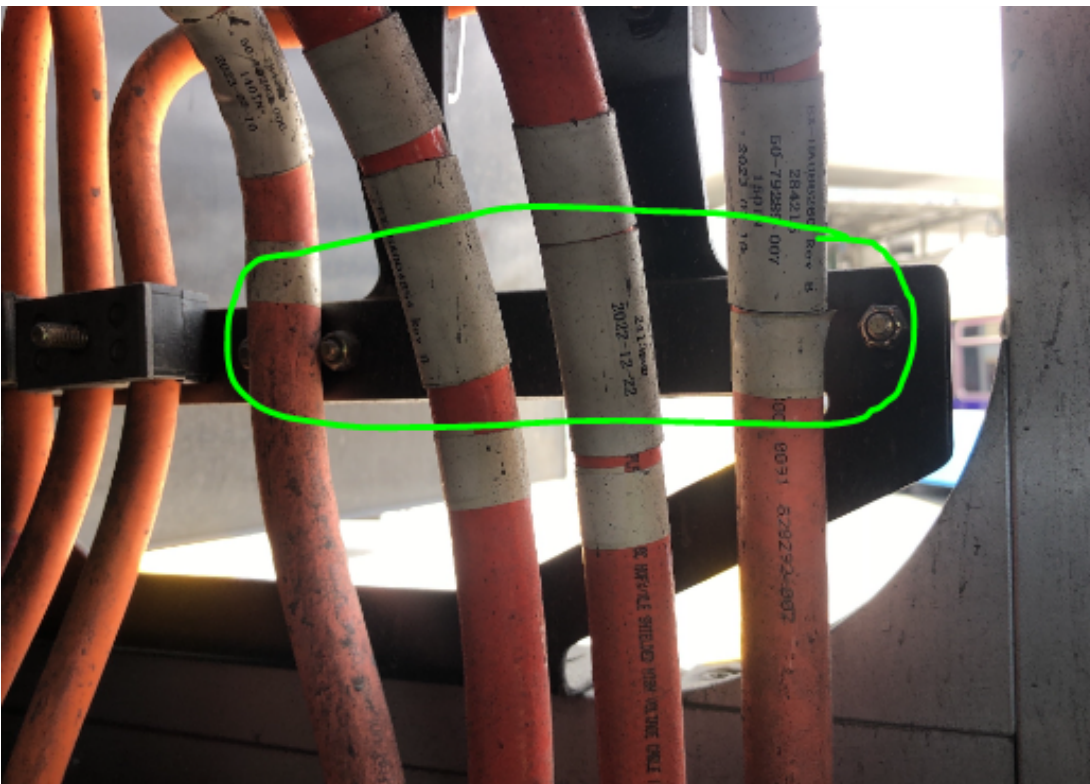
Cable clamp missing on some BEB Gen3.0 buses for the HV Charge port cables near the curbside HVJBox.

Cables rubbing together or against support bracket

Verify nylon cable clamp is missing by visual inspection - visible through upper rear curbside access door.
