Technical Journal Title ICUP, MY23->, Scratchy sound, Premium Sound Audio		Ref. No. TJ 36743.3.0	
Issuer (Dept.) Technical Service		Issue Date 4/16/24	Status Date 4/18/24
Car Market United States and Canada	Partner 3 US 7510 Volvo Car USA	Function Group 3900	
Function Description Media, navigation and communication		Page Page 1 of 4

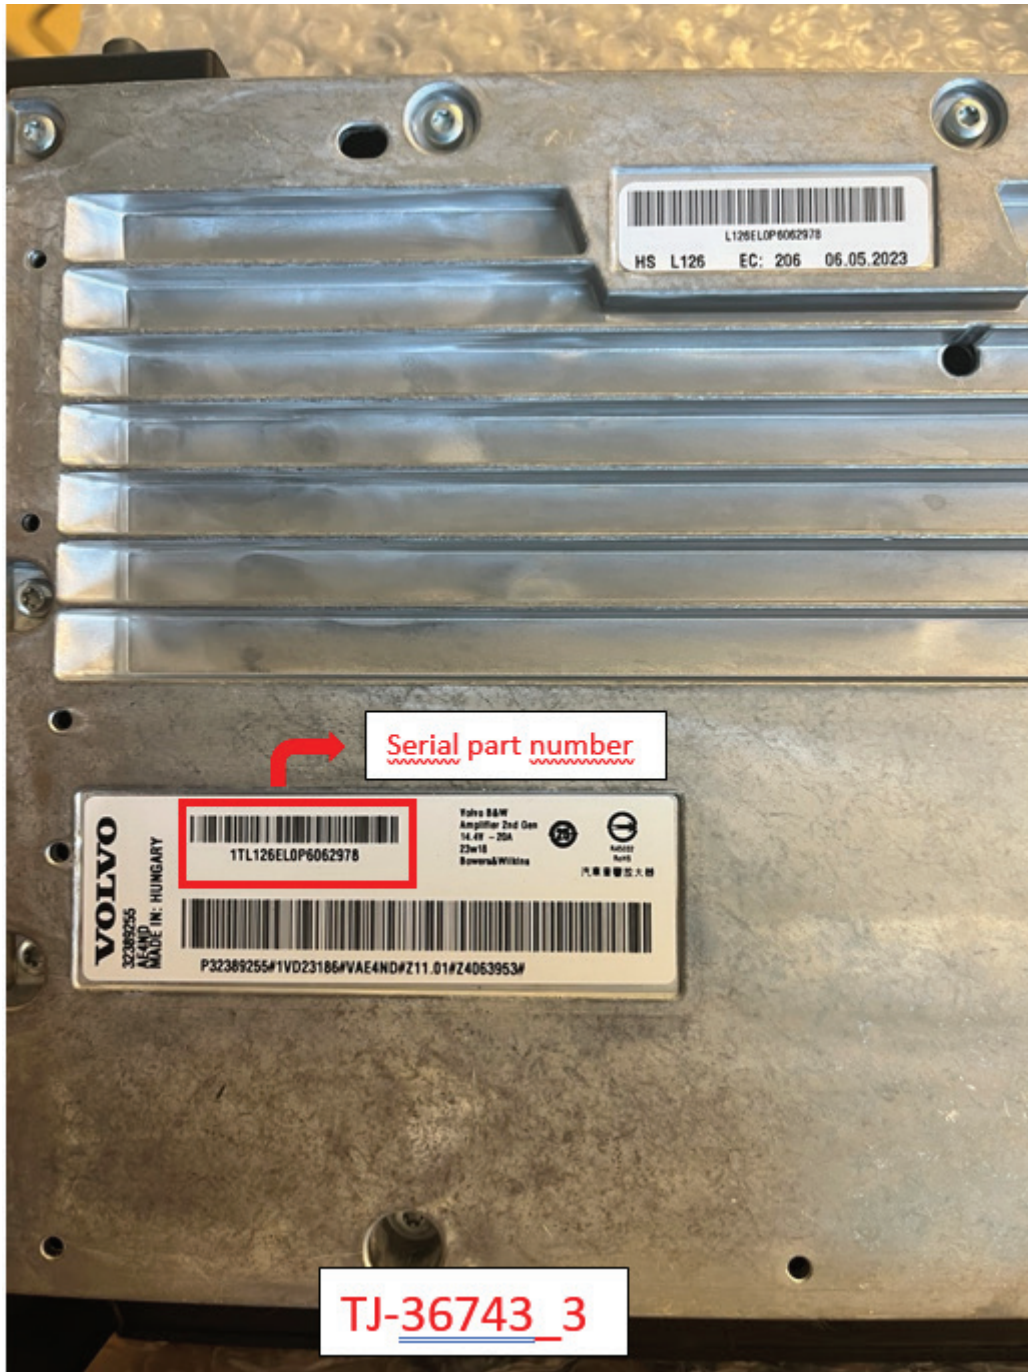
\*Make sure that spare part (AUD) is ok and has production week 23w32 or higher, see sample in attachment (TJ\_36743\_1.PNG for location of production week on AUD label).

If the symptom is confirmed and sound matching the files and DTCs from the list are valid replace the AUD-unit.
