**Volvo Car USA LLC****Technical Journal**

Technical Journal Title		Ref. No.	
Upper front suspension creaking/knocking noise		TJ 36512.2.0	
Issuer (Dept.)		Issue Date	Status Date
Technical Service		4/20/23	4/28/23
Car Market	Partner	Function Group	
United States and Canada	3 US 7510 Volvo Car USA	7233	
Function Description		Page	
Mounting		Page 1 of 3

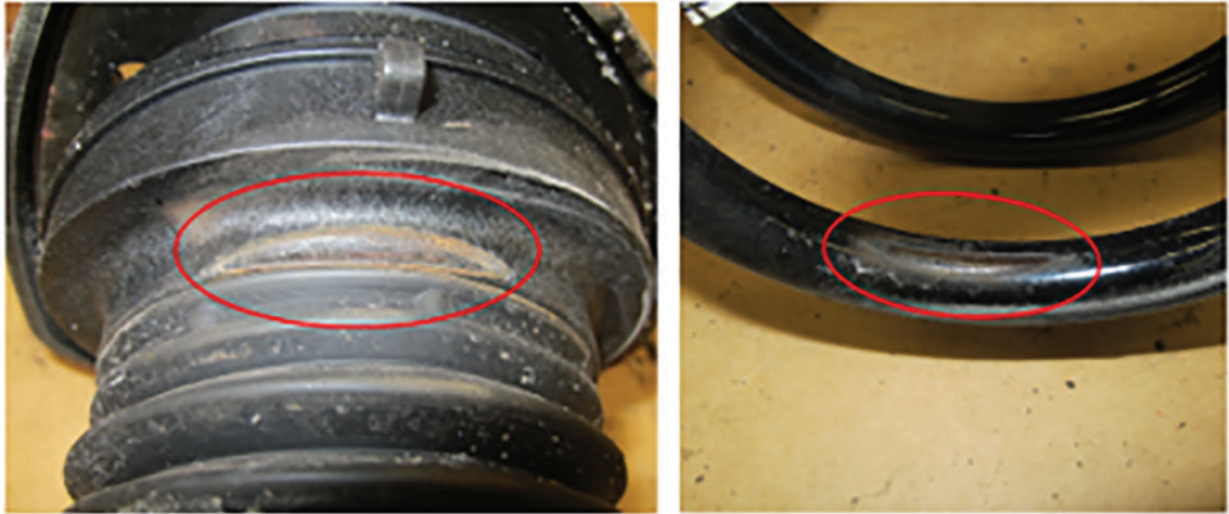
- During acceleration/braking ([knocking noise.MOV](#) and picture 1)
- During (slowly) driving over bumps and into turns ([knocking noise.MOV](#) and picture 1)
- During turning to left or right when standing still ([Creaking noise.mp4](#) and picture 2)
- During parking maneuvering ([Creaking noise.mp4](#) and picture 2)

Only replace the upper bearing according to VIDA.
