CADILLAC
DCS6876
URGENT - DISTRIBUTE IMMEDIATELY

Subject: UPDATE: N232428540 - Customer Satisfaction Program
Multiple Module Reprogramming
Population Expansion

Models: 2023 Cadillac LYRIQ

N232428540 Multiple Module Reprogramming

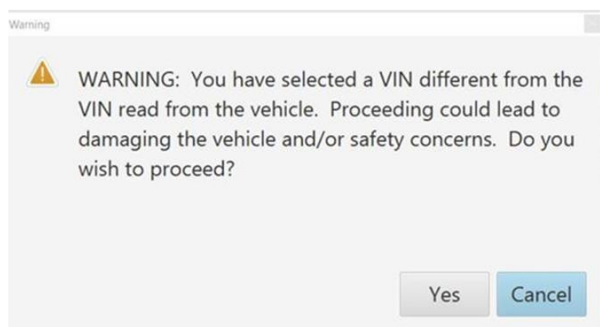
5877000

Important: If the vehicle VIN DOES NOT match, the message below will be shown.

- If the VIN that shows up in the TLC top center window after correctly reading the VIN from the vehicle does not match the VIN plate of the vehicle, manually type in the VIN characters from the vehicle VIN plate into the TLC top center window and use these for programming or reprogramming the subject module with the correct vehicle VIN and software and/or calibrations.
