GROUP	MODEL
TRA	2021-2024MY Multiple Models
NUMBER	DATE
108 (Rev 1, 4/25/2024)	September 2023

TECHNICAL SERVICE BULLETIN

SUBJECT: **4WD COUPLING ACTUATOR ASSEMBLY REPLACEMENT**

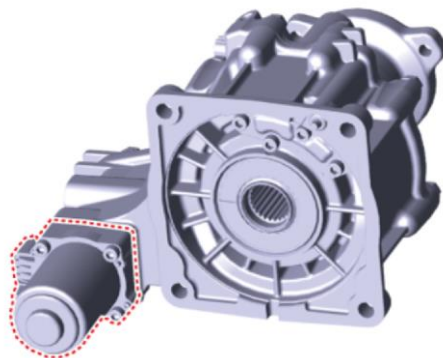
This bulletin provides information to replace the AWD coupling actuator assembly on some 2021-2024MY Kia AWD models listed on page 4. The affected vehicles may exhibit an inoperative AWD system (also referred to as 4WD) capability concern which may be caused by abnormal wear of the motor brushes inside the actuator assembly. This condition will cause the warning lamps on the instrument cluster to illuminate with stored DTC(s) P195800 and/or P19600. Follow the procedure outlined in this publication to inspect and, if necessary, replace the AWD coupling actuator assembly on the applicable vehicles.

P195800 - 4WD Torque Error

P196000 - 4WD Bleeding Pressure Error
