ECPC SPN 517081/FMI 14 False Fail for Welded Contactors BMS3 or BMS4 SPN 517000/FMI 6 or SPN 517001/FMI 6

TSB-08-001-FTL

Engine or Vehicle Affected:

- ▶ eM2
- ▶ eCascadia

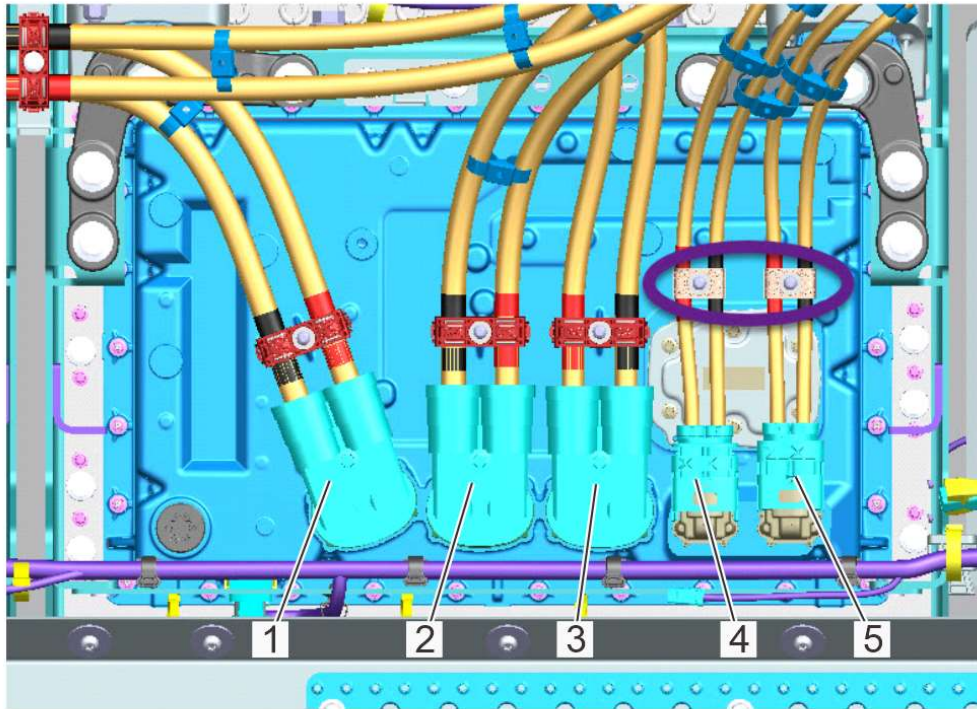
Fig. 1, HV battery connector callouts and Aux cable retention clamps

HV battery connector callouts and Aux cable retention clamps

- 1. Connector 1 (C1)
- 2. Connector 2 (C2)
- 3. Connector 3 (C3)
- 4. Connector 4 (C4)
- 5. Connector 5 (C5)

3. Connect all the HV connectors and the cable clamps that were removed during the decommissioning.
 4. Remove the cable retention clamp bolt at the battery 2, connector C3. See Fig. [1](#), item 3.
