992 2WD – DME Fault P310B00 – ‘Fuel Low Pressure – Implausible’

Customer complains of a check-engine light resulting from fault “**P310B00- Fuel low pressure – implausible**” in the DME control unit.

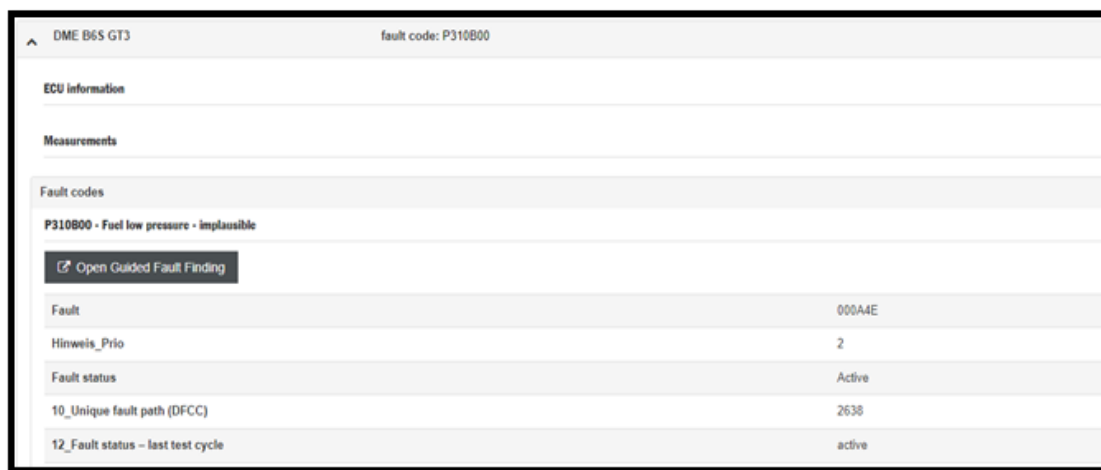
Figure 1

The diagnostic responsible for this fault monitors supply deviation within a finite time between the demanded or target low-pressure requested of the low-pressure fuel pump and that of the actual supplied quantity to meet the request, as correlated to pressure. In some instances, manufacturing tolerances for the low-pressure pump result in the actual supplied fuel quantity exceeding the DME's requested quantity, in other words, the pump's operation is 'too effective.' By consulting the Vehicle Analysis Log (VAL) containing the fault it is possible to see if the supplied fuel quantity exceeded the requested quantity in the low-pressure system to cause the fault.

If the fault data is consistent with the condition exemplified in Figure 1, please replace the fuel pump, **NOT** the fuel pressure sensor.
