Surround View Camera Intermittent Operation

Models	Model Year	Model Type	VIN Range	Vehicle-Specific Equipment
Taycan	As of 2020 up to 2024	Y1A, Y1B, Y1C	N/A	KA6

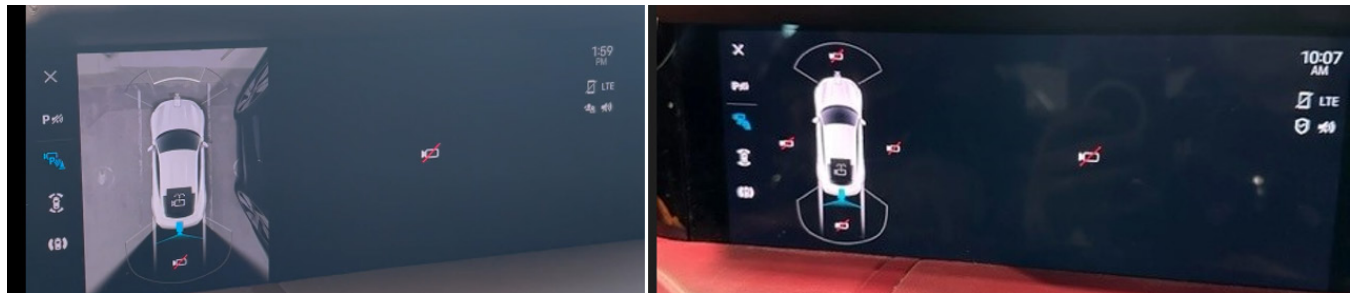
Figure 1- Failure Modes

The customer complains of intermittent operation for one or multiple surround view cameras that appear blank with a crossed-out camera icon for each failed camera.

Any component failure of the surround view system can lead to a single or a combination of surround camera images showing a blank screen within the PCM display.
