## SERVICE BULLETIN

**APPLICABILITY:** 2024MY Crosstrek & Impreza

**NUMBER:** 09-118-24

**SUBJECT:** DTCs P2404 & P0087 / Reprogramming Files

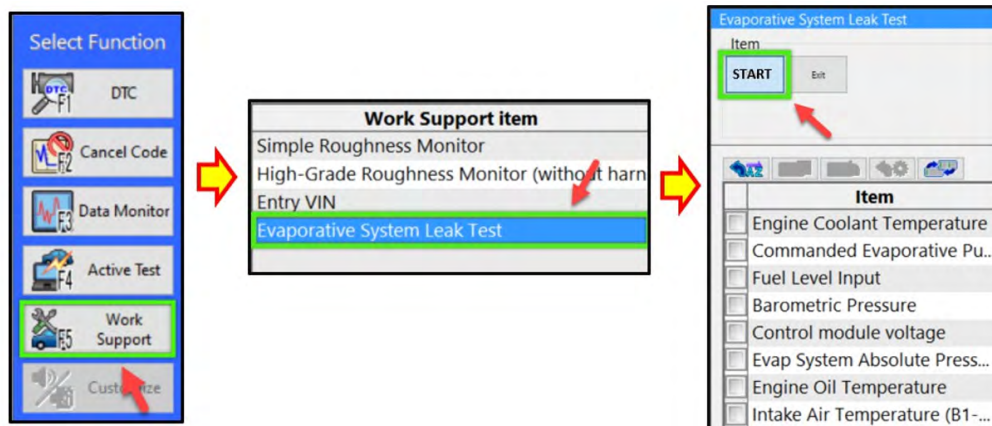
**STEP 6:** Connect the vehicle to a recommended power supply. See **APPENDIX A** for additional information regarding power supply. Using SSM, perform the Evaporative System Leak Test. Collect and save all data.

Once the evaporative system leak test is complete, check the DTCs and examine the vacuum value results. Record the value shown in the row labeled MID: \$3C, TID: \$C4, and Scaling ID: \$FE. This value should be lower than -0.26 PSI.

Value Must Be Lower Than -0.26 PSI

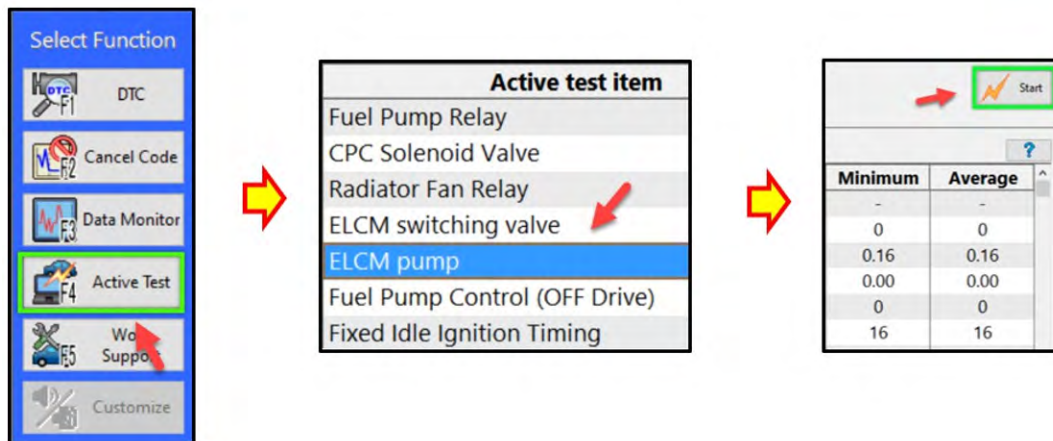
**STEP 8:** Using SSM, perform the ELCM Pump Active Test for a period of 35 minutes or more. See **APPENDIX A** for additional information regarding power supply.

Once the ELCM Pump Active Test has been performed for a period of 35 minutes or more, repeat the Evaporative System Leak Test outlined in STEP 6. Check the DTCs and the vacuum value results.
