Warning Message "Ignition Lock Faulty - Service Required" in the Instrument Cluster / Fault Memory Entry "B143C29" in the Rear-End Electronics Control Unit (SY 47/24)

Model Line: **911 (992)**

Model Year: **As of 2020**

Concerns: **Ignition starter switch**

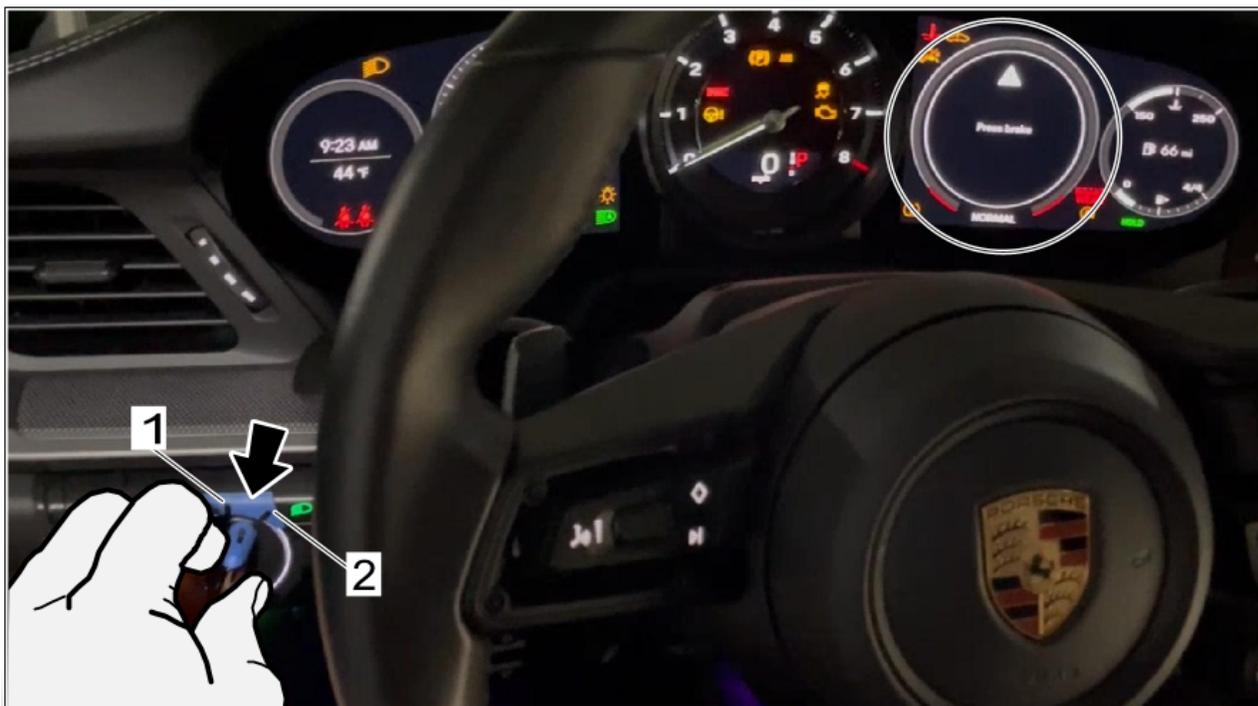
Ignition starter switch position

Symptom: **The white warning message "Ignition lock faulty - service required" is displayed in the instrument cluster during the engine start-up process. The following fault memory entry is stored in the fault memory of the rear-end electronics control unit:**

- B143C29 - Ignition starter switch, signal implausible (010066)

Cause: When the ignition starter switch is actuated, the engine is started through the system from the moment when the ignition starter switch is between switch position **-1-** (ignition on) and switch position **-2-** (engine start) ⇒ *Ignition starter switch position -Arrow-*.

If the ignition starter switch for the engine start is not **fully** turned to the "Start engine" switch position ⇒ *Ignition starter switch position -2-* but is released directly after engine start instead, therefore, thereby switching back to the "Ignition on" switch position ⇒ *Ignition starter switch position -1-*, the above-mentioned symptom occurs after the fifth consecutive incomplete start process.

Inform the customer to turn the ignition starter switch to the “Start engine” ⇒ *Ignition starter switch position -2-* switch position each time in order to start the engine so that the system will work as intended.

Delete fault memory entry “B143C29 - Ignition starter switch, signal implausible (010066)” in the rear-end electronics control unit.
