SERVICE BULLETIN

APPLICABILITY: 2023-24MY Outback & Legacy
 2023-24MY Ascent
 2024MY Crosstrek/Impreza

NUMBER: 15-311-23R
DATE: 06/23/23
REVISED: 04/12/24

SUBJECT: FOTA (Firmware Over-The-Air) Reprogramming for DENSO Gen 4.5 Audio Navigation Infotainment Systems via DCM

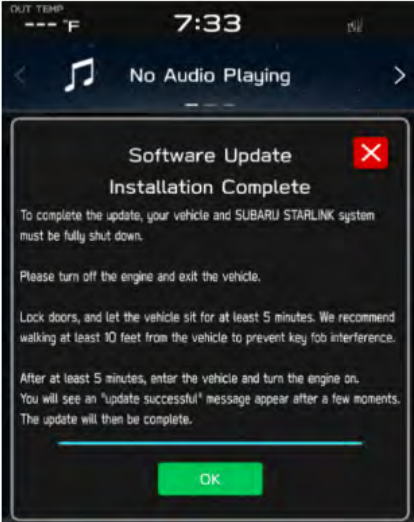
No	Category	Conditions/Symptoms to be improved
6	Reprogramming	<p>When the engine is turned off at a specific moment just before the completion of the CCU software update via FOTA, the expected completion notification screen does not appear when the engine is turned on next time.</p>

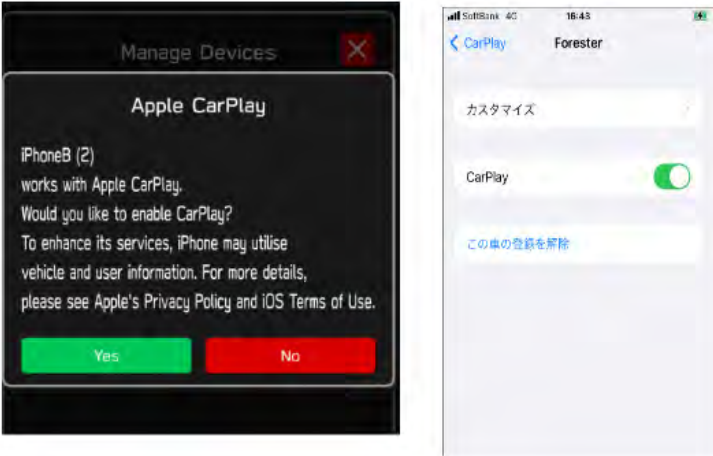
7	Phone	<p>When connected to CarPlay, phone calls cannot be answered or hung up using the steering wheel controls.</p> <p>(The maximum registration limit for Bluetooth-connected devices is 7, but CarPlay can control a maximum of 5 devices. Therefore, when receiving calls on the 6th or 7th phone, it was not possible to control the calls.)</p>
8	SXM	<p>Immediately after starting the engine and navigating to the SXM screen, various SXM functions are not working.</p> <p>Playback channel information is not displayed on the screen. Button operations are unresponsive. SXM audio is not playing.</p>
9	Bluetooth	<p>When following the steps below, Bluetooth connection may not become active, and it may become impossible to switch Bluetooth-connected devices (turning on/off the connection).</p> <p>➤ Steps With the CarPlay usage confirmation screen displayed on the CCU, press the 'Yes' button. Almost simultaneously, on the iPhone's settings screen, turn off the CarPlay toggle switch.</p>

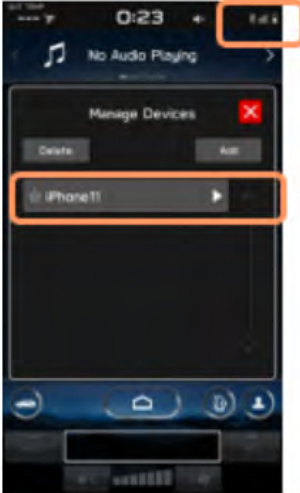
No	Category	Conditions/Symptoms to be improved
10	Bluetooth	Even with the Bluetooth actually connected, it is treated as not connected to Bluetooth on the audio screen ('No Device Connected' is displayed, and Bluetooth audio is not playing.)
11	CarPlay	<p>Symptom 1: Automatic connection of Wireless CarPlay fails.</p> <p>Symptom 2: The status bar icon at the top of the CID (Central Information Display) indicates a Bluetooth connection status, but the 'Manage Device' screen shows Bluetooth as disconnected, resulting in inconsistent information as depicted below.</p>

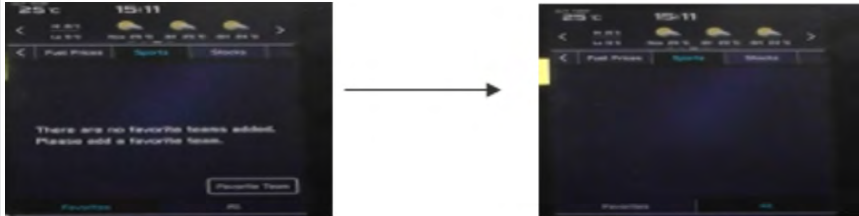
12	SXM	<p>When pressing the "All" tab on the TravelLink Sports screen, a blank tab screen is displayed.</p> <p>To navigate to the "LPGA" within the "Sport" / "Golf" category, you need to press it twice.</p>

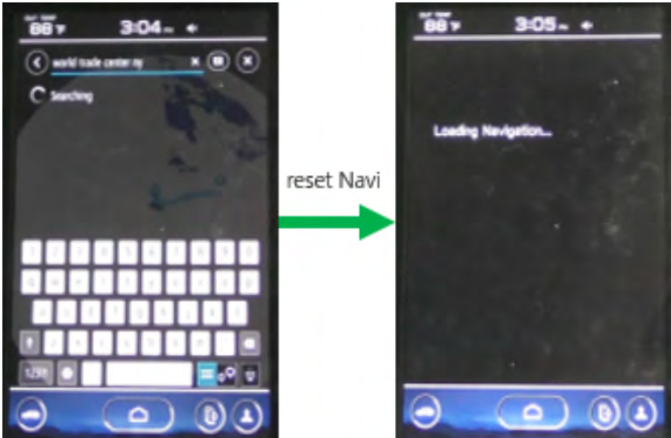
13	Navi	<p>When repeatedly entering text on the destination search screen, the screen may freeze, and the navigation app restarts itself.</p>

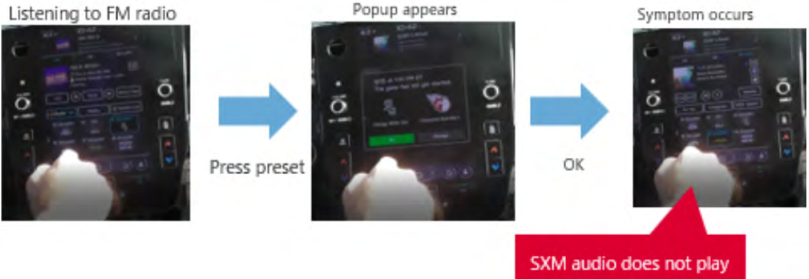
No	Category	Conditions/Symptoms to be improved
17	SXM	<p>While listening to the radio (FM/AM) and attempting to select a sports team channel (SXM channel) from the presets, if the chosen team has a scheduled game on that day but it hasn't started yet, a popup screen displaying the game schedule appears. However, after the popup screen appears, the system returns to the previously played channel, and the SXM audio does not play.</p>

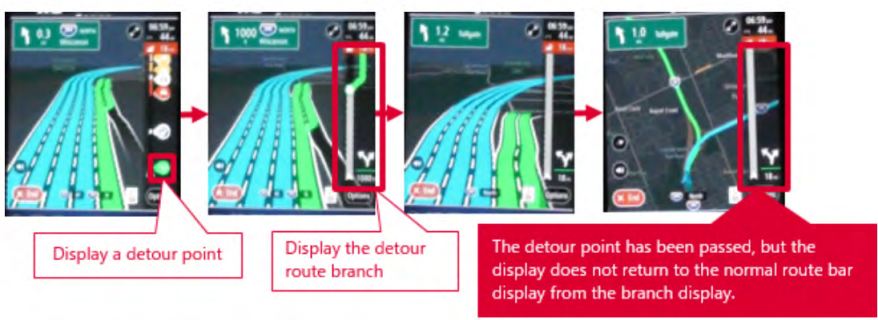
No	Category	Conditions/Symptoms to be improved
24	Navi	<p>After passing through a detour point, the route bar does not return to the normal route bar from the detour route branch display on the map.</p>

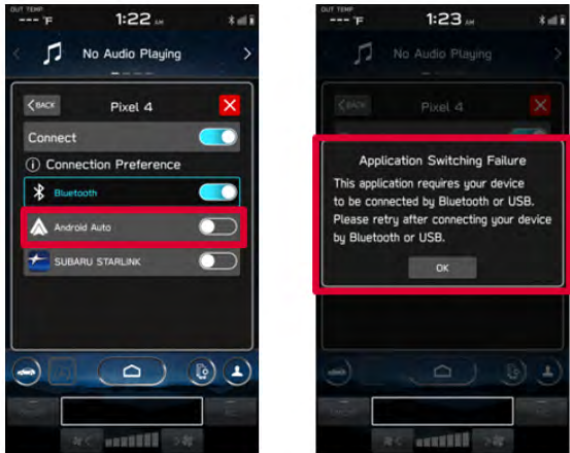
32	AndroidAuto	<p>When you toggle on Android Auto from the Manage Device screen in CID while the Android device is not connected via USB, there may be a failure to start Wireless Android Auto.</p>

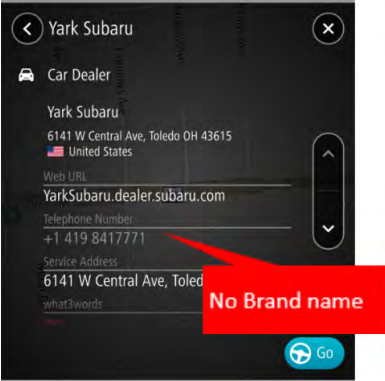
33	Navi	<p>When the system language is set to English, the brand name of that facility is not displayed on the POI (Point of Interest) details screen. In other languages, brand names like ‘Subaru’ are displayed, and it should also be correctly displayed in English.”</p>

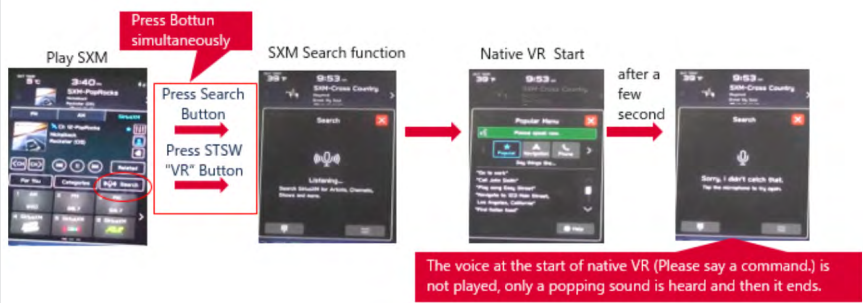
No	Category	Conditions/Symptoms to be improved
34	Voice recognition	<p>Starting the CCU (Cockpit Control Unit) voice recognition while using the SXM Voice Search function results in an error and ends the voice recognition.</p>

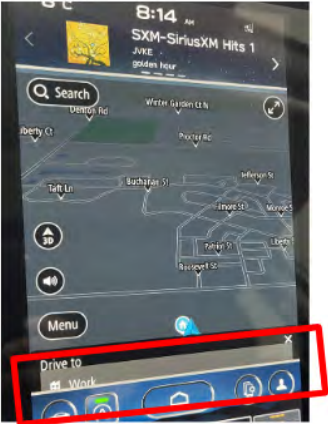
35	Navi	<p>In the navigation screen, the bottom of the destination suggestion list's popup screen is cut off and not fully displayed.</p>

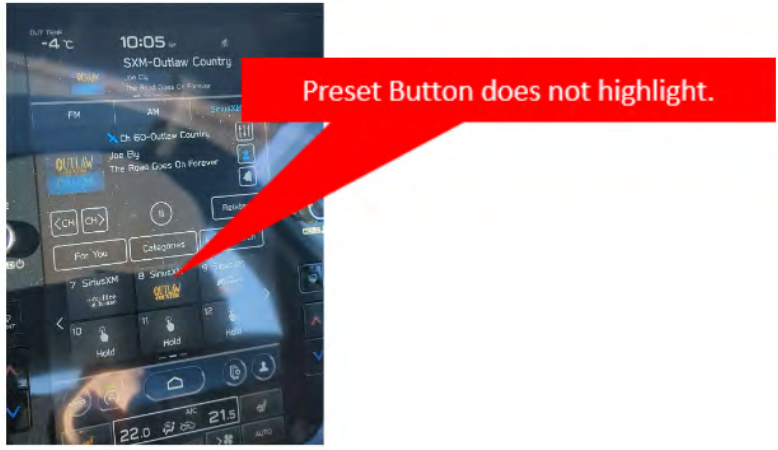
36	Radio	<p>When pressing a preset button for a registered radio channel, you can play the channel. But the button you pressed does not highlight, and you cannot operate through presets using the steering wheel controls.</p>

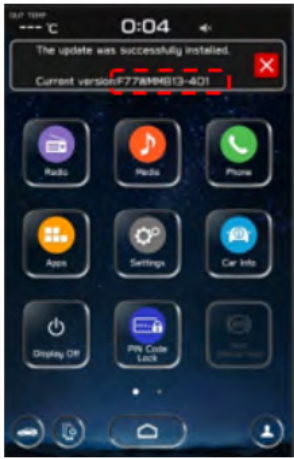
No	Category	Conditions/Symptoms to be improved
38	Reprogramming	<p>After the installation of software updates via OTA (Over-the-Air), the “Current Version” field in the popup screen that appears during the next IGN-ON may be blank or empty.</p>

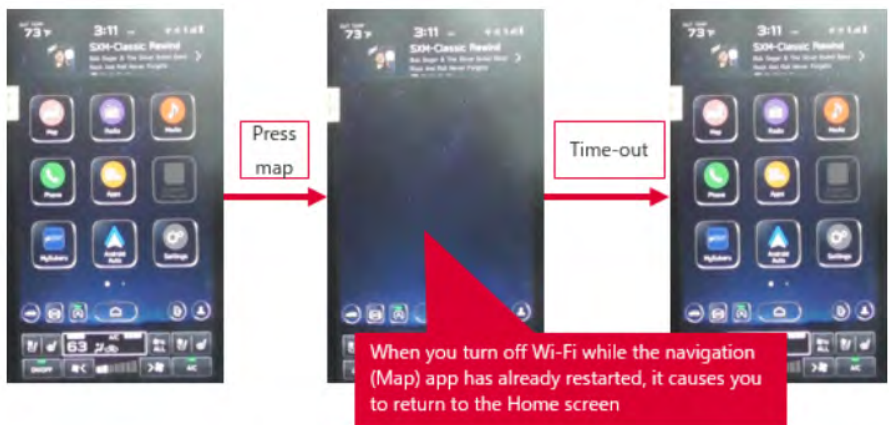
39	Navi	<p>Performing the following steps may cause the map scale to change to the default scale instead of the one you’ve set:</p> <p>Display the map (with the set scale). Ignition off/on. Change the map display mode (North-Up ↔ Heading-Up).</p>
40	Navi	<p>During map data updates, if you switch off the Wi-Fi function from the Settings screen, pressing the Map icon on the Home screen doesn’t display the Map screen for a while.</p>

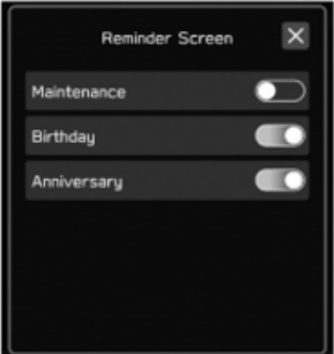
No	Category	Conditions/Symptoms to be improved
42	Reset	<p>When multiple reminders for maintenance dates, birthdays, and anniversaries are set and nearing, a series of pop-up notifications appear on the CID screen after starting the engine. If you try to delete a reminder right before it switches to the next one, the CID screen may reboot.</p>

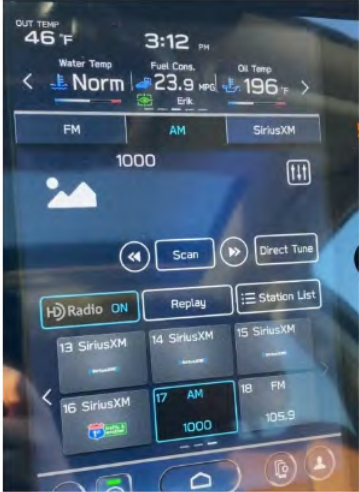
No	Category	Conditions/Symptoms to be improved
47	SXM	<p>After registering SXM channels in the presets, when pressing the preset button after a while, it receives the broadcast information and displays the channel logo on the preset button. However, when switching the audio source to AM radio afterward, the preset button returns from the channel logo to a temporary logo 'SiriusXM'.</p>

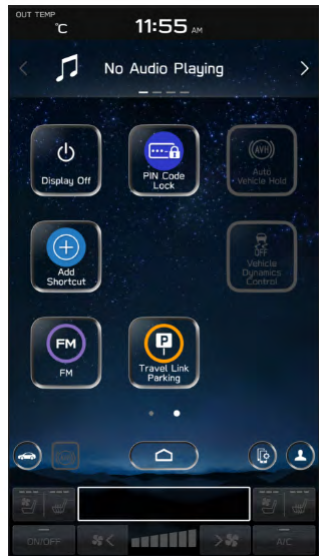
48	Display	<p>When starting the engine remotely with a registered Driver Profile, one of the following display issues occurs.:</p> <p>The VDC (Vehicle Dynamic Control) icon on the Home screen is not displayed and remains blank.</p> <p>The icon next to the VDC icon on the Home screen is not displayed and remains blank.</p>

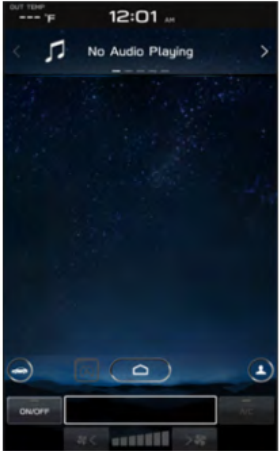
No	Category	Conditions/Symptoms to be improved
51	Black Screen	<p>When shifting from R to any other gear immediately after starting the engine, the CID screen takes some time to return to the home screen, displaying only a background.</p>

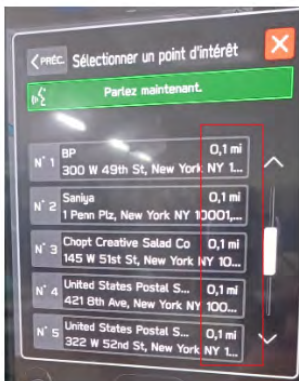
No	Category	Conditions/Symptoms to be improved
60	Navi	<p>When a language other than English is set, the distance to the destination displayed in the navigation destination is abnormal. When the distance is greater than 1.0, the decimal point is rounded down. When the distance is less than 1.0, the value becomes 0.1.</p>

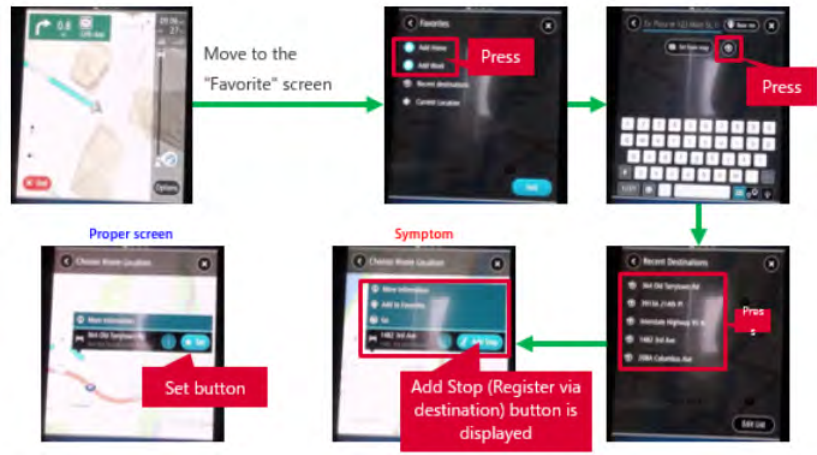
No	Category	Conditions/Symptoms to be improved
64	Navi	<p>Situation: To move to the “Favorite” screen with the navigation destination set. Press Add Home/Work. Select a location from the Destination History screen.</p> <p>Symptom: Add Stop (Register via destination) button is displayed instead of Set button, and Favorite registration for Home/Work cannot be done.</p>

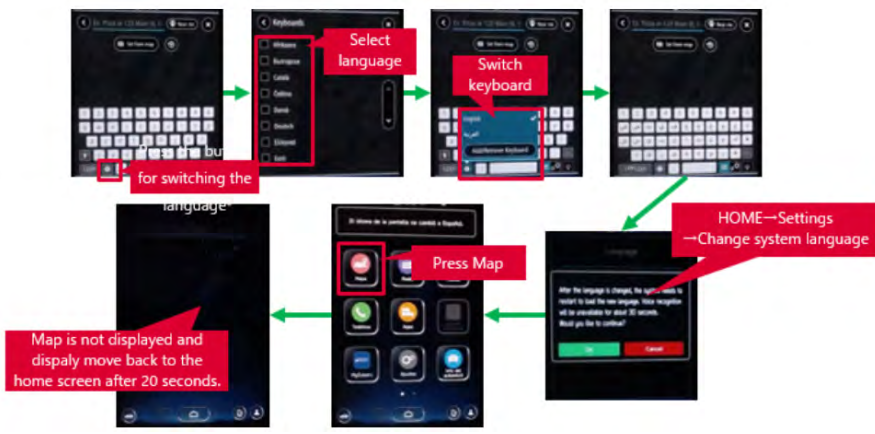
65	Navi	<p>Situation: Switching the language used for the text input keyboard on the search screen of the navigation application. Changing the system language of CCU.</p> <p>Symptom: Map is not displayed when Map is pressed from the home screen.</p>

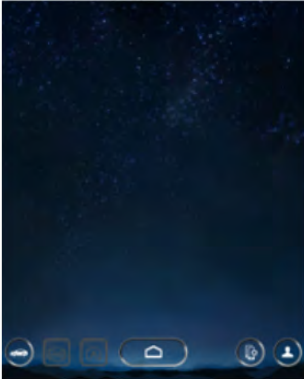
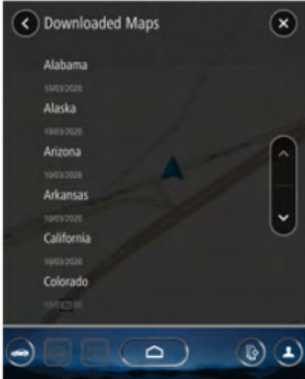
No	Category	Conditions/Symptoms to be improved
67	Navi	<p>When you set a navigation destination and drive, repeatedly triggering rerouting by deviating from the route, and then start a map update via Wi-Fi. If you wait for about 30 minutes on a screen other than the navigation screen (like the HOME screen) before transitioning back to the navigation screen, the following symptom occur:</p> <p>symptom 1: The map is not displayed. symptom 2: The download start button is not displayed on the map update screen.</p> <div style="display: flex; justify-content: space-around; align-items: center;"> <div style="text-align: center;"> <p>Symptom 1</p>

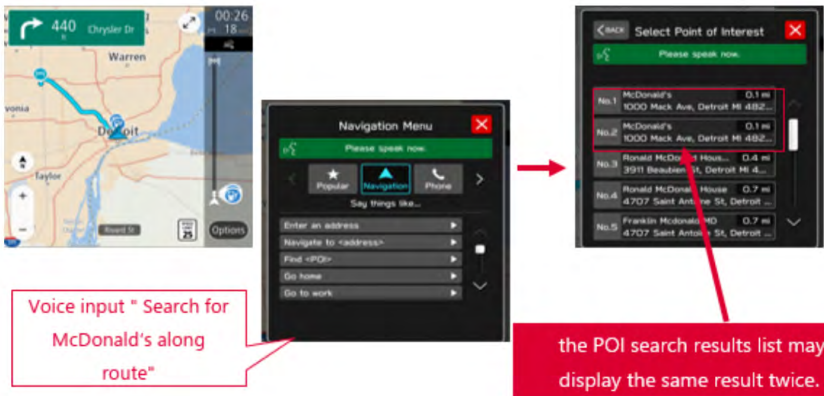
No	Category	Conditions/Symptoms to be improved
92	Navi	<p>When using voice recognition during navigation to say 'Search for **** along route,' the POI search results list may display the same result twice.</p>

<p>Voice input " Search for McDonald's along route"</p> <p>the POI search results list may display the same result twice.</p>
93	SXM	<p>Situation: Initiating the SXM Search feature simultaneously with the activation of the CCU unit's voice recognition.</p> <p>Symptoms: The voice recognition function encounters an error and ends.</p>

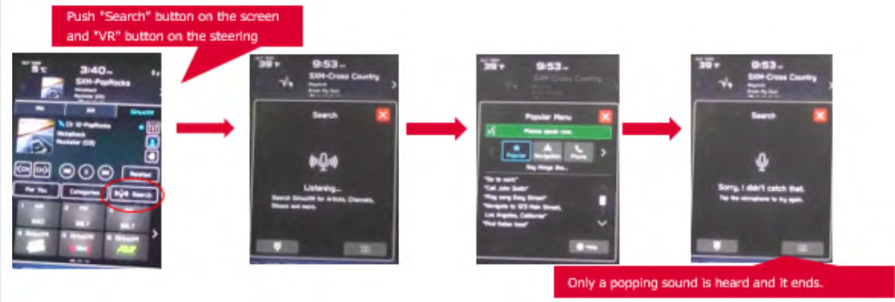
<p>Push "Search" button on the screen and "VR" button on the steering</p> <p>Only a popping sound is heard and it ends.</p>
94	Operation	<p>Situation: Displaying CarPlay call status in the Information Bar at the top of the CID during a call. Another popup overlaps on the Information Bar.</p> <p>Symptoms: Screen performance slows down, and touch operations become less responsive.</p>

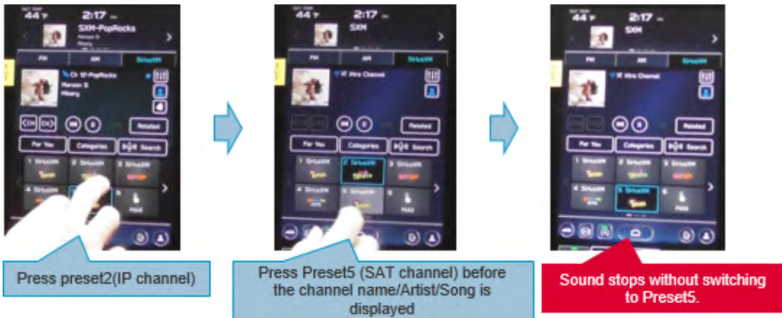
No	Category	Conditions/Symptoms to be improved
96	SXM	<p>When switching to the SAT channel (satellite channel) immediately after selecting the IP channel (Internet channel) on the SXM360, song information is not displayed and audio playback stops.</p>

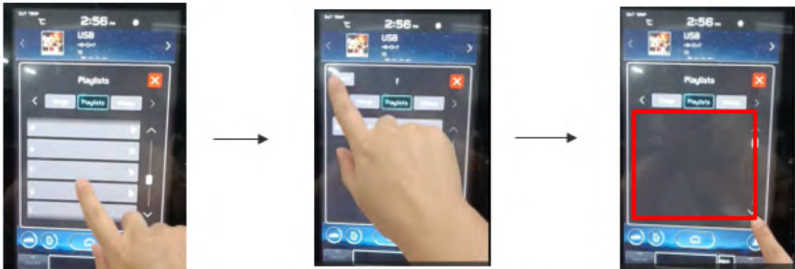
<p>Select an item on the Playlist list screen → Press "Back" on the song list screen → List is blanked out.</p>
111	Radio/SXM	<p>Situation: When the SXM satellite channel and IP channel are registered alternately in the radio preset registration, and the preset channel selection is switched continuously using the steering switch.</p> <p>Symptoms:</p> <ol style="list-style-type: none"> 1. the highlight of the radio preset disappears. (It shifts from the currently selected preset.) 2. Information on the radio screen becomes blank. 3. SXM sound is interrupted. 4. The channel does not change even if the preset button is pressed.

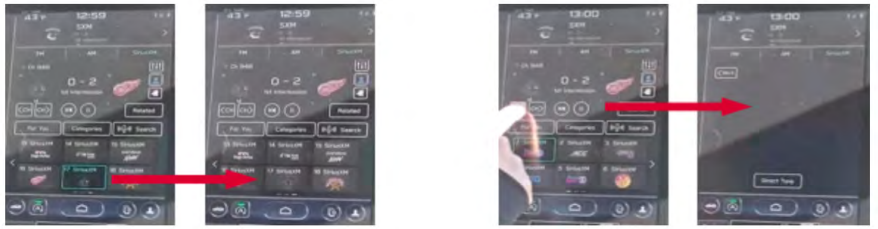
<p>Preset button highlight disappears (shifts) → The information on the screen is blank.</p>

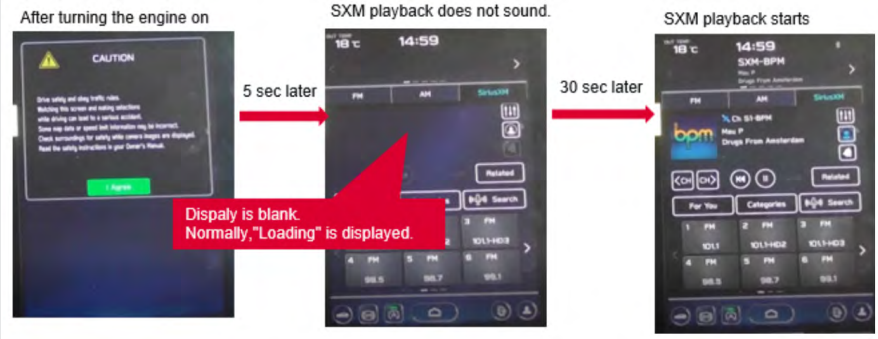
No	Category	Conditions/Symptoms to be improved
113	SXM	<p>After turning the engine on, "Loading" should appear on the channel information screen until SXM playback starts, but it does not appear and remains blank.</p>

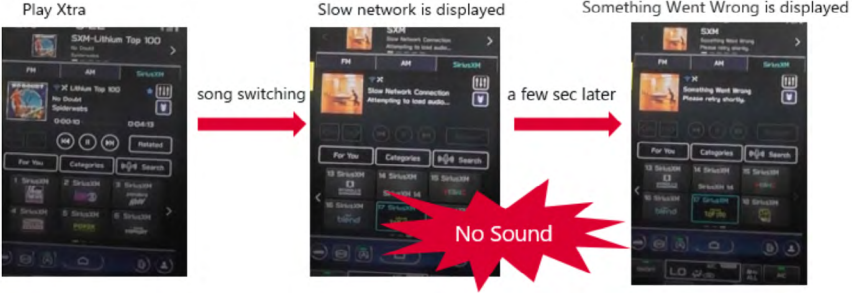
No	Category	Conditions/Symptoms to be improved
118	SXM	<p>While watching SXM's Xtra channel, "Slow Network" --> "Something Went Wrong" is displayed and no sound is heard.</p>

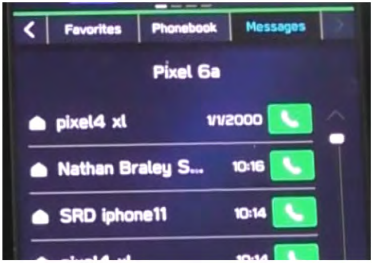
No	Category	Conditions/Symptoms to be improved
125	Display	<p>The date of an e-mail received message is displayed as 1/1/2000 instead of the correct date. This occurs on some models of phones with Android OS 13 or later.</p>
