Technical Service Bulletin

72 Rear backrest release in the luggage compartment is inoperative

72 24 55 2062113/6 April 16, 2024. Supersedes Technical Service Bulletin Group 72 number 23-52 dated December 21, 2023 for reasons listed below.

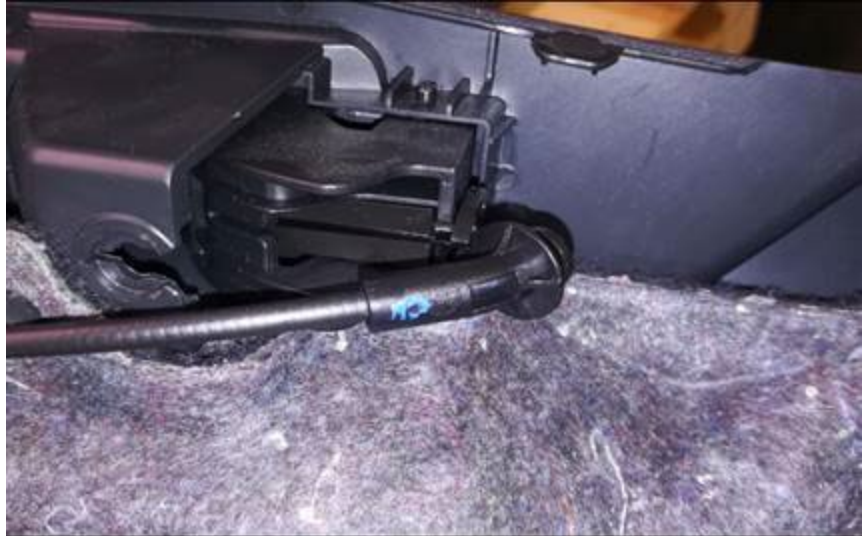
The Bowden cable disengages from its attachment point and does not release the backrest latch.

In some cases, this results in damage to the Bowden cable or to its attachment point in the luggage compartment side trim.

1. If the second-row backrest release lever is without resistance or feels loose, the Bowden cable in the luggage compartment side trim has become disengaged (Figure 1).

Figure 1. Bowden cable is disengaged from the attachment point.

2. Remove the luggage compartment side trim of the affected side according to the repair manual in Elsa.
3. Inspect the Bowden cable and the backrest release mechanism for any damage.
4. Reinstall the Bowden cable in the backrest release mechanism and secure it with a tie wrap (Figure 2).

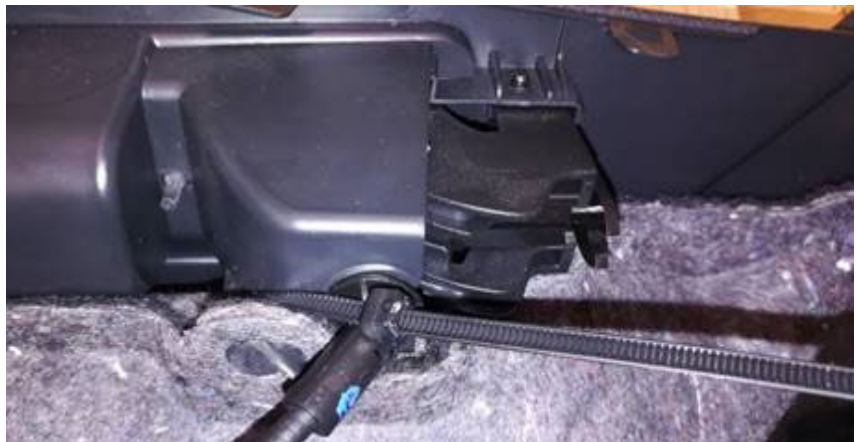
Figure 2. The Bowden cable; reinstalled and secured with a tie wrap.

5. Check the operation of both backrest release levers in the luggage compartment.
6. Reinstall the luggage compartment side trim.
