# Technical Service Bulletin

## 87 Noise from the air conditioning compressor when the AC is active

87 24 72 2063467/6 April 18, 2024. Supersedes Technical Service Bulletin Group 87 number 23-49 dated August 9, 2023 for reasons listed below.

Model(s)	Year	VIN Range	Vehicle-Specific Equipment
e-tron quattro	2019 2021 - 2023	All	Not Applicable
e-tron Sportback quattro	2020 - 2023		
Q8 e-tron, SQ8 e-tron, Q8 e-tron Sportback, and SQ8 e-tron Sportback	2024

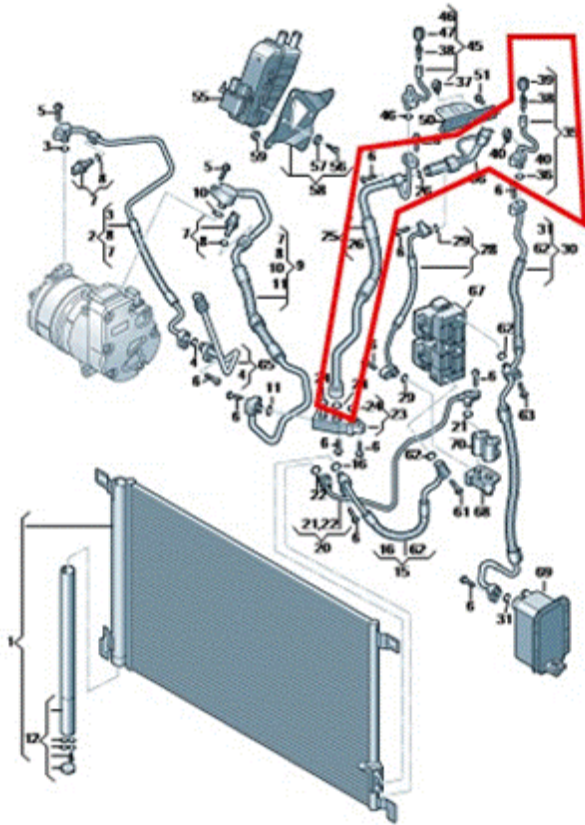
The source of this noise may be due to direct contact between adjacent refrigerant lines (Figure 1) or between a refrigerant line and the Bowden cable clip for the front hood release in the front motor compartment (Figure 2).

When the air conditioning compressor is operating the noise created by the vibration is transferred from this point of contact and into the cabin.

**Figure 1.** The refrigerant lines possibly make contact.

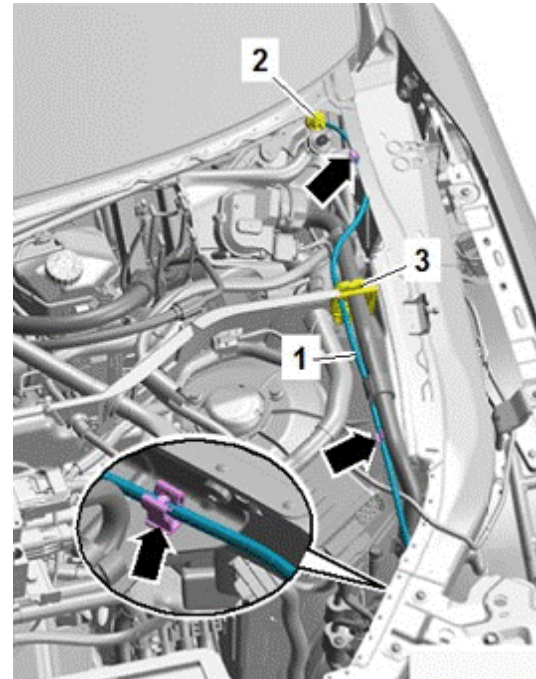
**Figure 2.** Location of the Bowden cable clip for the front hood release.

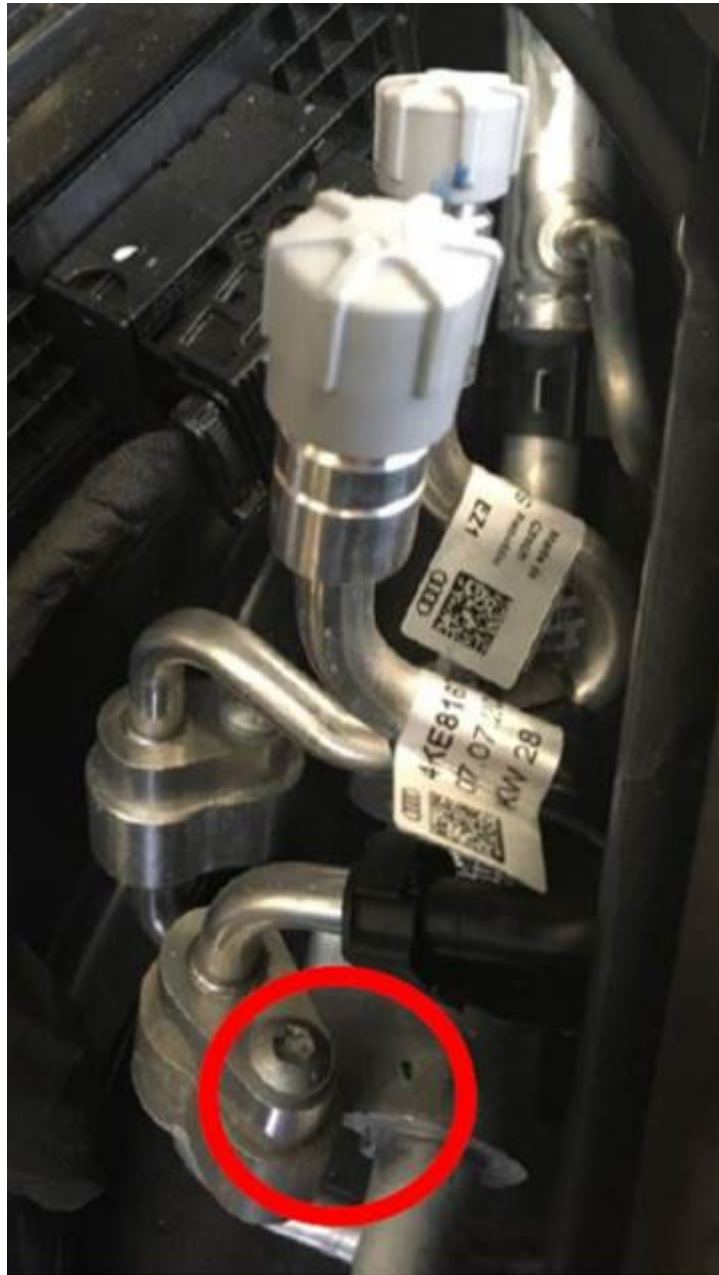
1. Figure 3 shows refrigerant lines close enough to make contact and elicit vibration transfer and noise.

*Figure 3. The refrigerant lines are making contact.*

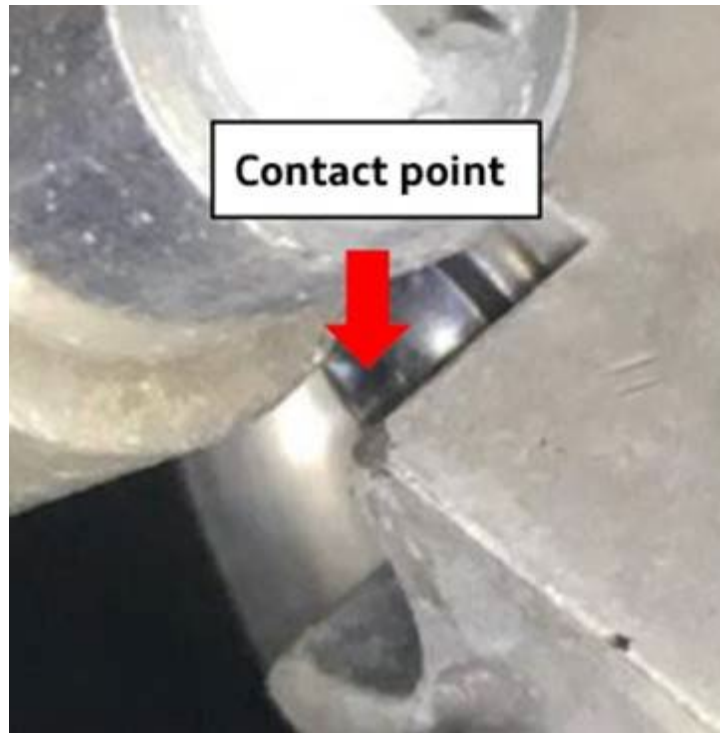
2. Figure 4 shows a close-up view of the point of contact.

*Figure 4. Point of contact.*

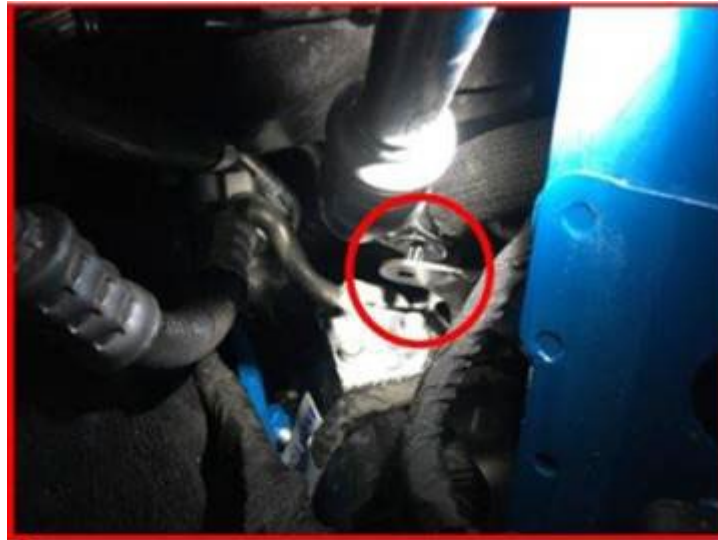
**Figure 5.** The area in the motor bay where contacting lines are located.

3. These refrigerant lines must be separated and, if necessary, retained in a separated position using a hose holder, clip, or tie-wrap (Figure 5).

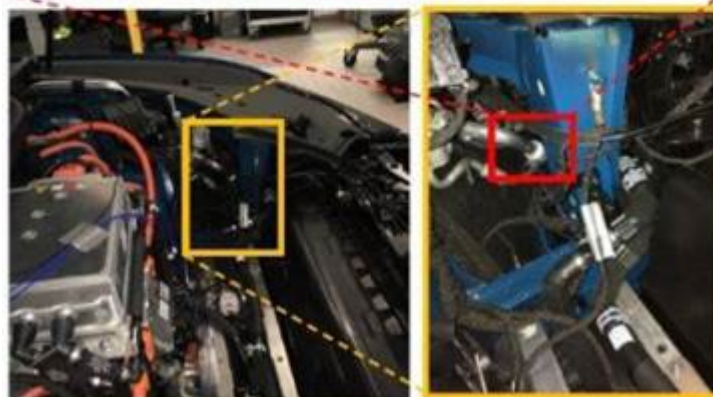
**Figure 6.** Refrigerant lines retained in a separated position.

4. Figure 6 shows properly separated refrigerant lines.

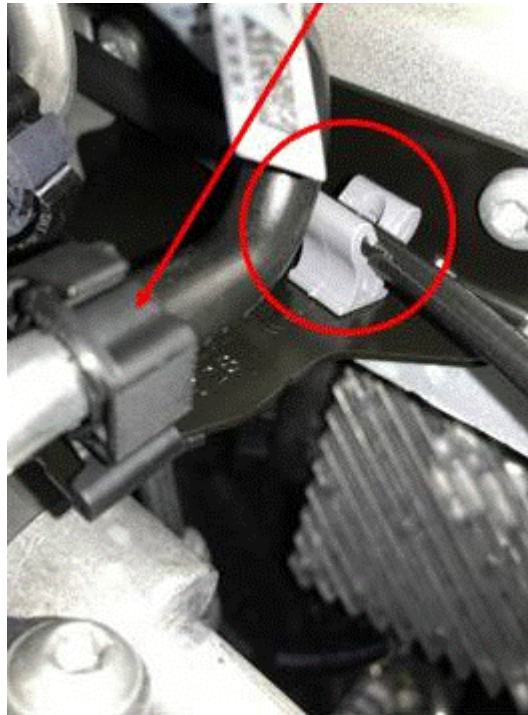
**Figure 7.** Point of contact between refrigerant line and Bowden cable clip.

5. An additional point of contact may be found between the refrigerant line containing the service port and the clip that retains the Bowden cable for the front hood release. If contact is found here these components must be separated and secured in a separated position. The retaining clip for the refrigerant line allows the line to slide within it. This is to be considered when securing the line away from the clip for the Bowden cable.

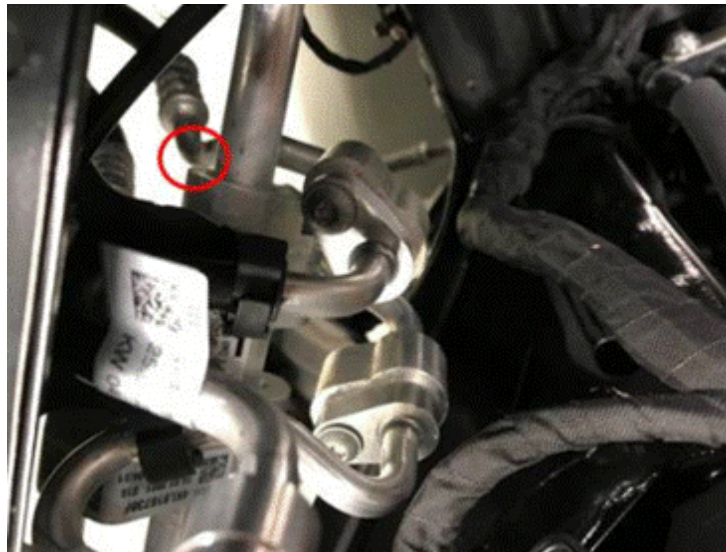
6. Figure 8 shows an additional point of contact possible at the coaxial refrigerant line where it crosses the refrigerant line containing the service port. Again, separate and secure these lines in a separated position.

**Figure 8.** Point of contact between coaxial refrigerant line and the refrigerant line containing the service port.

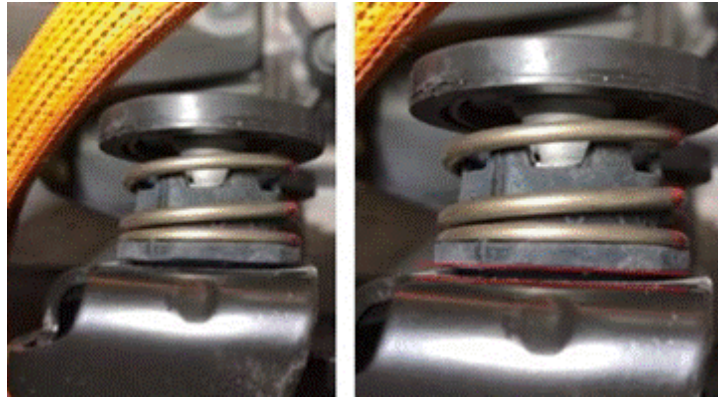
7. In some cases, the compressor isolator spring is not indexed correctly in the rubber mounting causing an incorrectly seated compressor isolator assembly. Inspect the isolator / spring assembly for proper fit of the spring to the isolator at the top and bottom seating areas. Figure 9 shows a poorly seated isolator showing a gap between the rubber isolator and the mounting bracket.

**Figure 9.** Poorly seated compressor isolator / spring assembly.

8. The spring and / or rubber mount may need to be twisted to correct the spring to rubber mount index allowing the isolator assembly to lie flat against the bracket. Figure 10 shows a properly seated isolator / spring assembly.

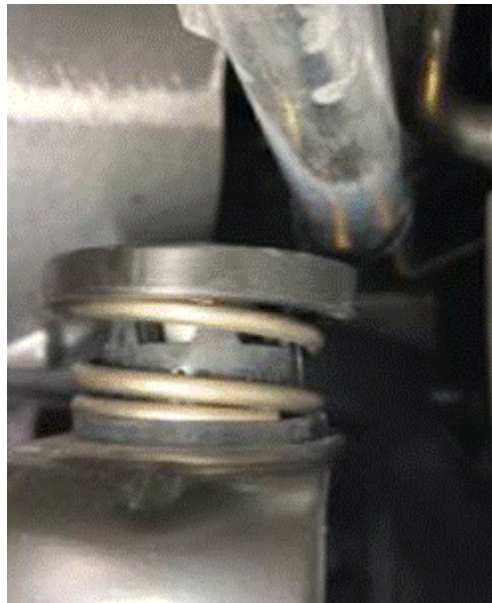
**Figure 10.** Correctly seated compressor isolator / spring assembly.

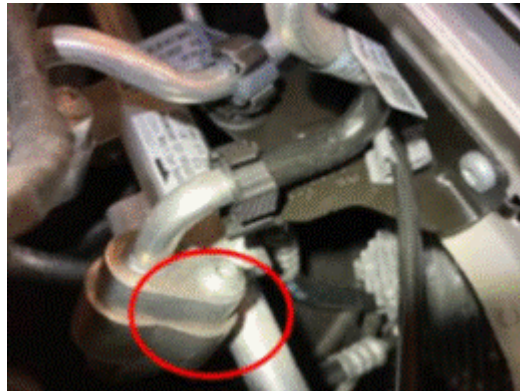
9. An additional possible point of line contact is the service port mounting block in Figure 11.

**Figure 11.** Service port mounting interference with adjacent line.

10. Correct this by pushing the service port in the direction of the arrow with just enough force to create a permanent clearance as shown in Figure 12.

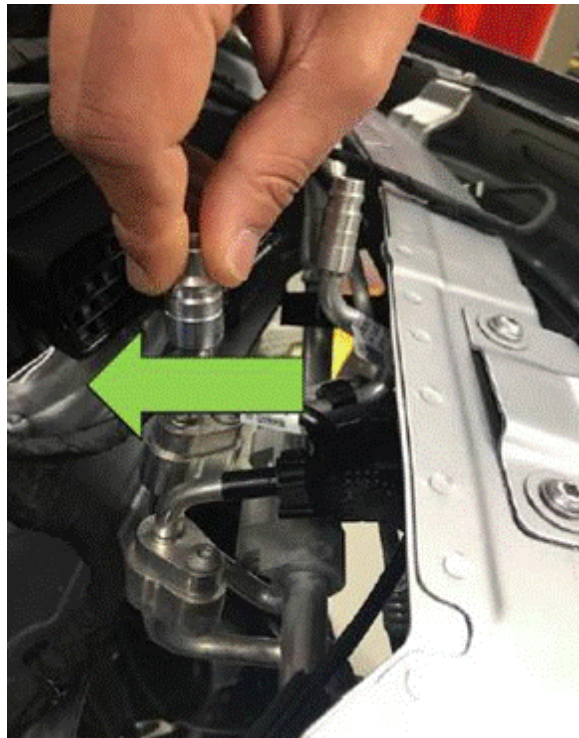
**Figure 12.** Creating a permanent gap between the service port mounting and the adjacent line.
