SERVICE BULLETIN

APPLICABILITY: 2023-24MY Ascent
2023-24MY Legacy & Outback

NUMBER: 07-225-24R

SUBJECT: EyeSight Reprogramming Files / DTCs B28C7, B28A6, Halt Code E5

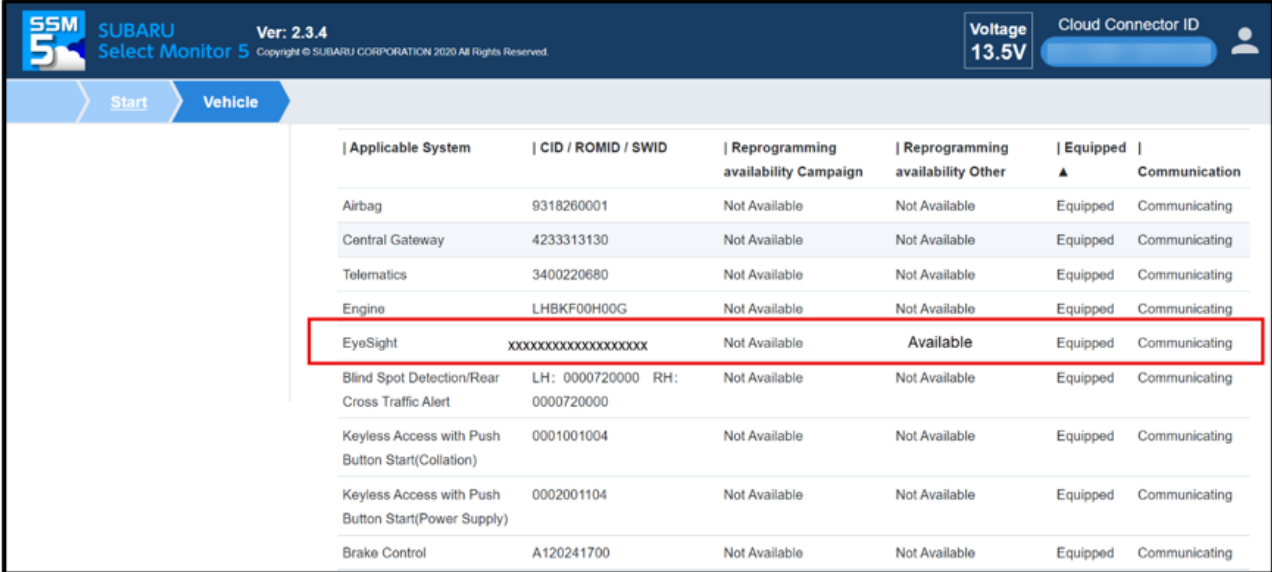
STEP 5: Using the Subaru Select Monitor 5-R (SSM5-R), confirm the following EyeSight Stereo Camera Assembly information:

The reprogramming column reads “**Available.**”

NOTE: Additional information regarding SSM5-R can be found in TSB 14-28-21R.

STEP 6: Are new reprogramming files available?

YES: Proceed to the next Step.

NO: Reprogramming is not required. Diagnosis must be performed as per the applicable Service manual.
