# Service Bulletin

Bulletin No.: 23-NA-197

**Subject: Noise from Transmission Area, Malfunction Indicator Lamp (MIL) Illuminated**

Brand:	Model:	Model Year:		VIN:		Engine:	Transmission:
		from	to	from	to		
Chevrolet	Corvette	2020	2023	—	—	—	M1L, M1M

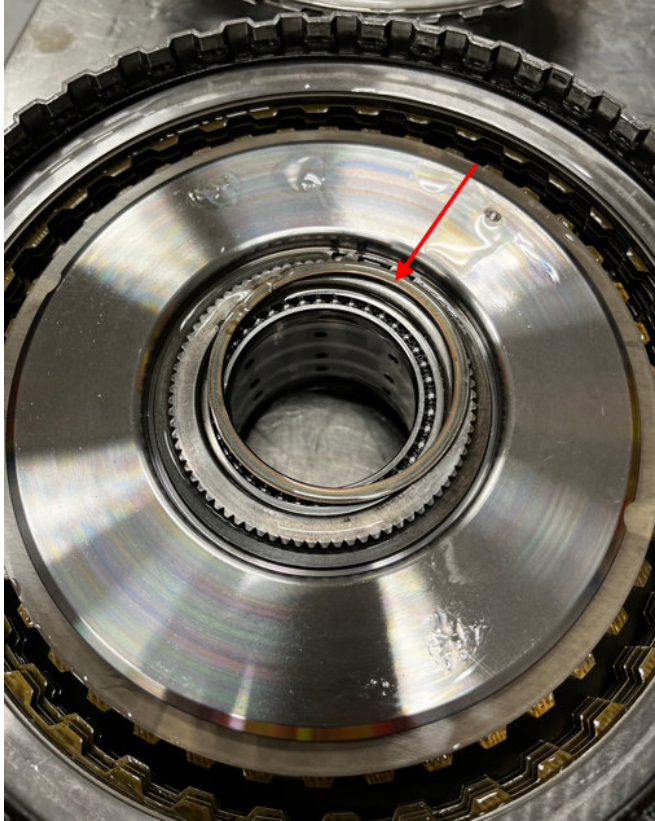
<p><b>Cause</b></p>

<p>This condition may be caused by a dislodged snap ring in the direct clutch assembly. <span style="float: right;">6444881</span></p> <ul style="list-style-type: none"> <li>- One or more pressure DTCs may set due to the valves sticking in the Main Control Valve (MCV) Body, due to debris.</li> <li>- The direct clutch can contact the fluid tubes, stator shaft and/or the transmission housing.</li> </ul>
<p><b>Correction</b></p>	<p>Refer to the Service Procedure below.</p>

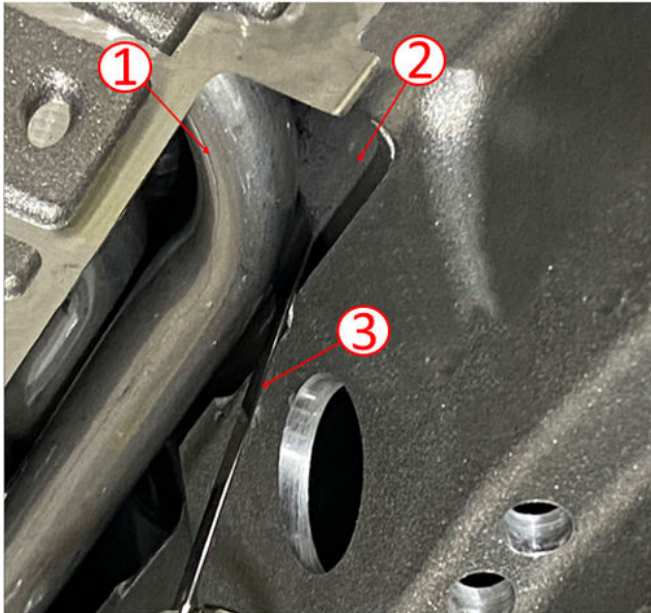
6444679

4. Utilizing a feeler gauge (3), inspect the clearance between the direct clutch (2) and fluid tube (1).
  - ⇒ If clearance is 0.5 mm, follow service information to replace the MCV, filter and canister filter.
  - ⇒ If clearance is 0 mm, remove transmission and go to step 5.

**Note:** If the direct clutch is seized onto the stator housing, the transmission will need replacement.

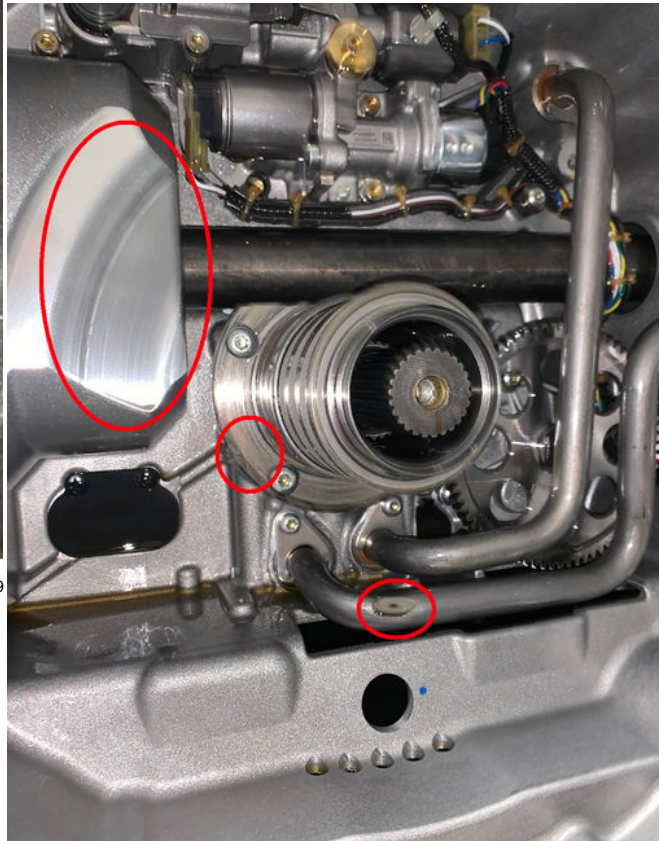
6444902

5. Remove the direct clutch. Refer to *Direct Clutch Replacement*.
  - If the direct clutch has seized to the stator and it cannot be removed, the transmission will have to be replaced.
  - If the direct clutch cannot be turned easily by hand, this is evidence that the snap ring has failed. Remove the direct clutch and inspect the transmission case. If it is found to have damage from direct clutch contact, start a technical assistance case and attach photos.

**Important:** Light damage to the housing caused by the direct clutch contact, will not require replacement. The graphic above depicts areas of concern.

- If the direct clutch can be removed easily but has contacted the pipe and stator, replace said parts as needed. Refer to SI.

**Note:** The direct clutch and stator housing will need replacement as the causal part.
