Service Bulletin

Bulletin No.: 24-NA-033

Subject: HVAC Temperature Control Switch Sticking

Brand:	Model:	Model Year:		Breakpoint:		Engine:	Transmission:
		from	to	from	to		
Chevrolet	Trax	2024	2024	SOP	October 25, 2023	—	—

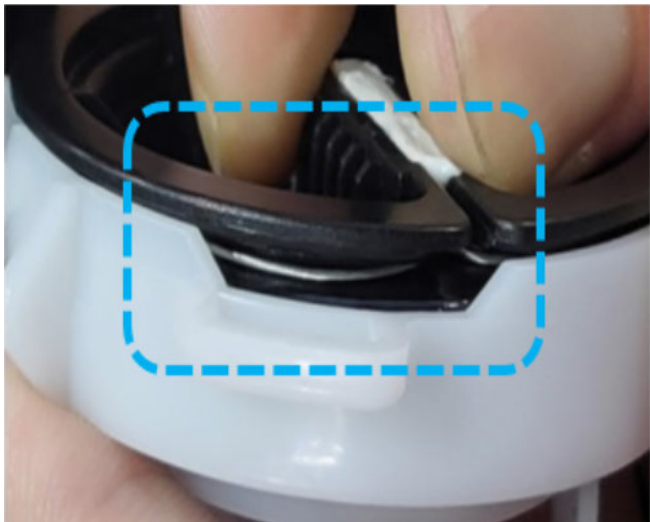
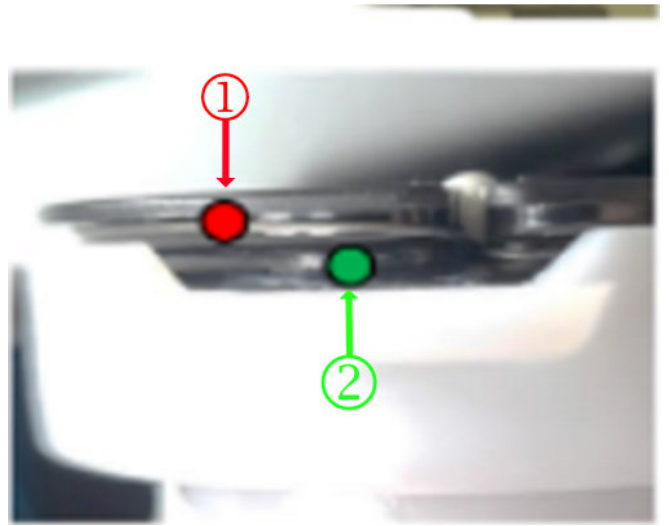
- 4. Check the cable position in the temperature cable. If the cable is not in the normal position (1), reposition the cable into the groove (2) as shown in the pictures above.

Note: The wire position needs to be checked with the pulley in the 'HOT' position.
