Service Action

Code: 87H9

Subject	Pressure & Temperature Sensors																									
Document History	<table border="1"> <thead> <tr> <th>Date</th> <th>Summary</th> </tr> </thead> <tbody> <tr> <td>04/11/2024</td> <td>Updated claiming instructions</td> </tr> <tr> <td>02/23/2024</td> <td>Updated claiming instructions</td> </tr> <tr> <td>02/13/2024</td> <td>Original publication</td> </tr> </tbody> </table>	Date	Summary	04/11/2024	Updated claiming instructions	02/23/2024	Updated claiming instructions	02/13/2024	Original publication																	
Date	Summary																									
04/11/2024	Updated claiming instructions																									
02/23/2024	Updated claiming instructions																									
02/13/2024	Original publication																									
Affected Vehicles	<table border="1"> <thead> <tr> <th>Country</th> <th>Beginning Model Year</th> <th>Ending Model Year</th> <th>Vehicle</th> <th>Vehicle Count</th> </tr> </thead> <tbody> <tr> <td>USA</td> <td>2021</td> <td>2022</td> <td>E-TRON QUATTRO</td> <td>7,387</td> </tr> <tr> <td>USA</td> <td>2020</td> <td>2022</td> <td>E-TRON SPORTBACK QUATTRO</td> <td>3,307</td> </tr> <tr> <td>CAN</td> <td>2021</td> <td>

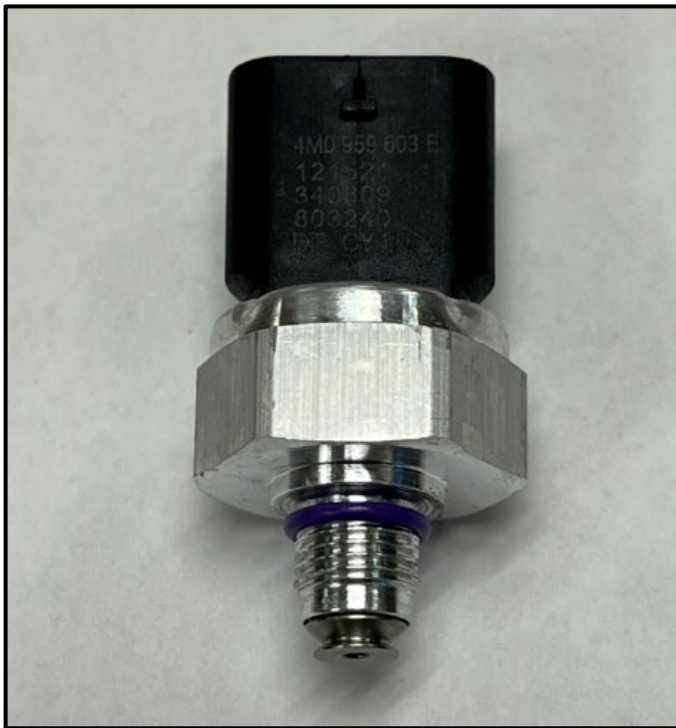
- Inspect G395 and G826 pressure/temperature sensors.
- Replace if necessary.

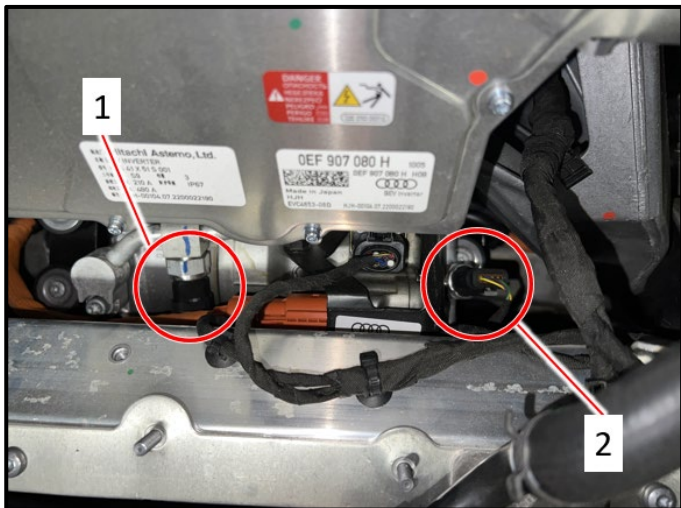
Inspect G395 and G826 pressure/temperature sensors:

- Remove front luggage compartment liner <1> per the ELSA repair manual:
 - *Repair manual > Body > Body Interior > Interior Trim > Luggage Compartment Trim Panels > Front Luggage Compartment Liner, Removing and Installing*

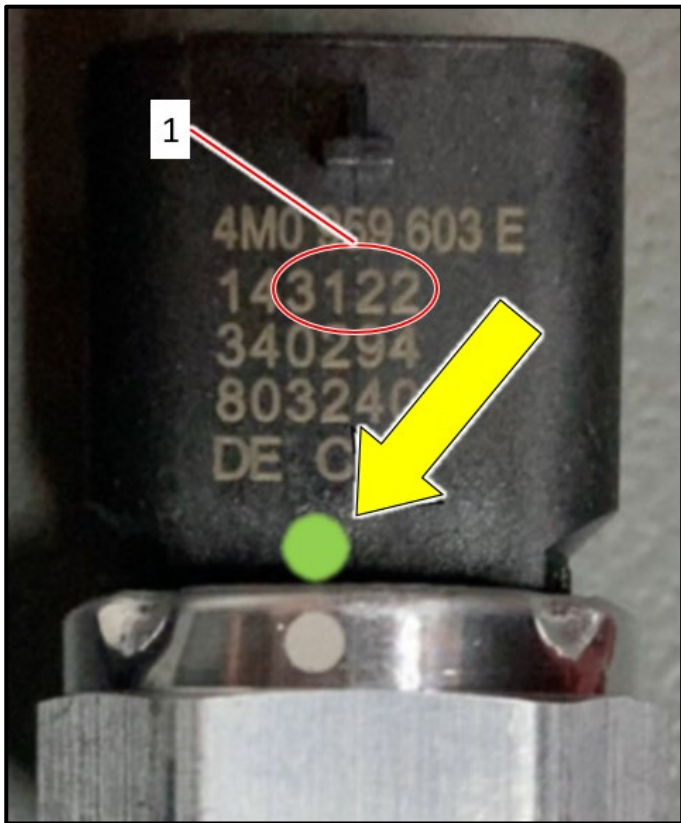
The connectors for the G395 and G826 can be swapped! Ensure that the connectors are reinstalled in their correct locations if removed.

- Locate the G395 <1> and G826 <2> sensors in the under hood compartment.
- Label the sensors and connectors as needed.
- Ensure the ignition is turned off.
- Disconnect the sensors.

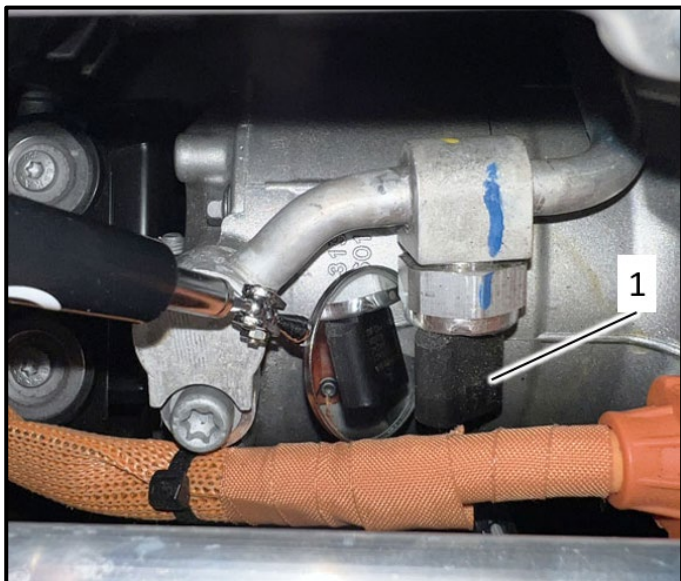
- Check for a green dot <arrow> on the connector housing of the G395 and G826.
- If the green dot is present on both sensors:
 - The sensors do not require replacement.
 - Continue with the reassembly instructions in this section.
- If the green dot is **NOT** present on the sensor(s):
 - Check the production date <1> of the affected sensor.
 - If the affected sensor was produced calendar week 23 of 2020 through calendar week 30 of 2021, the sensor must be replaced.

The production date <1> of the sensor pictured is calendar week 31 of 2022. This sensor does not require replacement. The date format is week/year.

- If a sensor requires replacement:
 - Proceed to section C.
- If both sensors are ok and do not require replacement:
 - Continue with the reassembly instructions in this section.
