Technical Service Bulletin

96 Lane change assist: side assist and exit warning system: unavailable. Sensor view restricted (DTC C12AA00)

91 24 01 2073683/1 April 16, 2024.

Model(s)	Year	VIN Range	Vehicle-Specific Equipment
RS 6	2021 - 2024	All	Not Applicable

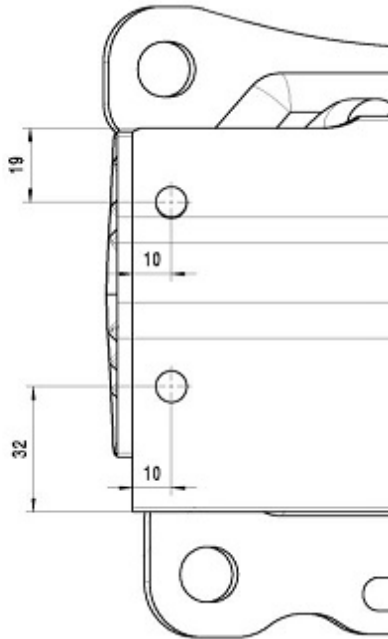
Figure 1: Illustration showing positioning of holes for spreader rivets.

In order to secure the covers, two holes (8 mm diameter) must be drilled on each side (left and right) of the bumper cover, as shown in the image below:

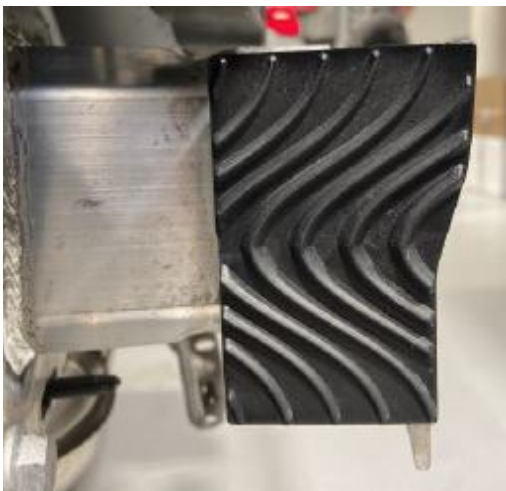
Figure 2: Cover mounted on bumper carrier (left side).

Cover the holes and openings on both sides of the bumper carrier. To do so, please use the following covers:

- 4K0 807 245 / 4K0 807 246
