Complaint - Oil Leak on Intake Side of Right Turbocharger: Replace Intake Pipe (210/20)

Model Year: **As of 2020 up to 2021**

Vehicle Type: **911 Carrera (992) / 911 Carrera S (992) / 911 Carrera 4 (992) / 911 Carrera 4 S (992) / 911 Targa 4 (992) / 911 Targa 4S (992) / 911 Turbo (992) / 911 Turbo S (992)**

Concerns: **Intake pipe on turbocharger, right**

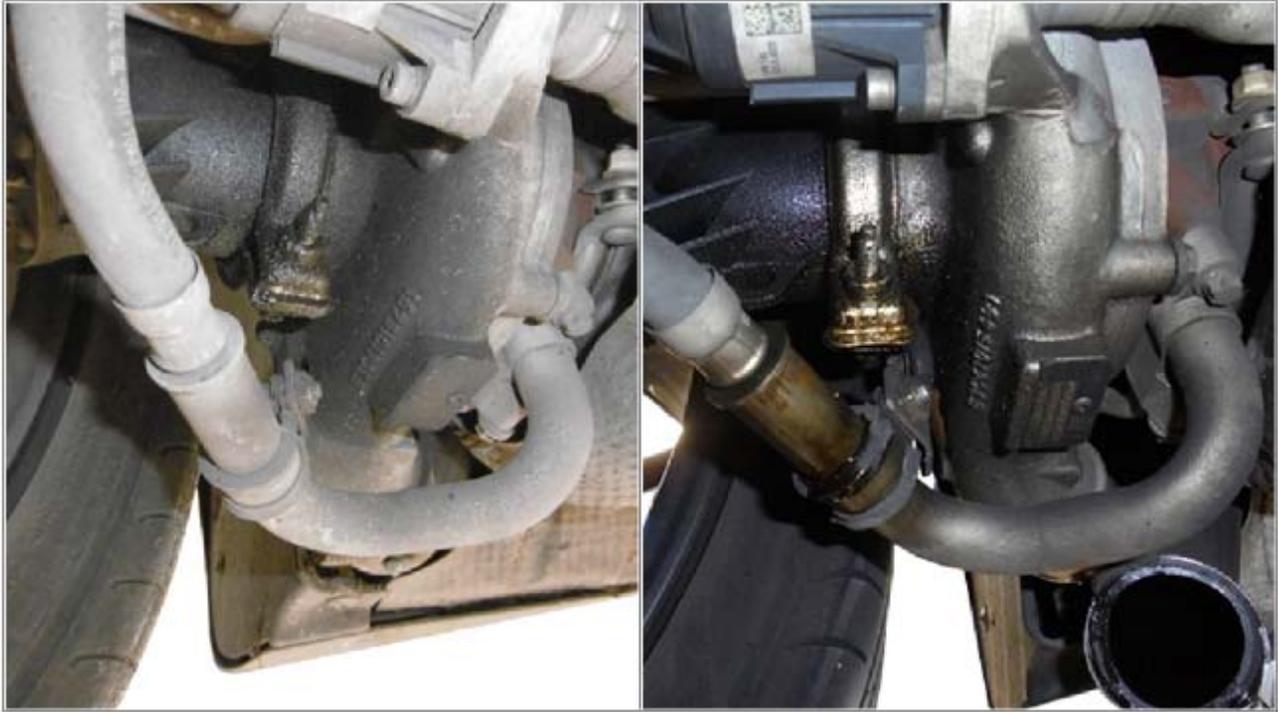
Information: The right turbocharger shows a leak on the intake side and there are traces of oil visible on the turbocharger and intake pipe housing.

Oil leak on right turbocharger

Action required: If there is a customer complaint, **replace** the intake pipe instead of the turbocharger..
Replacing the turbocharger or oil separator will not correct this problem.
