Field campaign

Topic	Bentayga - Data bus control unit (J533) replacement (SC24/05)
Market area	United States E05 Bentley USA and rest America (6E05)
Brand	Bentley
Transaction No.	2073264/2
Campaign number	EC97
Note	
Type	
US code

The Data bus control unit - J533 (Gateway) must be replaced

Replacement of the Data bus control unit - J533 (Gateway) is required

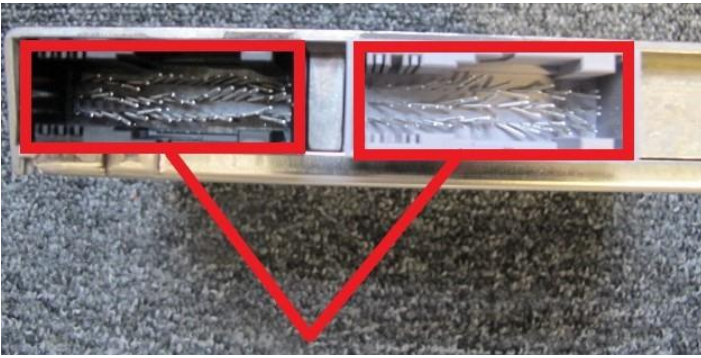
- 25) Raise a non-technical DISS query ensuring the following is included
- Photograph of the original Data bus control unit - J533 showing the damaged / bent pins (Figure13)

16) Once removed - Using a suitable tool (Figure 12) flatten / bend each individual pin within the grey and black connectors of the original Data bus control unit - J533 (Gateway) until all pins are as shown in Figure 13

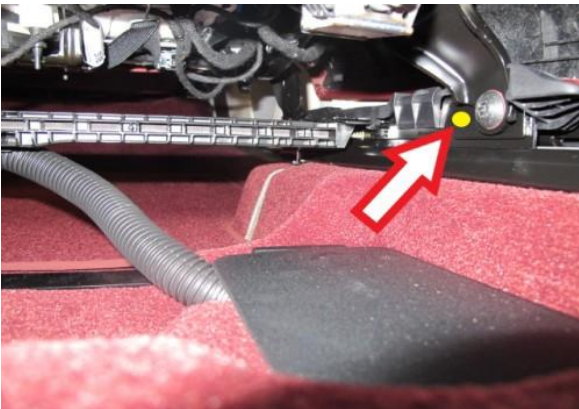
Yellow paint mark on the driver's seat outer rail confirms completion as shown in Figure 16

- Save an ODIS log online
- 26) Referring to Figure 16 - Apply a yellow paint mark on the driver's seat outer rail at the location shown
