WRB1 - Replacing Gateway Control Unit (Workshop Campaign)

Model Line: **Taycan (Y1A / Y1B / Y1C)**

Model Year: **As of 2023 up to 2024**

Concerns: **Gateway control unit**

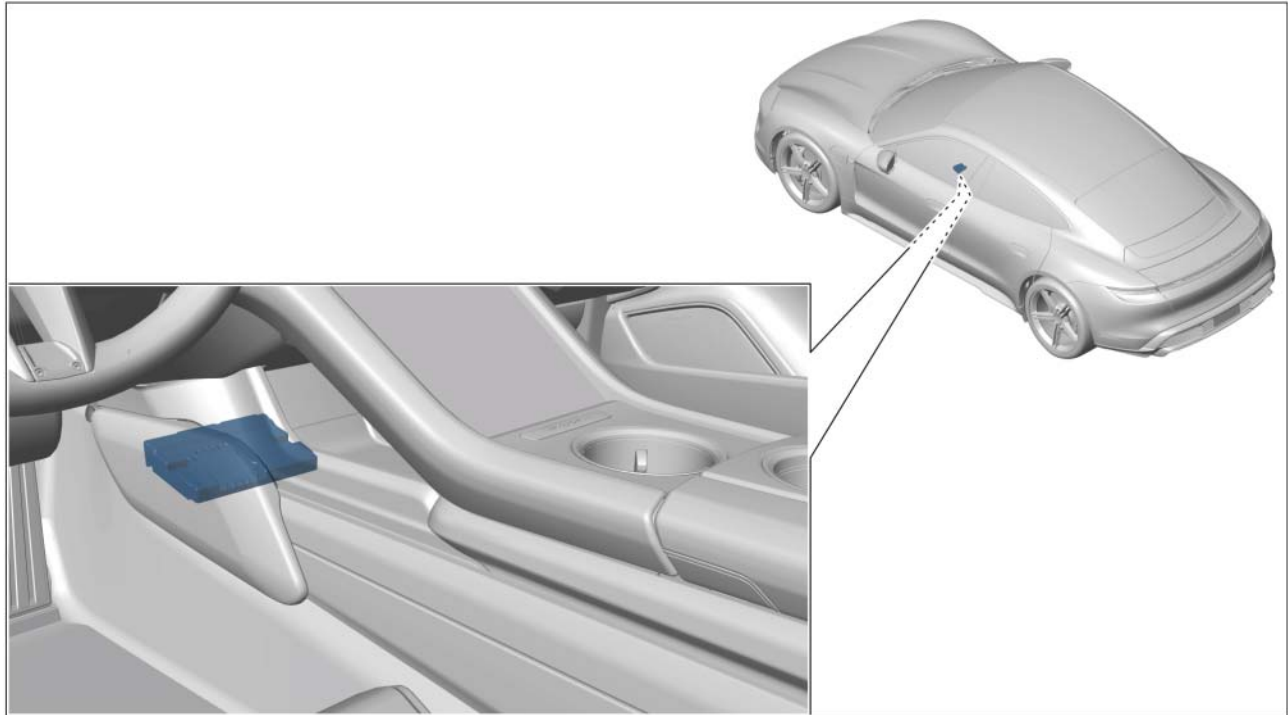
Installation position of gateway control unit
