<b>Topic</b>	New Continental GT and New Flying Spur Series - Data bus control unit (J533) replacement (SC24/06)
<b>Market area</b>	United States E05 Bentley USA and rest America (6E05)
<b>Brand</b>	Bentley
<b>Transaction No.</b>	2072950/2
<b>Campaign number</b>	EC98
<b>Note</b>	
<b>Type</b>	
<b>US code</b>

### New Continental GT and New Flying Spur Series

The Data bus control unit - J533 (Gateway) must be replaced

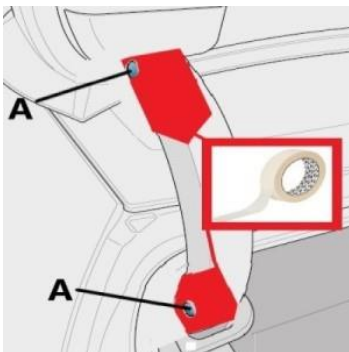
The hinge covers scratch very easily, take great care when releasing the clipping points, please also observe the following precautions to prevent any damage

Referring to Figure 1 - Apply several layers of masking tape at the highlighted locations before removing the trim cover clips (A) **extra care must be taken when removing the clips**

- Using a non-metallic slotted trim tool, carefully remove the clips and **DISCARD**

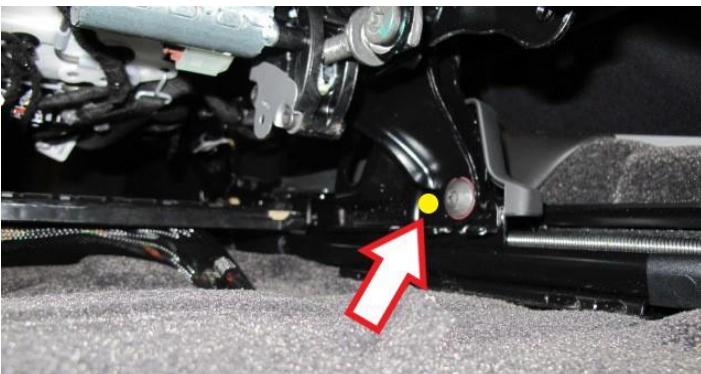
Yellow paint mark on the driver's seat outer rail (behind fixing) confirms completion as shown in Figure 6

16) Referring to Figure 6 - Apply a yellow paint mark on the driver's seat outer rail (behind fixing)
