## Technical product information

<b>Topic</b>	Convertible roof - C flap Bowden cable replacement
<b>Market area</b>	Worldwide Bentley (1WBE)
<b>Brand</b>	Bentley
<b>Transaction No.</b>	2033467/2
<b>Level</b>	EH
<b>Status</b>	Approval
<b>Release date</b>

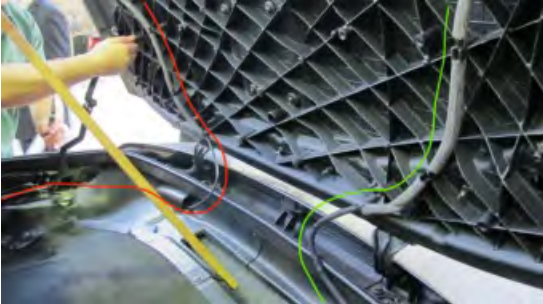
Figure 1 depicts the original routing of the Bowden cables. Note the sharp radius of the Bowden cable and the multiple clips securing the cable to the tonneau cover all these contribute to the increased friction in the system. The new arrangement removes the sharp radius and deletes all but one of the clips securing each cable to the tonneau cover

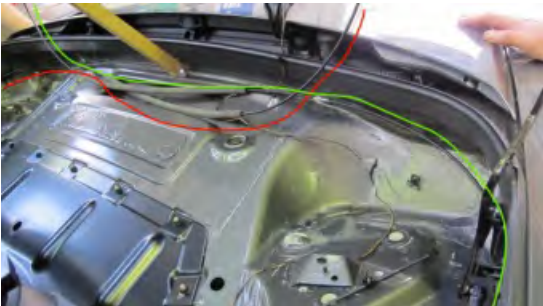
Figure 2 depicts the new longer cables following the cross over routing
