NOISE FROM FRONT MAP LIGHT SURROUNDINGS

Bulletin No.: 09-021/24

2024 CX-90 (with panorama sunroof)

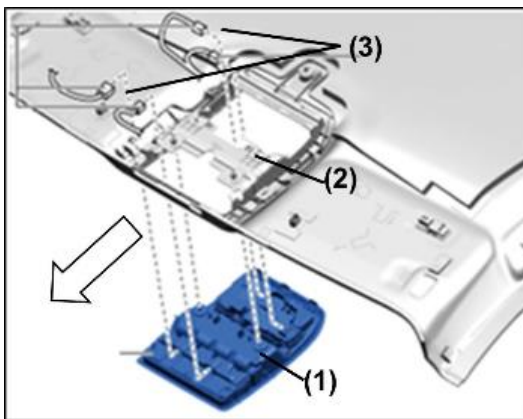
Some customers may complain about a rattle or vibration noise coming from front map light surroundings when driving on a rough road. This may be caused by the bracket for the map light. Due to heat or vibrations, the fastener fixing the front map light to the bracket may deform, making the joint loose. In such case, when the vehicle bounces, the bracket may oscillate and produce a rattling noise. To eliminate that concern, non-woven fabric will be attached to the headliner.

1. Front map light
2. Bracket
3. Connectors
