<b>Subject:</b>  <b>POWER LIFTGATE MAY OPEN UNINTENTIONALLY WHILE VEHICLE IS PARKED/STOPPED</b>	<b>Bulletin No.:</b> 09-022/24
	<b>Last Issued :</b> 04/08/2024

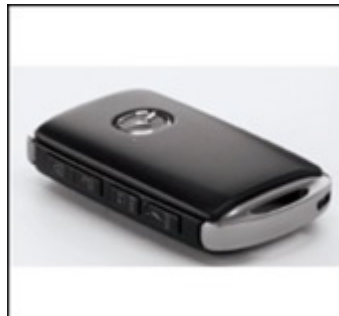
7th Generation Transmitter

Due to the shape of the 7th generation remote transmitter, the power liftgate button may be long pressed unintentionally in a pocket or a bag. To eliminate this concern, the keyless control specification has been modified. The button press time has been increased from 0.5 seconds to 1 second.

1. Verify the concern.
2. Replace the start stop unit according to the instructions on MGSS:
  - CX-5: START STOP UNIT REMOVAL/INSTALLATION
  - CX-9: START STOP UNIT REMOVAL/INSTALLATION
3. Verify the repair.

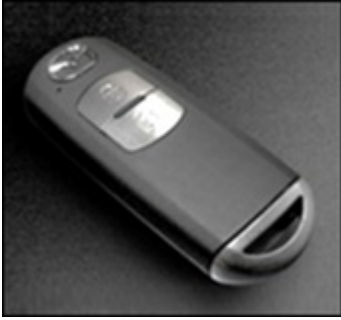
6th Generation Transmitter

**CAUTION:** Vehicles with 6th generation remote transmitter do NOT apply to this Service Information.
