Service Alert

Subject: MAZDA CONNECT INTERMITTENT AUDIO NO SOUND AND/OR STATIC NOISE FROM SPEAKERS	Service Alert No.: SA-021/24
	Last Issued : 04/09/2024

2020-2024 CX-30

2019-2024 Mazda3

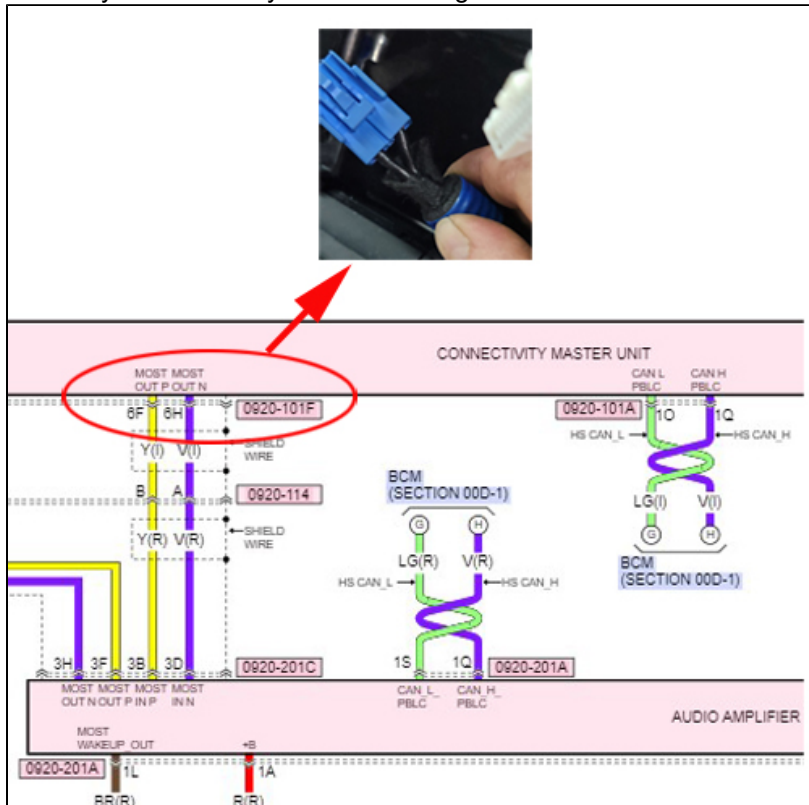
This may be caused by PIN 6F backing out at the CMU connector 0920-101F.

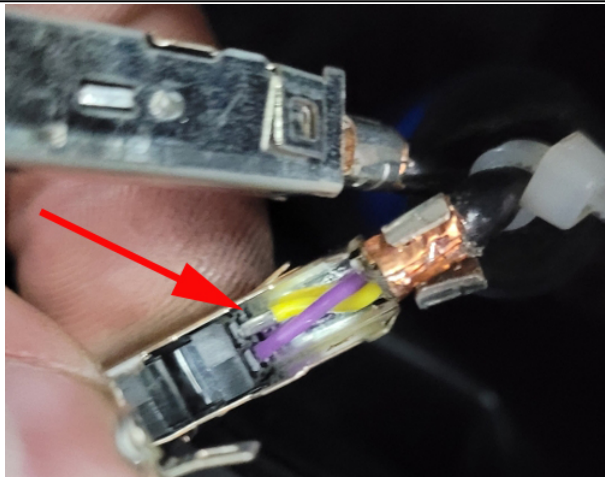
PIN 6F is backed out

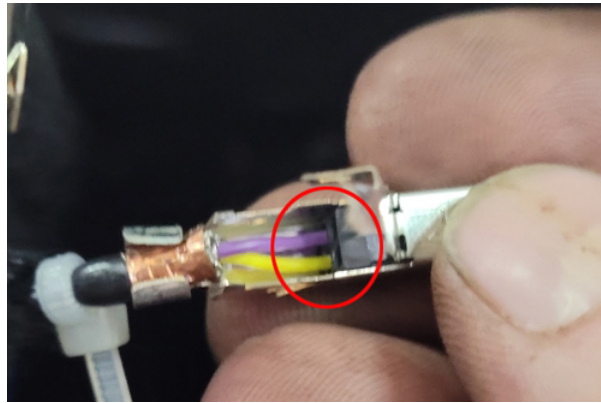
PIN 6F is untwisted and repaired

5. Untwist pins 6F and 6H (straighten) and reinstall them into connector 0920-101F.
