Service Alert

RATTLE NOISE UNDER HOOD FROM HOOD PROP ROD

Service Alert No.: SA-023/24

2019-2024 Mazda3 2020-2024 CX-30

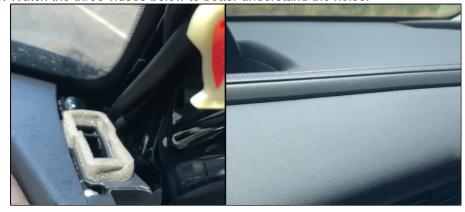
The customer may report a rattling noise from the front of the vehicle under load. It may sound as if it is coming from the dashboard, but it is coming from the hood prop rod (aka lock-bonnet stay).

1. Watch the three videos below to better understand the noise.
