RYKER 2019-20-21-22-23 Incorrect Camshaft Timing - 136437

We have Rykers 900 engines that may have the incorrect camshaft timing

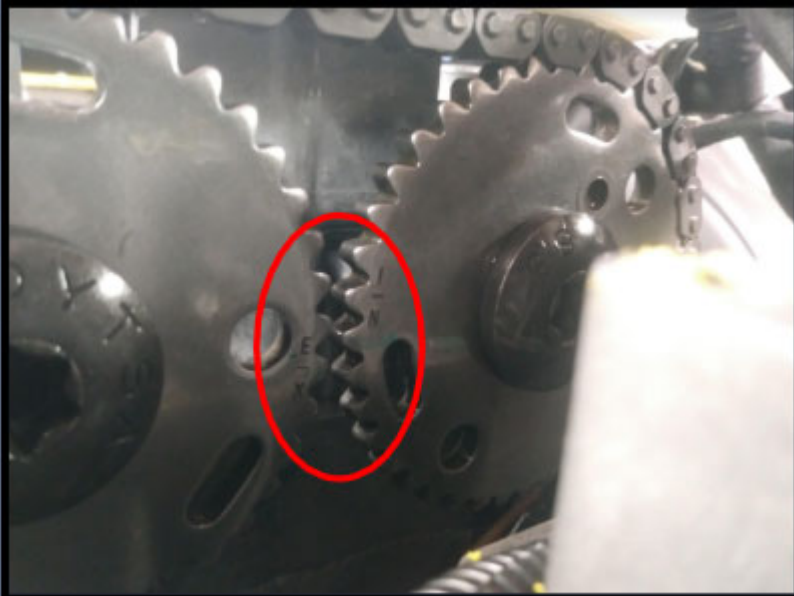
At PDI or low miles, the Ryker equipped with the 900 engine may start well when cold but then can have a rough idle or even dies at idle when the engine is warmed up. It is possible that the camshaft timing is off by one or two teeth.

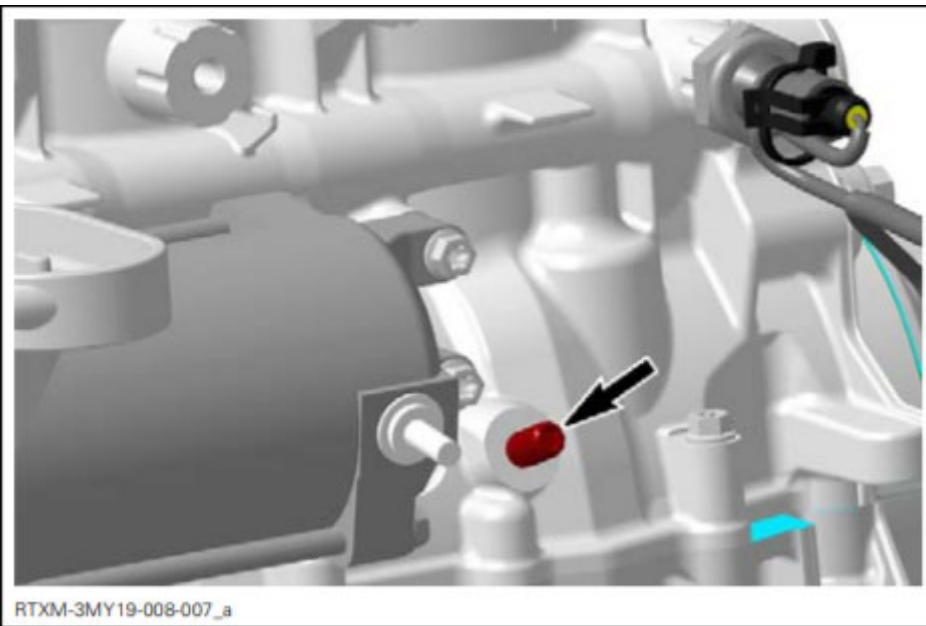
6. NOTE that the tip of the BRP locking screw can be modified a little for ease of use. You can grind the tip a little to have a V-shaped.

5. Lock crankshaft. Make sure to lock the crank with the REQUIRED TOOL CRANKSHAFT LOCKING BOLT (P/N 529 035 617)

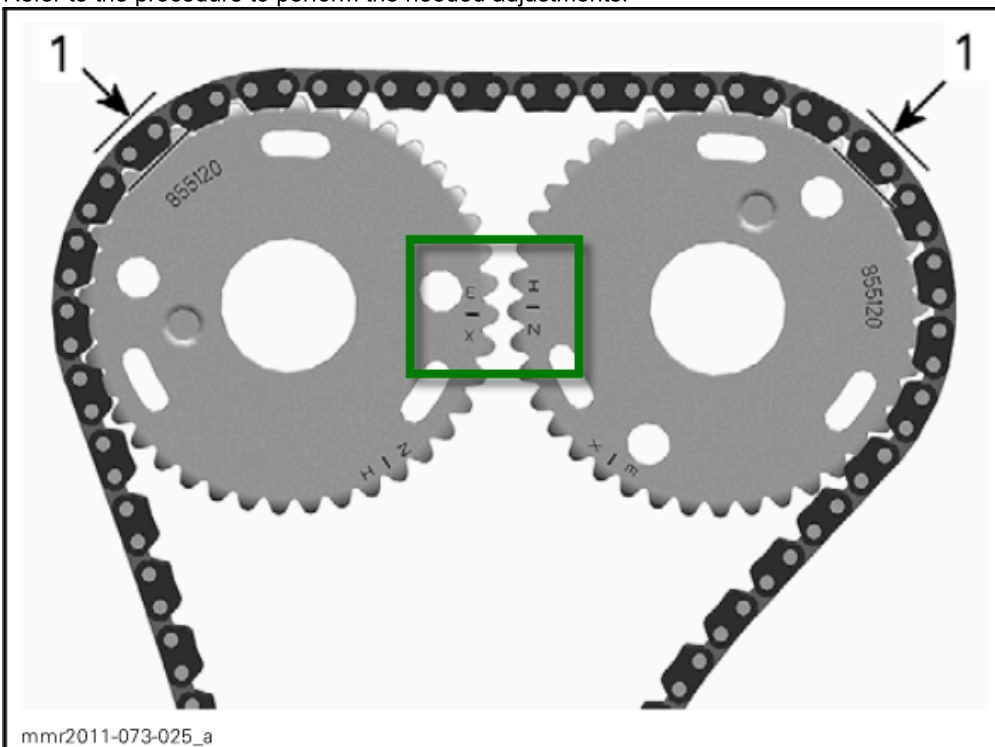
9. mmr2011-073-025_a

8. Once the crankshaft is locked properly on the reference TDC, these two settings should be checked and corrected as needed:
- 1- the marks should be aligned between the intake and the exhaust sprockets
 - 2- the camshaft locking tool should fall into place easily without pushing

Refer to the procedure to perform the needed adjustments.
