Mazda North American Operations Irvine, CA 92618-2922

DOOR OUTER HANDLE TOUCH SENSOR DOES NOT WORK (LOCK AND/OR UNLOCK)

Bulletin No.: 09-023/24

Last Issued : 04/11/2024

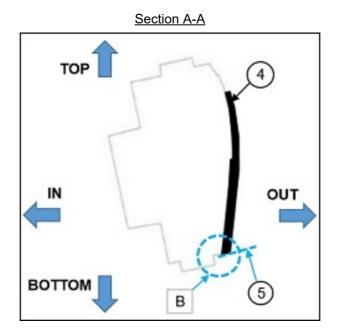
Detail B

- (2) 2 inches (55mm)
- (3) 0.63inch (16mm)
- (4) Butyl tape: 1/16inch (1.5mm) thickness

3. If rubber sheet is installed, remove the rubber sheet (1) from the sensor and then apply the butyl tape (4), aligning the bottom edge (5) of the butyl tape (4) to the edge of the sensor. **NOTE:**

- · Location and size of the applying area are as follows.
- · Peel off the release paper on the butyl tape just before assembling to the front outer handle.
- DO NOT let the butyl tape stick out beyond the edge (6).
- DO NOT leave a gap (7).

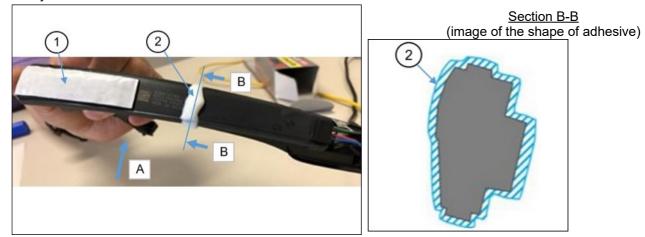
View A

(1) Butyl tape

(2) Adhesive: Apply the adhesive around the touch sensor

4. Waterproof the outer handle and the touch sensor by applying adhesive to the touch sensor.

NOTE: White adhesive and a transparent touch-cover are used in the picture below to show the shape of adhesive clearly.

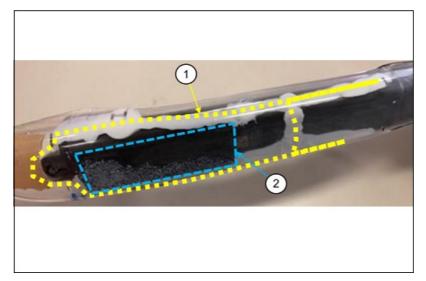
(1) Image of the adhesive application location(2) Butyl tape

8. Fill the adhesive from the back of the outer cover.

9. Let the adhesive dry for 2 hours, keeping the position of the outer cover so that the adhesive on the back of it does not drip.
