Service Alert

CONNECTED VEHICLE SYMPTOM TROUBLESHOOTING

Service Alert No.: SA-017/24

Last Issued : 04/11/2024

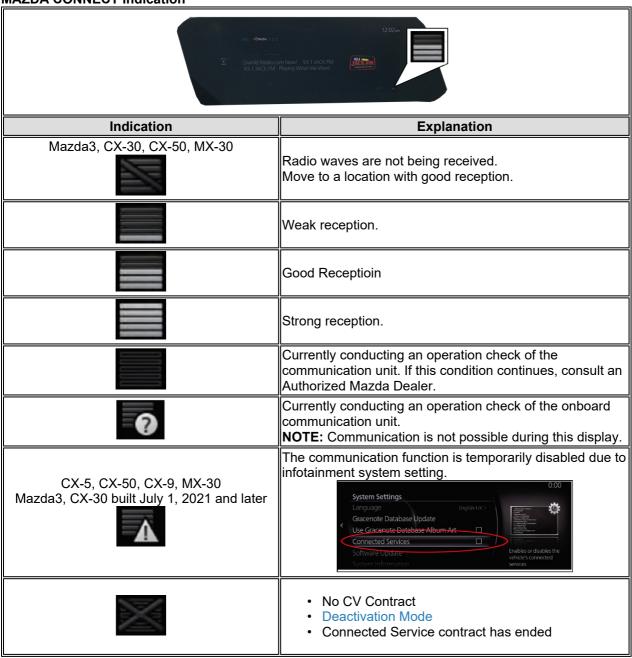
MAZDA CONNECT Indication

- 1. Infotainment Center Display does not provide the Authorization Code (OTP) during the MyMazda App Connected Vehicle enrollment.
- 2. Remote function(s) inoperative.
 - Engine Start / Stop
 - · Door Lock / Unlock
 - · Lights ON / OFF
 - Climate Control
- 3. MAZDA CONNECT connected vehicle reception strength icon shows "X" or "\".

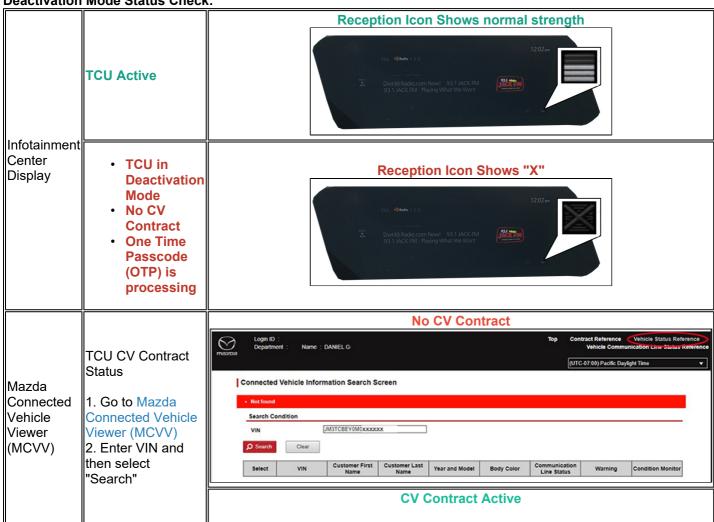
Deactivation Mode Status Check:

- Deactivation Mode Temporary Suspension 6/16/2023 (6/11/2023 retail date and later)
- Vehicles retailed before 6/11/2023 and in Deactivation Mode will remain in Deactivation mode.

- Customer/Dealer can activate CV services anytime via MyMazda app
 - Customer There might be a slight delay in making the backend connection since it was temporarily deactivated.
 - Dealer Go to Repair Procedure -> TCU Activation
- When TCU is in Deactivation Mode, infotainment Over-the-Air (OTA) Connectivity Master Unit (CMU) software
 update is not possible (disabled).
- Prior to Retail Date, the TCU is active.
