Technical Service Bulletin

| SUBJECT: | | | No: TSB-22-55-002REV3 |
| A/C UNINTENTIONALLY TURNS OFF, REMAINS OFF OR THE TEMPERATURE SETTING CHANGES - REVISED | | | DATE: April 2024 |

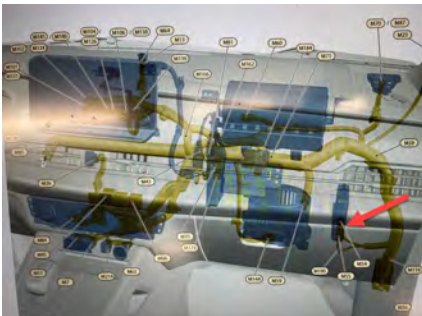
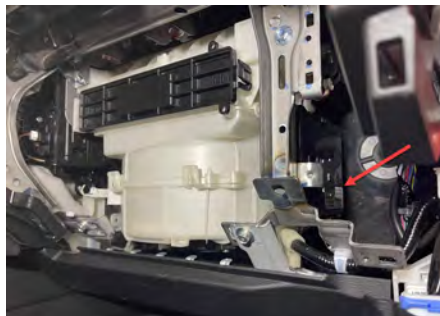
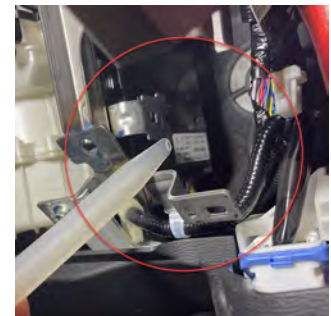
4. AC Auto Amp is on the right hand side of the HVAC Case (fresh air intake) and is held by "1" screw.
