Service Bulletin

Bulletin No.: 22-NA-003

Subject: Instrument Panel Cluster (IPC) Warning Lamps, Malfunction Indicator Lamp (MIL) Illuminated, Diesel Exhaust Fluid (DEF) Message Displayed - Various DTCs Set

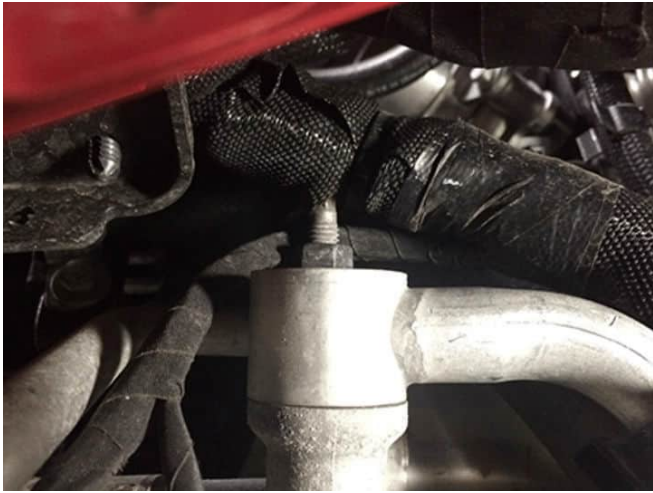
4573211

- Air Conditioning (AC) compressor, AC compressor suction and discharge line manifold, AC line and AC compressor clutch.

Concerns in the area of the AC compressor, lines or suction/discharge pipes may cause:

- The MIL to illuminate.
- The Driver Information Center (DIC) may display a reduced power message or service power steering message.
- The engine to run rough.
- The Service Four Wheel Drive (4WD) Light or Stabilitrak light may illuminate.
- A possible extended crank or a crank no start.
- The oil pressure gauge may read erratically or read no oil pressure.
- The Air Conditioning (AC) may not cool or blow hot air.
- An open fuse in the Underhood Bussed Electrical Center (UBEC).

DTCs associated with chaffing in this area include:

- B127E, C0306, C0321, C0398, C0800, P0071, P0072, P0091, P0117, P0119, P0340, P0341, P0406, P0483, P0522, P0628, P0641, P06A3, P0700, P20BB, P20BF, P227E, P24B1, U0073, U0077, U0121, U0131, U0140, U0151, U0415, U2099, U0401, U0415 and U0420.
- Serpentine Belt. The fan clutch wiring harness support bracket may be out of position allowing the harness to rub on the belt.

If you encounter these scenarios, inspect, repair (as necessary) and route the wiring harness away from these possible chafe points.

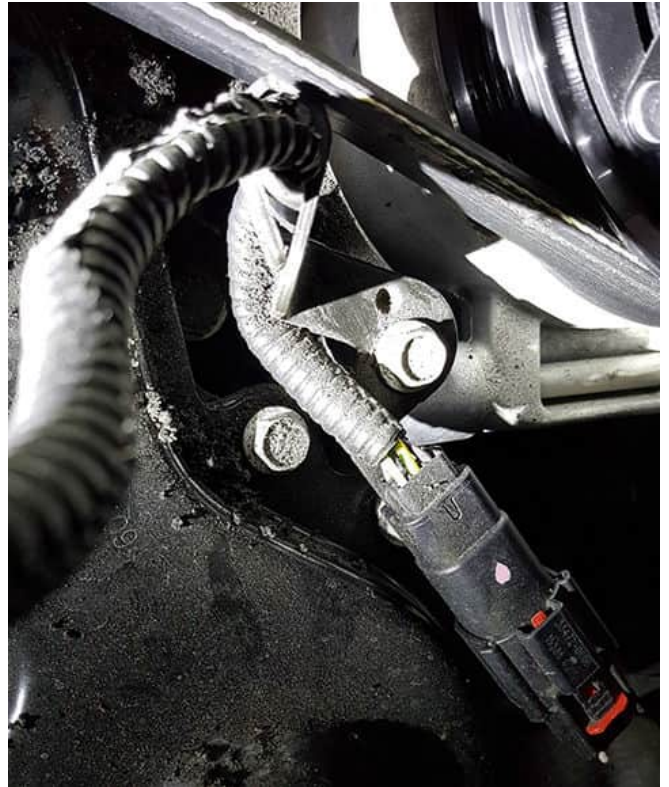
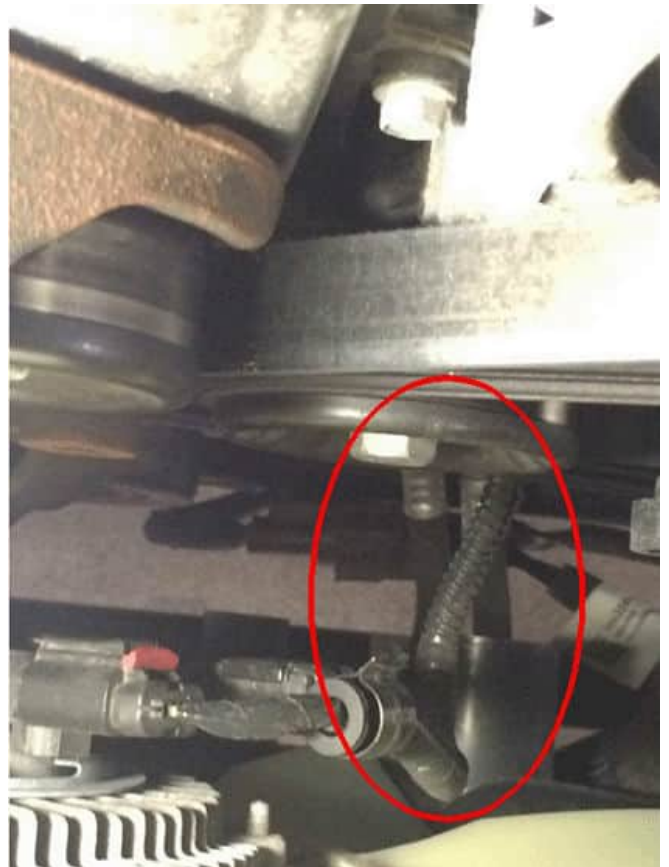
Concerns in the area of the serpentine belt may cause:

- Various IPC warning lights to illuminate.
- A crank no start concern.
- The MIL to illuminate.
- The engine may run rough or misfire.
- The Service Four Wheel Drive (4WD) light may illuminate.
- The Stabilitrak light may illuminate.
- The Air Conditioning (AC) may not cool or may blow hot air.

DTCs associated with chafing in this area may include:

- C0273, P0526, P0480, P0336, P0526, P0641 and P0651.
- Right rear of engine. Check for harness damage on the exhaust heat shield as described in the latest version of bulletin 16-NA-081.

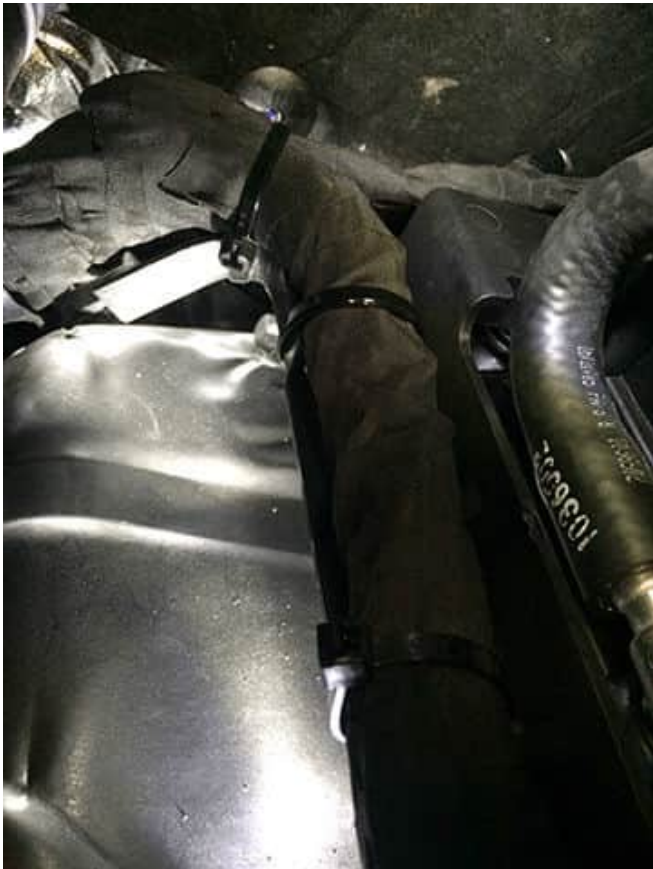
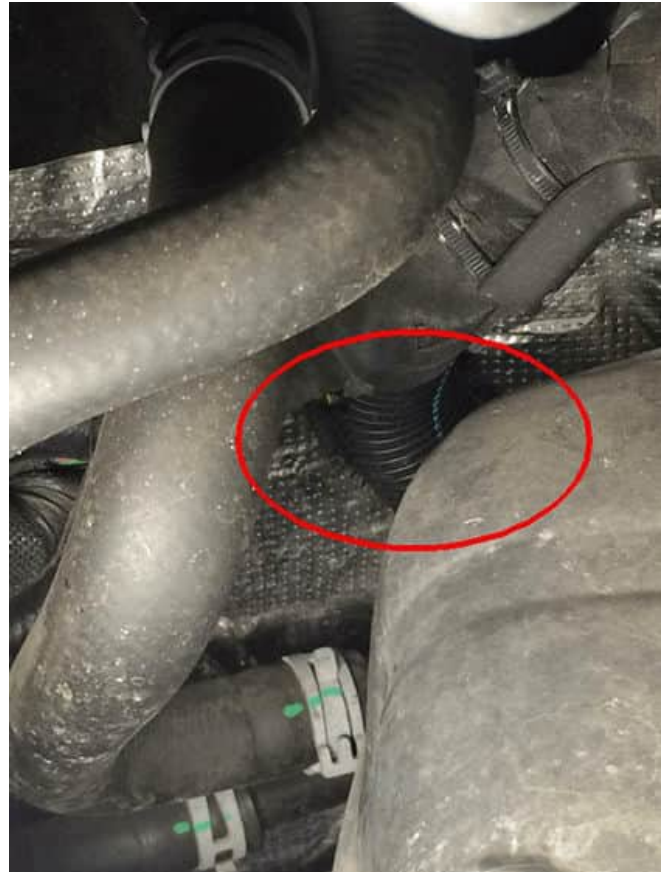
Concerns in the area of the right rear of engine / exhaust heat shield may cause:

- Various IPC warning lights to illuminate.
- The Service Four Wheel Drive (4WD) light may illuminate.
- The Stabilitrak light may illuminate.
- The check engine light to illuminate.
- The Driver Information Center (DIC) may display a reduced power message.
- An open fuse in the Underhood Bussed Electrical Center (UBEC)

DTCs associated with chafing in this area may include:

- B1011, C0306, P0201, P0202, P0203, P0204, P0410, P0575, P062D, P0697, U0073, U0100, U0121, U0140, U0415 and U0420.
- Transmission bell housing bolt/stud.

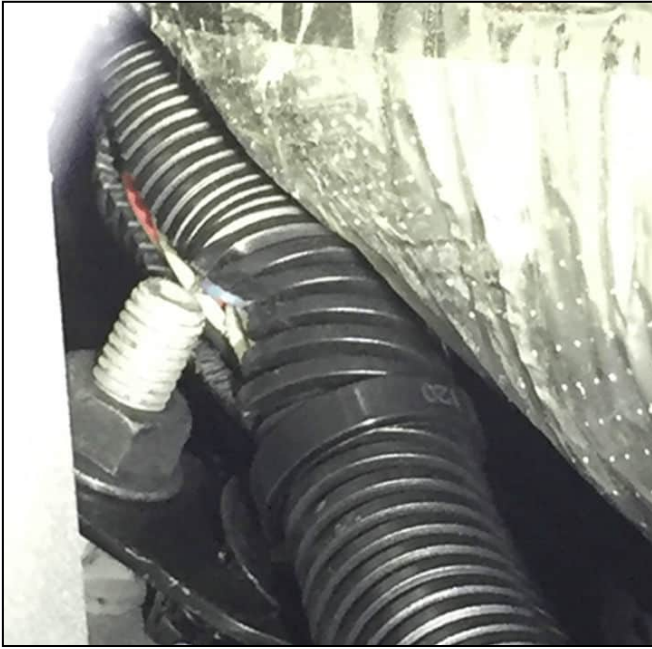
4573244

Concerns in the area of the rear of engine / transmission bell housing bolt/stud may cause:

- Various IPC warning lights to illuminate.
- The Service Four Wheel Drive (4WD) light may illuminate.
- The Stabilitrak light may illuminate.
- The MIL to illuminate.

DTCs associated with chaffing in this area may include:

- P0201, P0202, P0203, P0204, P0392, P0401, P0420, P062D and U0073.
- Coolant pipe and clamp tabs between engine and cowl.

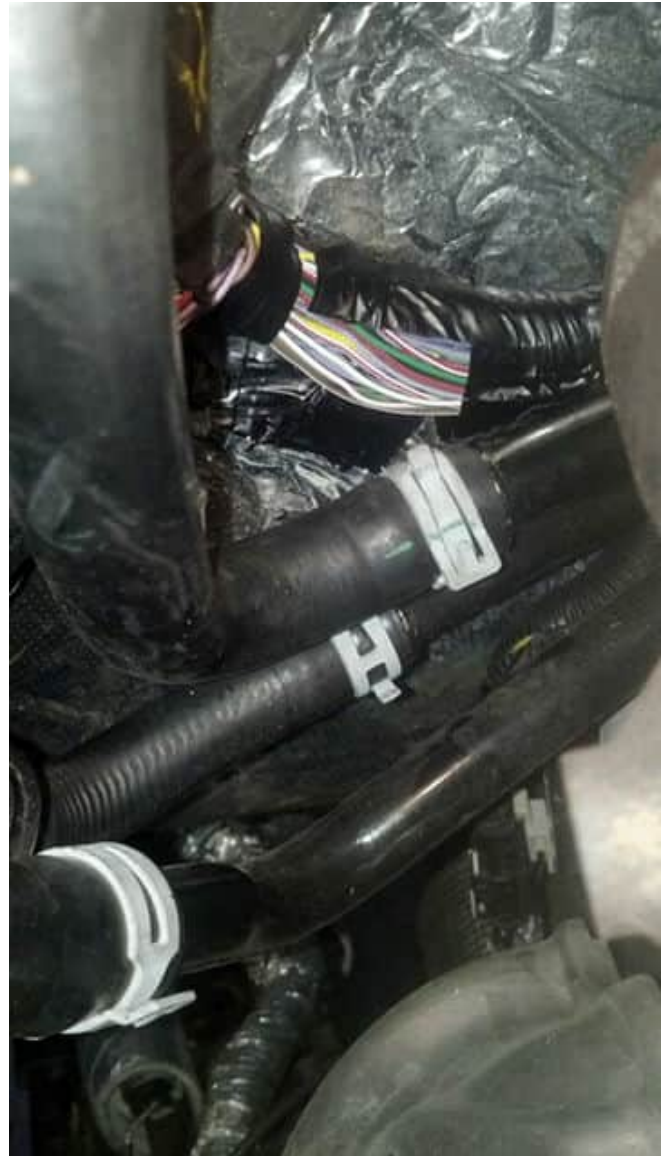
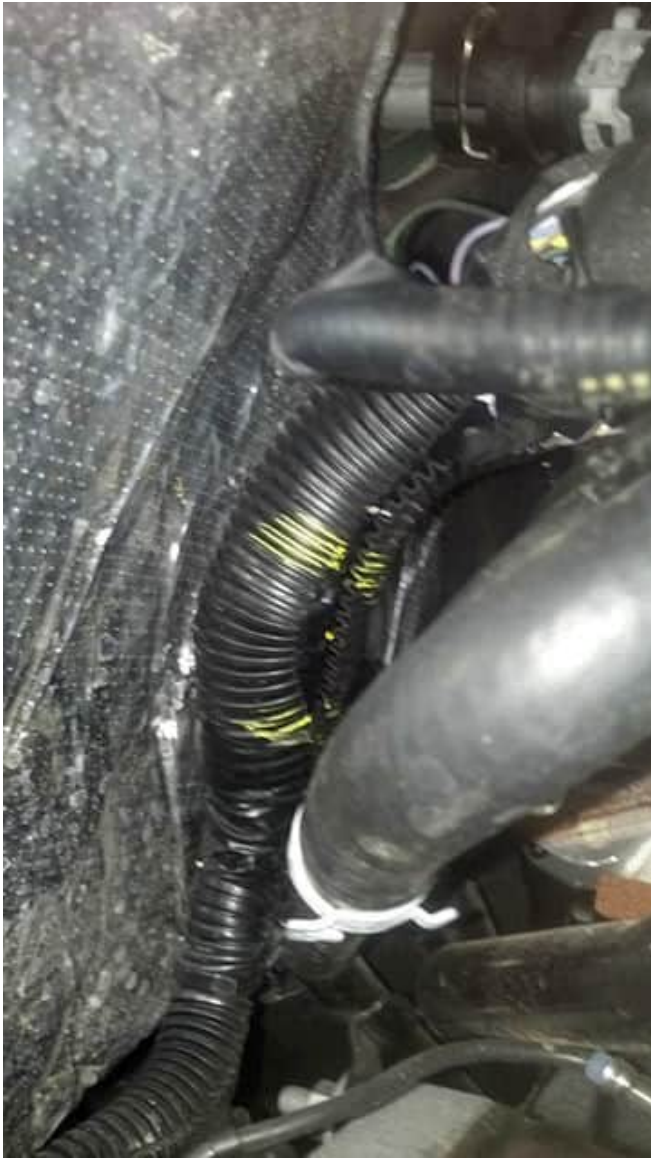
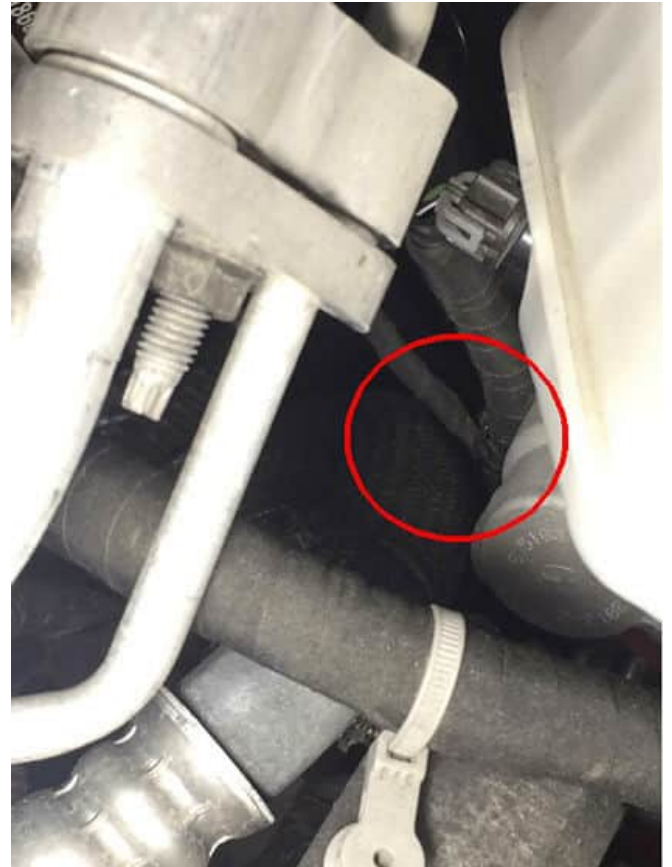
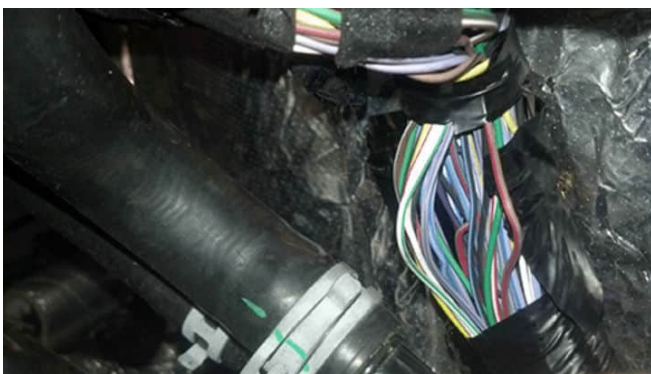
- The Stabilitrak light may illuminate.
- The MIL to illuminate.

DTCs associated with chafing in the area may include:

- B1011, P0575, U0073, U0100, U0121, U0140, U0415 and U0420.
- Near the brake fluid level switch.

Concerns in the area of the coolant pipe / clamp / clamp tabs between engine and cowl may cause:

- Various IPC warning lights to illuminate.
- The Service Four Wheel Drive (4WD) light may illuminate.

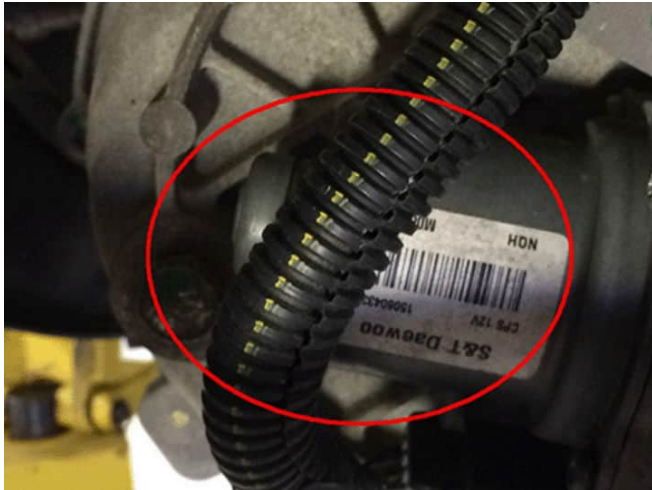
4573221

Concerns in the area near the encoder motor on the transfer case may cause:

- Various IPC warning lights to illuminate.

DTCs associated with chafing in this area may include:

- C0396.
- Turbocharger Vane Position Actuator Connector.

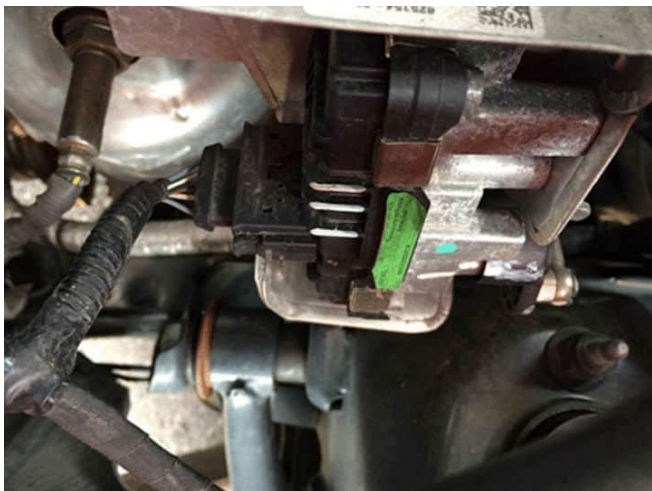
4575279

Concerns with loose terminals or connector not fully seated at the Turbocharger Vane Position Actuator may cause:

- The Check Engine Light to illuminate.
- The Driver Information Center (DIC) may display a reduced power message.
- The vehicle may have a low power concern.

DTCs associated with a loose connector or terminals include:

- P0045 or P2599.
- Additionally, there may be chafing of the wiring harness on the power steering pump pulley.
