Service Bulletin

Bulletin No.: 22-NA-237

Subject: Service Cluster Message and DTC U3000 Set

Brand:	Model:	Model Year:		VIN:		Engine:	Transmission:
		from	to	from	to		
Buick	Envision	2022	2023

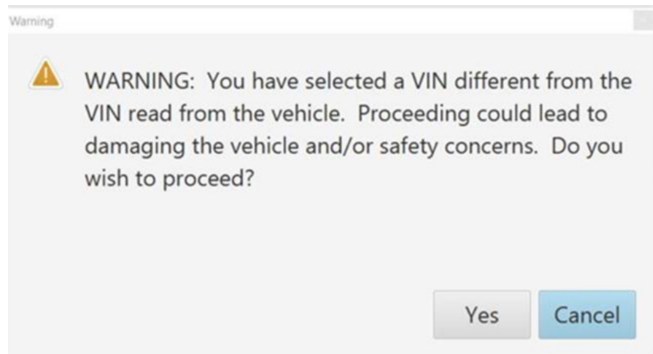
Important: If the vehicle VIN DOES NOT match, the message below will be shown

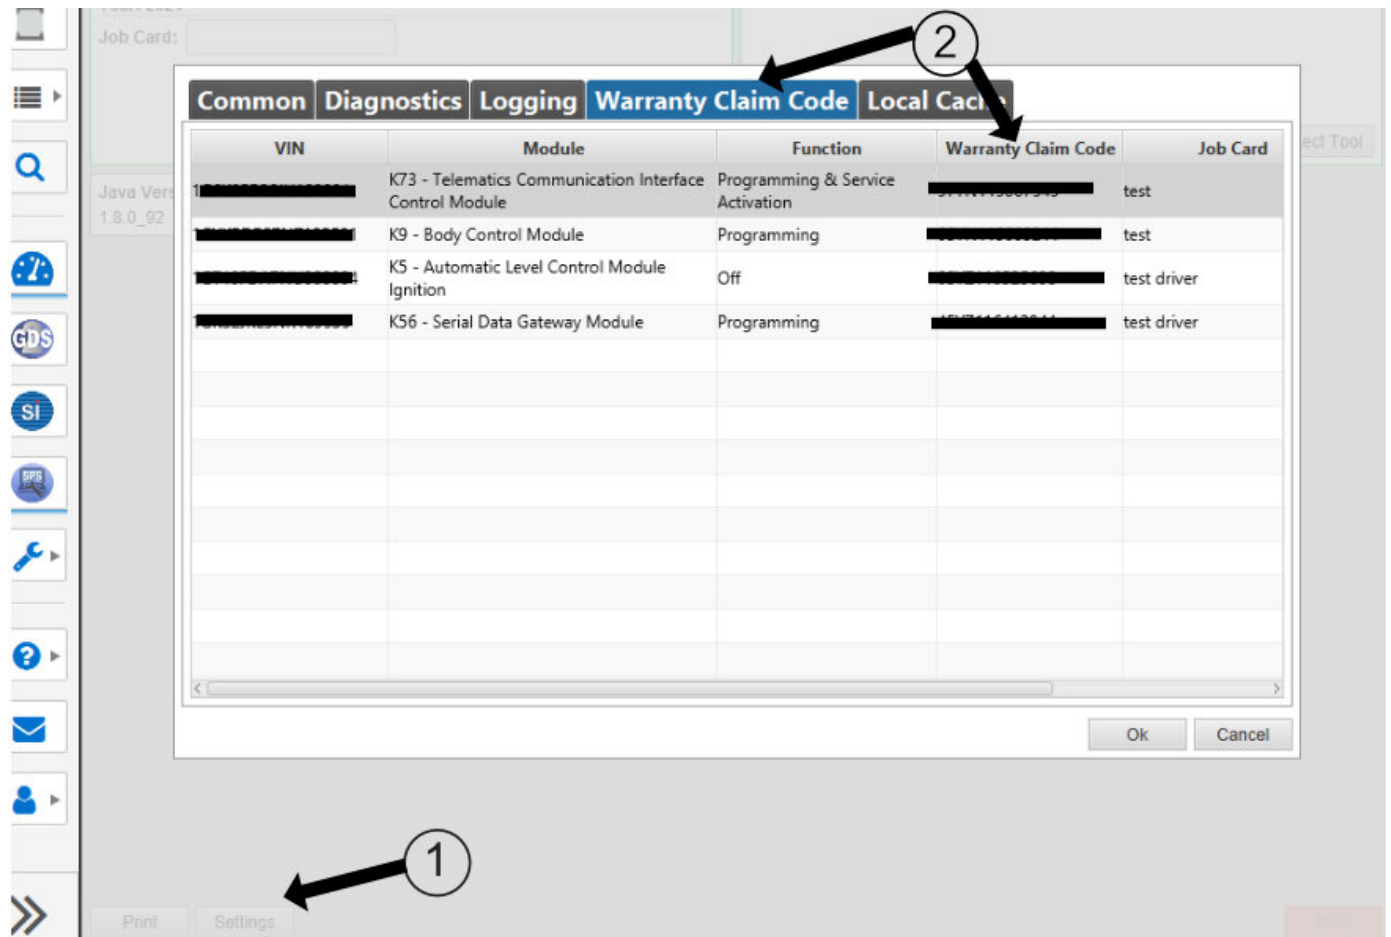
If the Warranty Claim Code was not recorded on the Job Card, the code can be retrieved in the SPS2 system as follows:

1. Open TLC on the computer used to program the vehicle.
2. Select and start SPS2.
3. Select Settings (1).

4. Select the Warranty Claim Code tab (2).
