# Service Bulletin

Bulletin No.: 24-NA-070

Date: April, 2024

**Subject: Vehicle Doesn't Restart After Coming to a Stop While in Start/Stop Mode, Malfunction Indicator Lamp (MIL) Illuminated - DTC P138C Set**

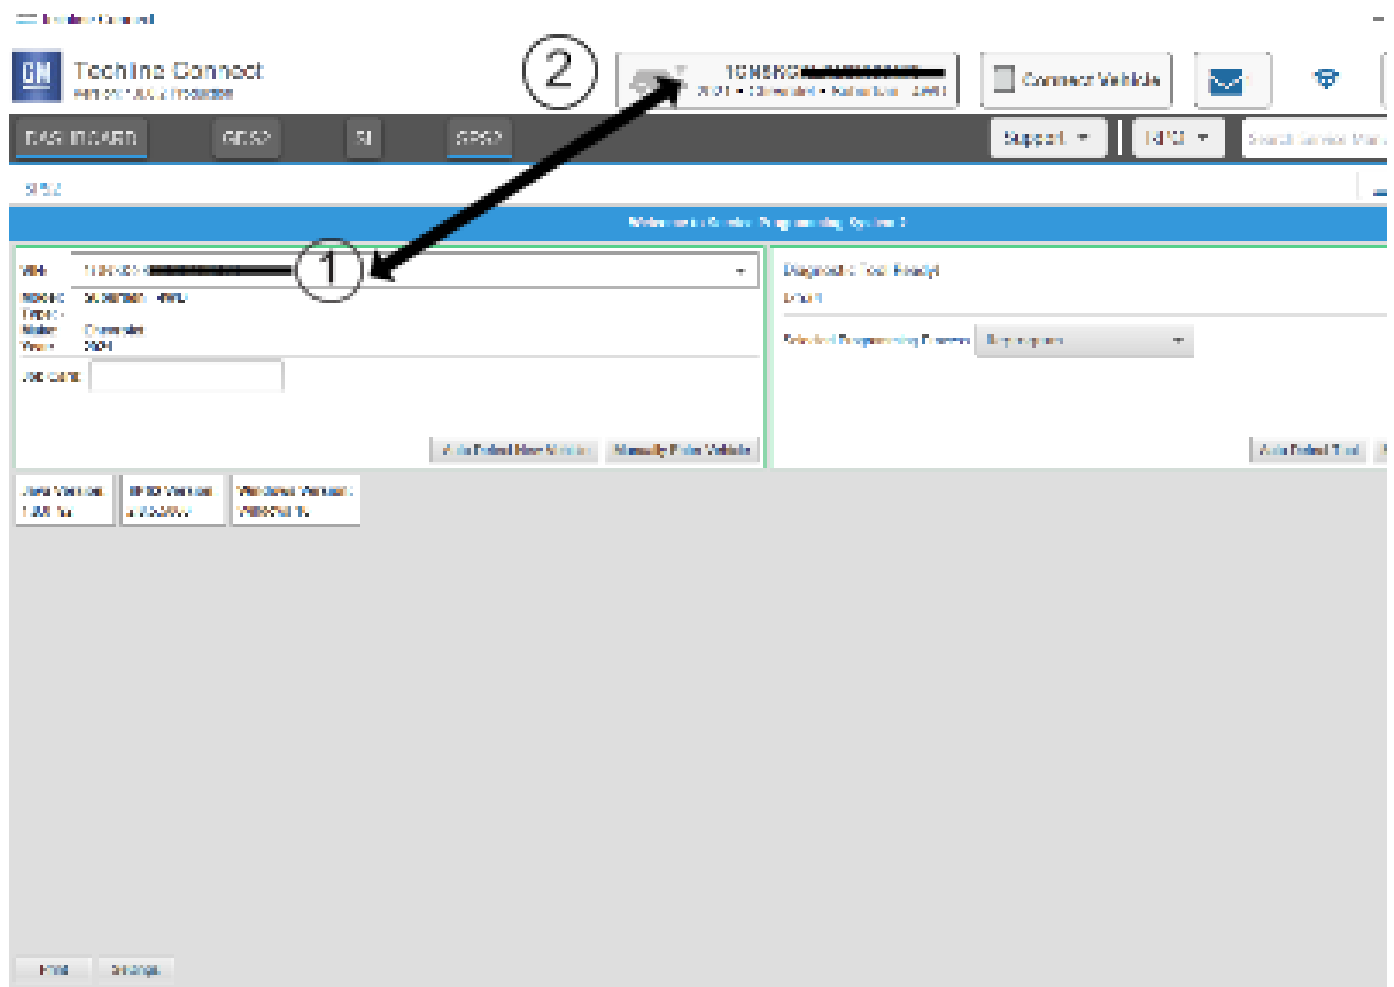
**Caution:** Be sure the VIN selected in the drop down menu (1) is the same as the vehicle connected (2) before beginning programming.

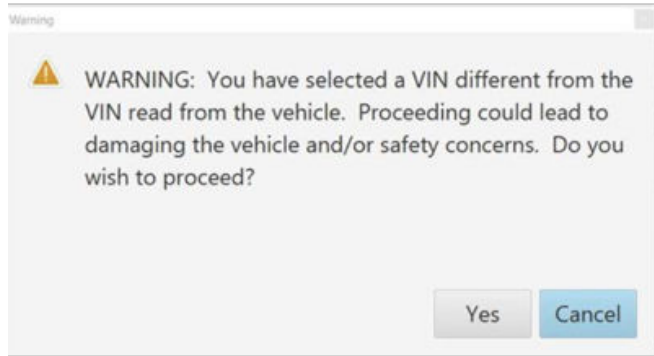
**Important:** If the vehicle VIN DOES NOT match, the message below will be shown

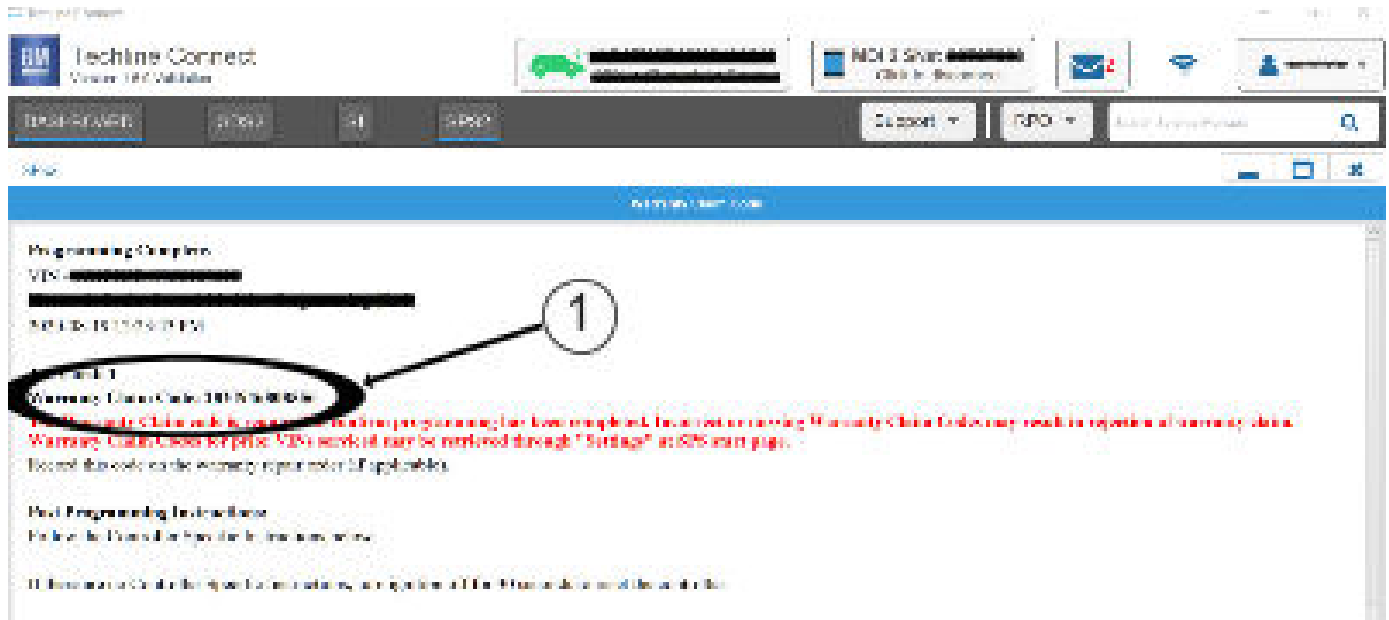
5644478

**Note:** The screenshot above is an example of module programming and may not be indicative of the specific module that is being programmed. Module selection and VIN information have been blacked out.

**Important:** To avoid warranty transaction rejections, you **MUST** record the warranty claim code provided on the Warranty Claim Code (WCC) screen shown above on the job card. Refer to callout 1 above for the location of the WCC on the screen.

1. Reprogram the Engine Control Module (ECM). Refer to *K20 Engine Control Module: Programming and Setup*.

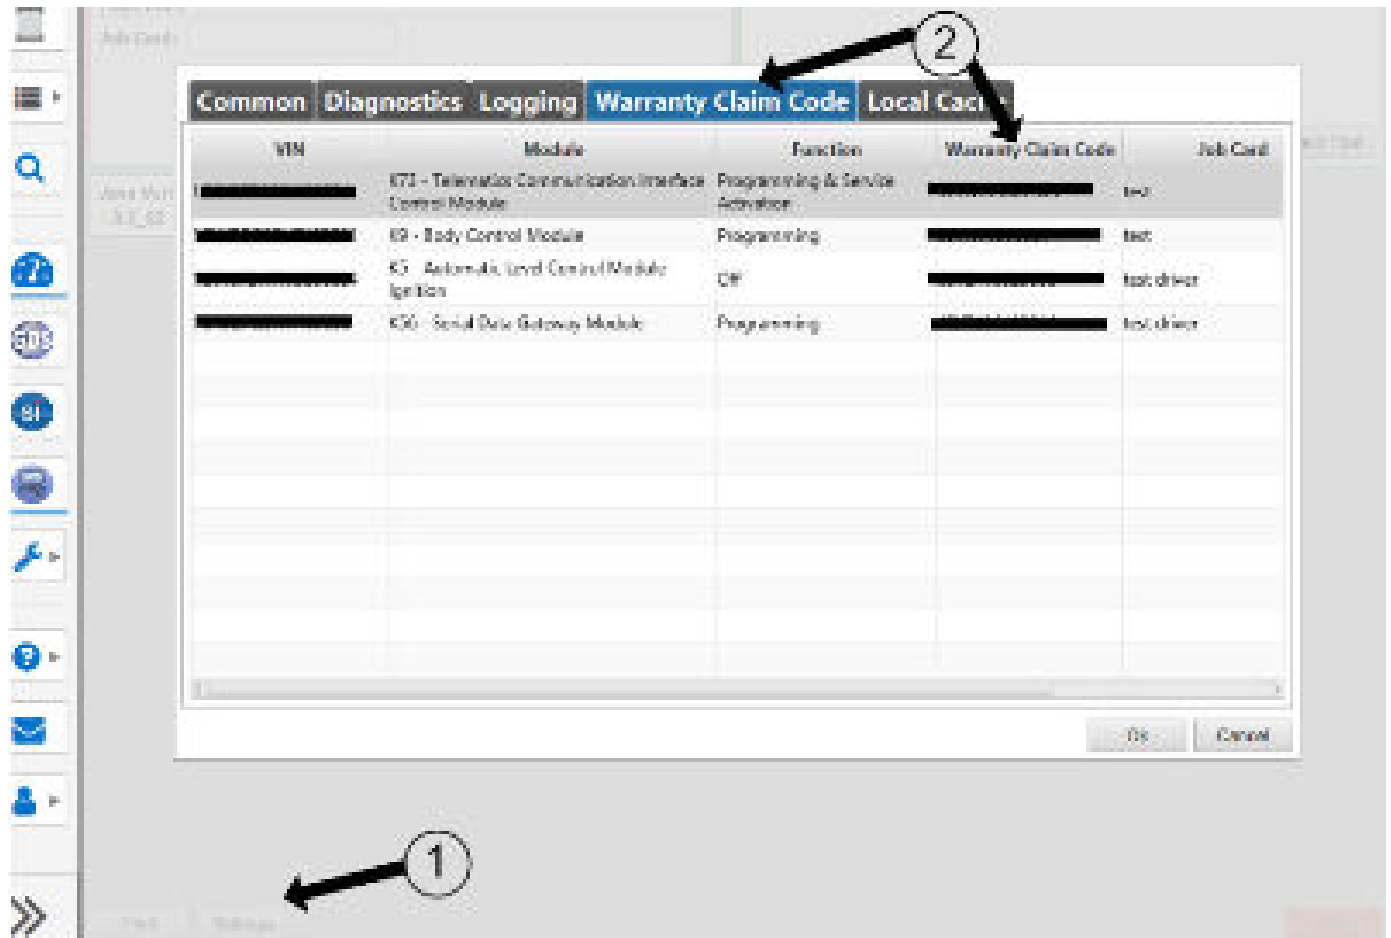
6125774

If the Warranty Claim Code was not recorded on the Job Card, the code can be retrieved in the SPS2 system as follows:

1. Open TLC on the computer used to program the vehicle.
2. Select and start SPS2.
3. Select Settings (1).

4. Select the Warranty Claim Code tab (2).

The VIN, Warranty Claim Code and Date/Time will be listed on a roster of recent programming events. If the code is retrievable, dealers should resubmit the transaction making sure to include the code in the SPS Warranty Claim Code field.
