2015-2019MY  
Soul EV (PS EV)

SC267Z (Rev 1, 05/07/2024)

## SUBSEQUENT REPAIR ACTION

HIGH-VOLTAGE BATTERY PACK ASSEMBLY  
REPLACEMENT (SC267Z)

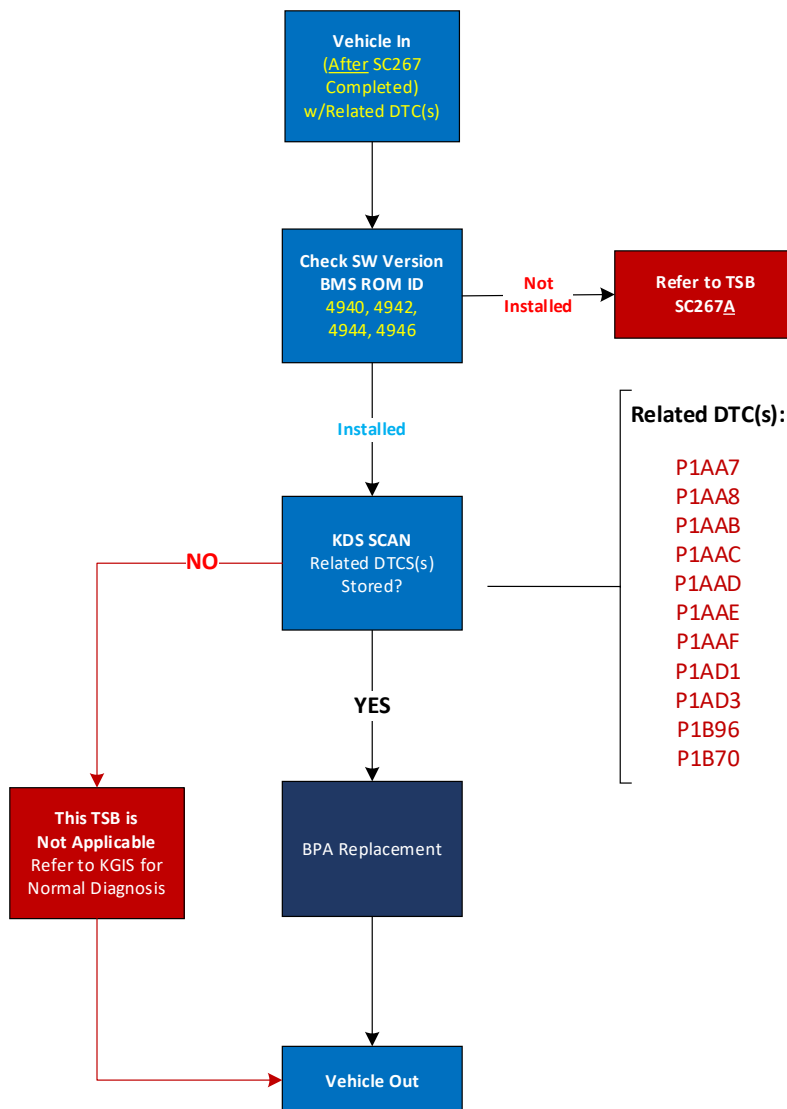
## Flowchart:

This publication is only applicable on a subject vehicle that has already had SC267 completed on a previous visit which has the 'latest' BMS software. The subject vehicle must have one or more of the related DTC(s) stored listed in this publication in order to claim the BPA replacement. Any other DTC stored must be diagnosed by referring to KGIS and may not be claimed under this Subsequent Repair Campaign.

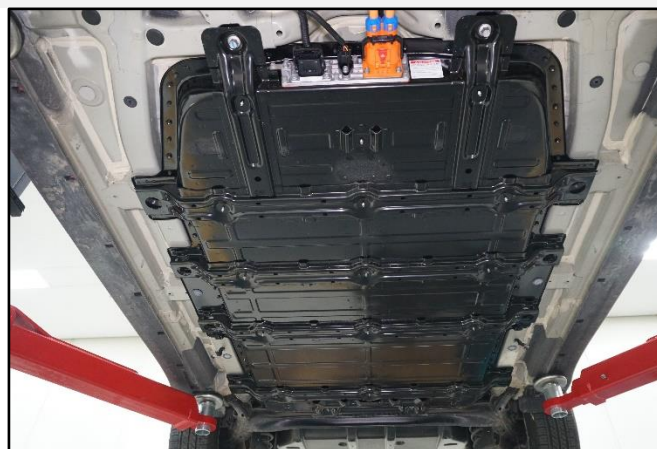
**15-17MY ONLY** new PN BPA is equipped with a "new" type harness. **(Rev 1) removed harness swap.**

1. Replace the HV BPA by referring to "EV Battery System → High Voltage Battery System → Battery Pack Assembly → Repair procedures (Removal)" in the applicable Shop Manual on KGIS. **Note:** Dealer must obtain TL PWA.

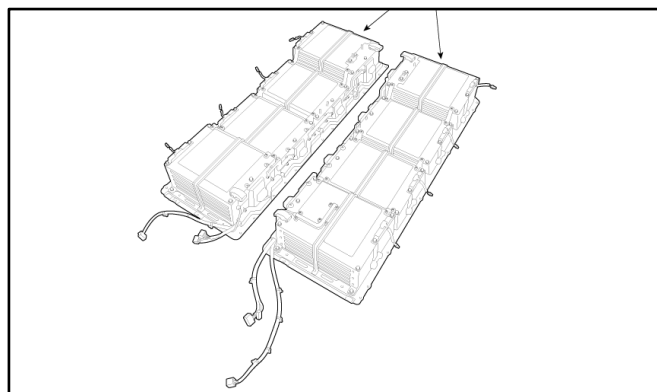
3. **Note:** The battery pack assembly (BPA) consists of two (2) (left and right) battery packs.

**18-19MY ONLY** new BPA is equipped with the "new" type harness. There is no need to swap.

4. Reinstall all removed parts in the reverse order of removal.
5. Clear related DTC(s) using KDS.
6. Confirm normal vehicle operation.
