Service Bulletin

Bulletin No.: 15-00-89-004G

- Subject:** Information Regarding the Differences Between Fluid Leakage and Seepage
- Models:** 2025 and Prior GM Passenger Cars and Light/Medium Duty Trucks (including BrightDrop Models)
- Attention:** This bulletin also applies to any of the above models that may be Export from North America vehicles.

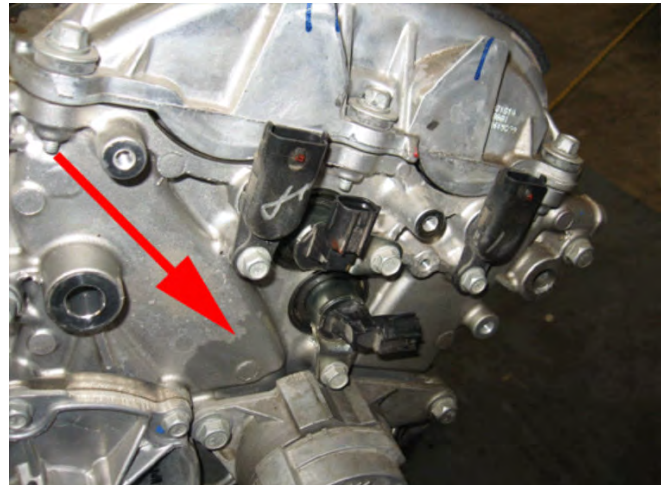
4170711

The engine illustrated above shows residual oil staining from assembly. There are no drips or leak paths present.

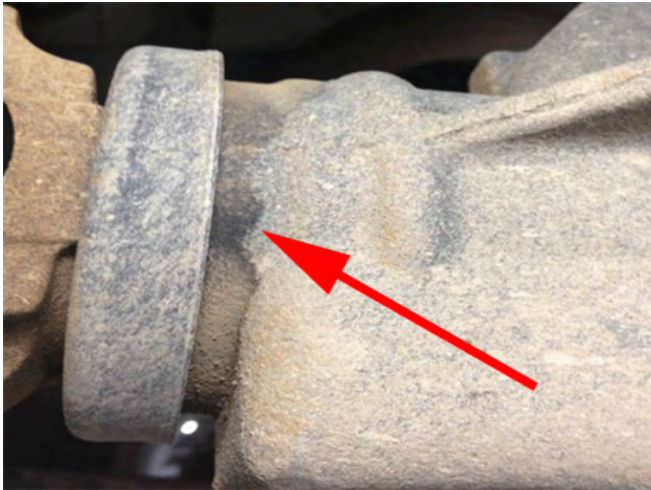
4164326

You can see the darker area where fluid has attracted dirt. There are no droplets at the bottom of the seal area.

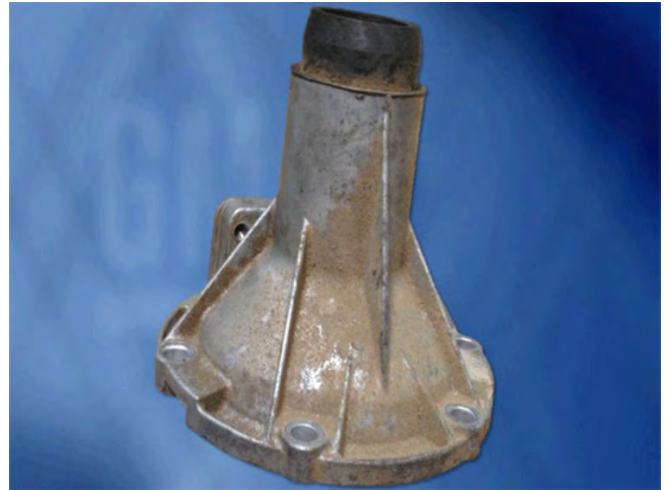
4164331

The housing illustrated above just has a light coating of dirt; there is no sign of fluid. So this would also be considered seepage. A very small amount of fluid coated the outer surface of the housing and dirt was attracted to the moisture.

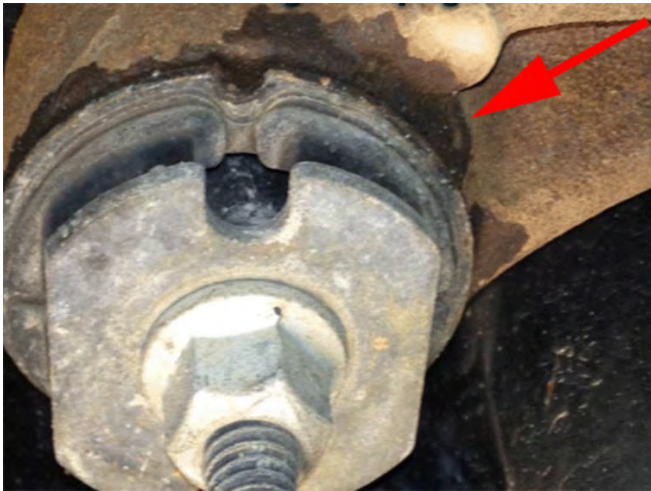
4164328

There is slight staining around the mount, but there are no droplets formed and fluid has not dripped onto other components.

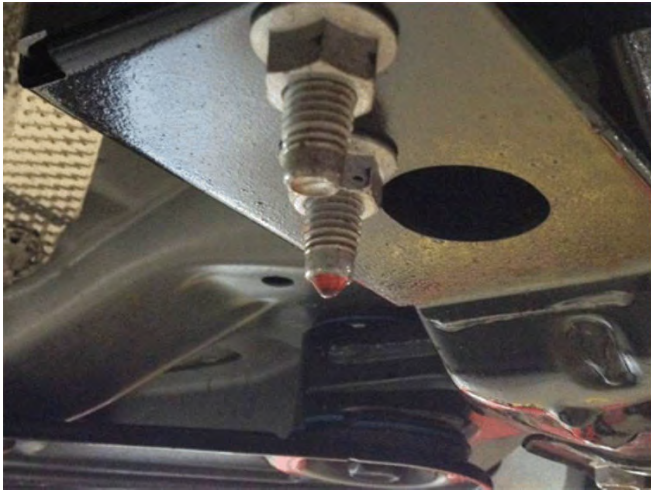
4164333

A droplet is formed on the end of the stud and the surrounding area is also covered with fluid.

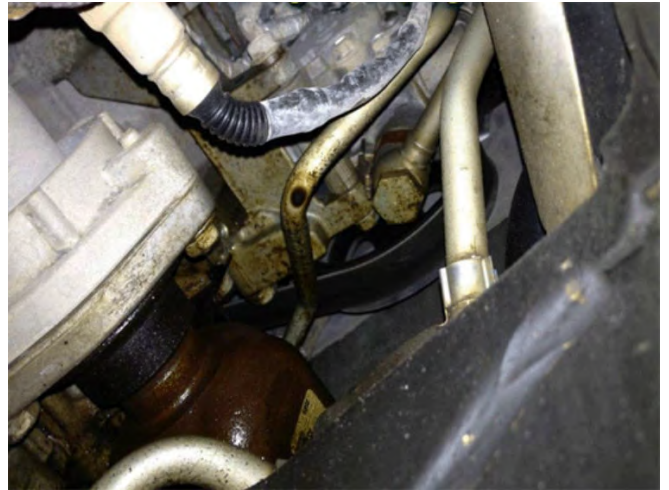
4164339

This is also a leak because there is a droplet formed on the bottom of the power steering line and fluid has dampened the drive axle.

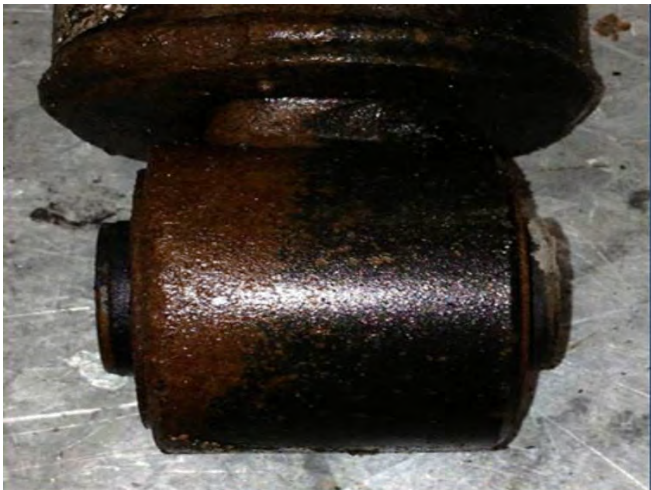
4164336

This shock is also leaking. The surface of the shock housing is wet and droplets formed at the bottom and dripped onto the ground.

For more information on the diagnosis and replacement of shock absorbers, refer to the latest version of Service Bulletin 05-03-08-002: Information on Diagnosis and Replacement of Shock Absorber and Strut Due to Fluid Leak.

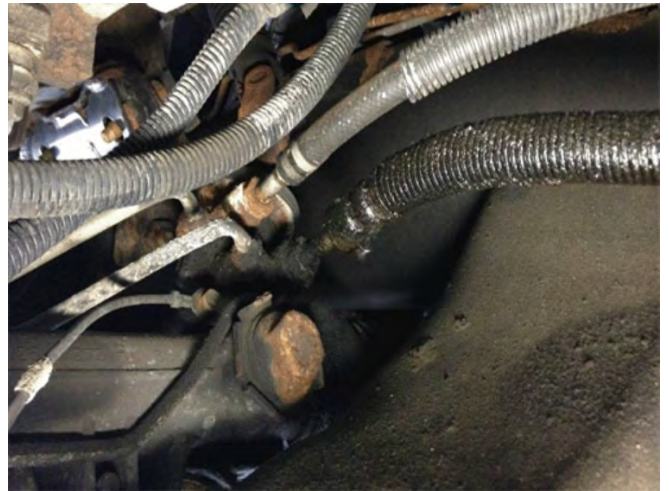
4164341

This would also be considered a leak because fluid has coated the fitting and hose. Although there were no droplets hanging from the component, it's obvious that a reasonable volume of fluid has been lost and when we followed the line to its low point, we did find droplets there.

Once a leak is identified, determine the cause of the leak by performing the following steps:

1. Operate the vehicle until the engine reaches normal operating temperature.
2. Park the vehicle on a level surface, over a large sheet of paper or other clean surface.
3. Wait 15 minutes.
4. Inspect for drippings.
