# Service Update

## N242444830 Driver's Side Outer Tie Rod Nut Retorque

Release Date: May 2024

Models: 2024 Chevrolet Malibu

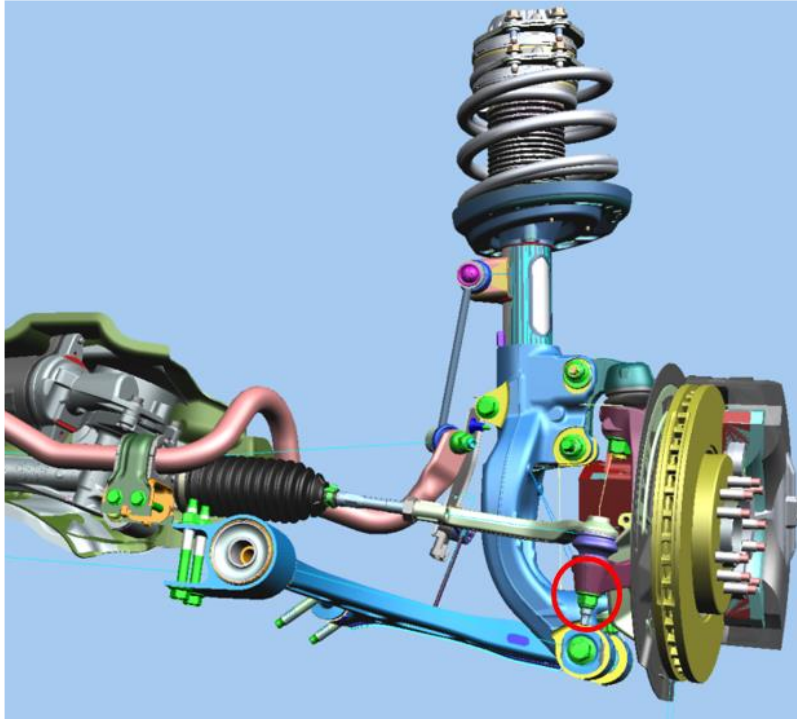
6636729

<b>Condition</b>	On certain 2024 model year Chevrolet Malibu vehicles, the driver's side outer tie rod nut to steering knuckle may be under-torqued.
<b>Correction</b>	Dealers are to retorque the driver's side outer tie rod nut.

2. Remove the outer ball joint nut and disconnect the outer ball joint from the knuckle.
3. Reinstall the outer ball joint in the knuckle and torque to:
  - First Pass: 35 N-m (26 lb ft)
  - Final Pass: (30–45 degrees)
4. Lower the vehicle. Refer to *Lifting and Jacking the Vehicle* in SI.
