CADILLAC
DCS6893
URGENT - DISTRIBUTE IMMEDIATELY

Subject: UPDATE: N232428540 - Customer Satisfaction Program
Multiple Module Reprogramming
Population Expansion

Models: 2023 Cadillac LYRIQ

N232428540 Multiple Module Reprogramming

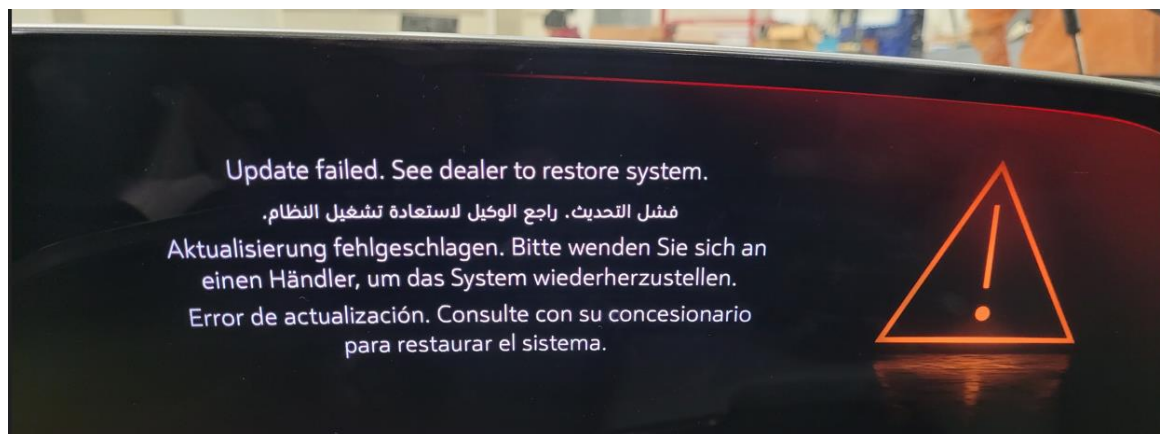
1. There is a chance for an error to be encountered during the USB update portion of the procedure right around 60% completed.
 - 1.1. This happens once the USB is in the vehicle and the progress bar can be seen on screen.
2. If the error occurs the screen will look like below

3. In this case pull the USB from the vehicle and reformat again as shown in step 7 under service procedure.
4. Access the Service Programming System (SPS) and follow the on-screen instructions.
5. On the SPS Supported Controllers screen, select A11 Radio – USB Copy/USB File Transfer.
6. Upon completion of the file transfer, properly eject the USB drive from the computer.
7. Connect the USB drive to the USB port in the vehicle.
 - 7.1. If the screen fails to show a progress bar once reinserted, pull out and reinsert again.
8. These steps should allow the progress bar to restart and complete successfully.
9. If you require further assistance, or would like verbal instructions in addition to this part of the service procedure please contact Techline Customer Support Center 1-800-828-6860 for English or 1-800-503-3222 for French (Canadian) for assistance.
