May 2, 2024

Version 2

MIL Is On with DTC P0868Supersedes 23-082, dated September 29, 2023, to revise the information highlighted in **yellow**.**AFFECTED VEHICLES**

Year	Model	Trim Level	VIN Range
2023	CR-V Hybrid	Sport Hybrid, Sport Touring Hybrid	ALL

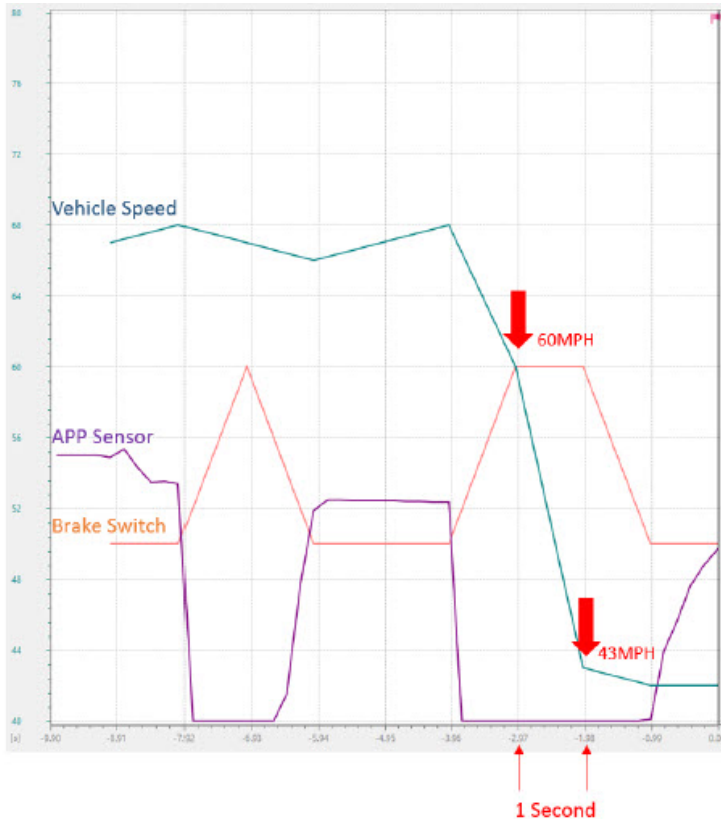
2. Verify P0868 OBS data that the DTC is generated under rapid vehicle deceleration.

NOTE: Rapid deceleration is defined as a reduction of 13MPH or more in 1 second.
