Troubleshooting Telematics System

Units Affected: Certain Altec units equipped with an AXIS telematics control unit (TCU) built from June 2018 to present. Verify your unit is affected by reviewing the attached list or accessing Altec Connect.

Background: Altec has learned that the affected units could have a telematics system that is not operating properly. Customers paying for digital complements such as JEMS Connect or E-Series Derricks Insights may not be receiving data.

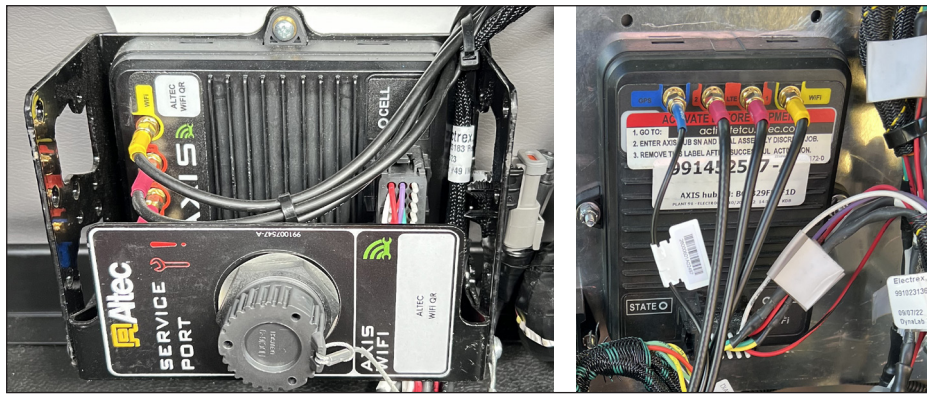
Figure 1 — AXIS TCU

1. Position the unit on a level surface, apply the parking brake, and turn off the engine. Remove the key from the ignition, and secure it following your employer’s vehicle lockout/tagout procedure. Chock the wheels.
2. Locate the AXIS TCU (refer to Figure 1).
 - For most units, this is inside the cab behind the seats.
 - On units without a cab, it is installed on the vehicle body.
 - On JEMS units, the TCU is installed with the JEMS bracket. Do not uncover the JEMS bracket.

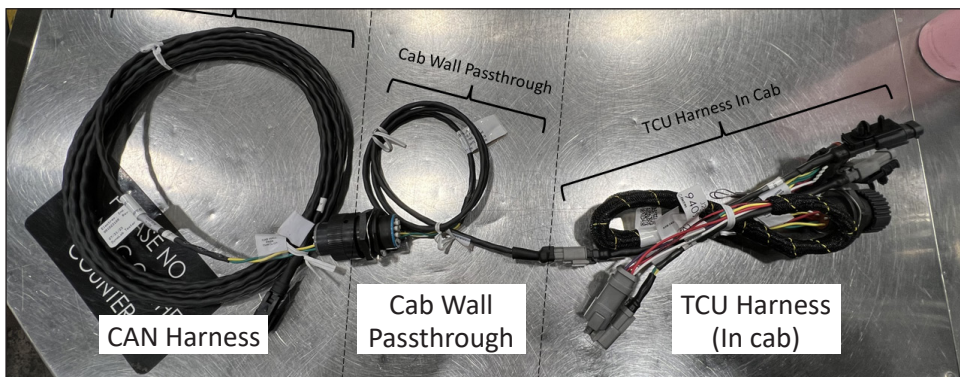
Figure 2 — Non-JEMS Wiring

3. Complete a visual inspection of the AXIS TCU wiring (refer to Figure 2). JEMS units only have one section of wiring while non-JEMS units have three sections.
 - For JEMS units, proceed to step 9.
 - For non-JEMS units, proceed to step 4.

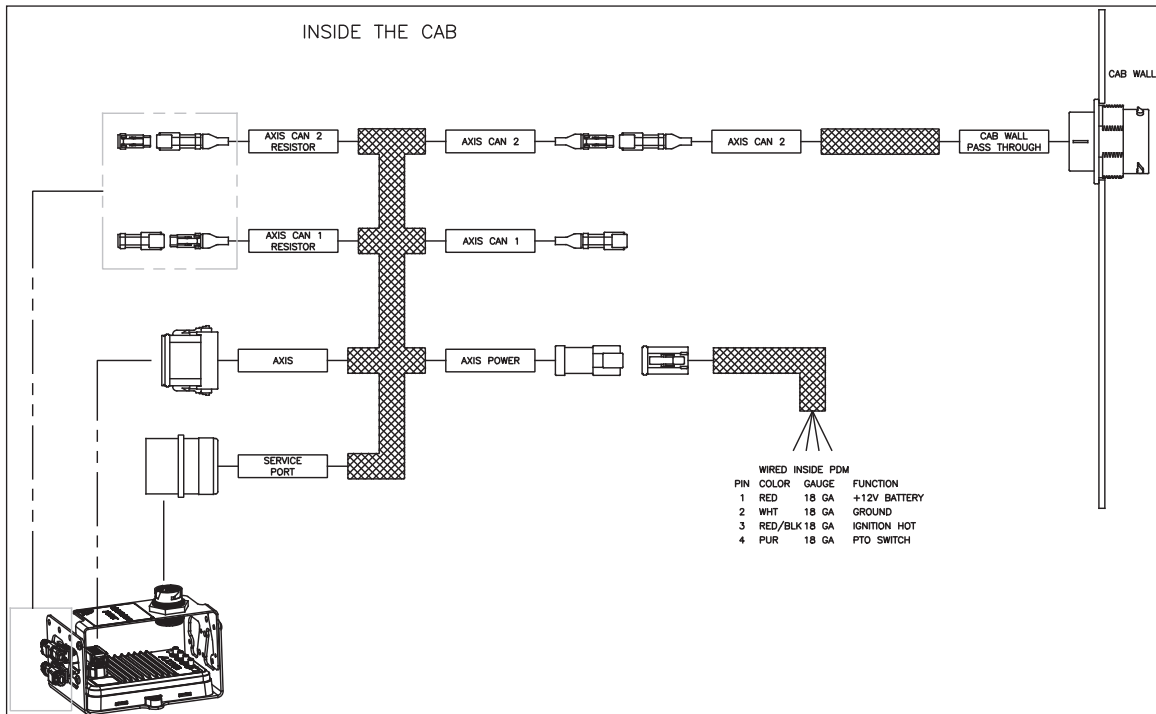
Figure 3 — Non-JEMS Wiring Schematic

4. On non-JEMS units, make sure the TCU harness AXIS CAN 2 is connected to the Cab Wall Passthrough plug. Correct the wiring if it is not.
 - If the harness is missing any connectors, order the T17 harness kit, part number 991707697. Do not complete the rest of this procedure until parts are received.
 - If the harness has all connectors and they are connected properly or you connected them as part of this step, proceed to step 5.

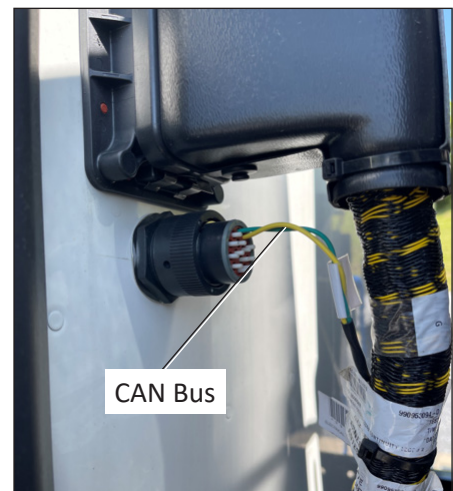
Figure 4 — Cab Wall Passthrough

5. Inspect the Cab Wall Passthrough harness (refer to Figure 4).
6. Verify all wiring is consistent: green to green, yellow to yellow, etc. Correct any wiring inconsistencies.

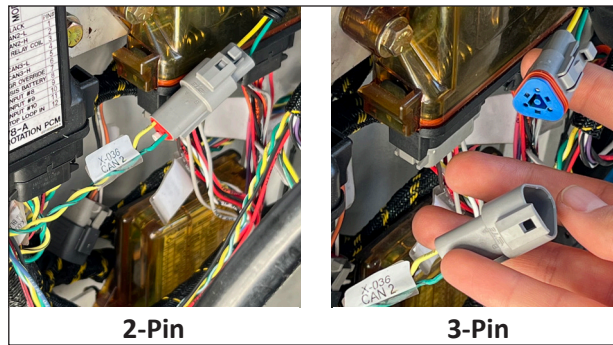
Figure 5 — Unit Interface CAN Harness Connector

- Visually verify the Unit Interface CAN harness connects the TCU to the Unit Control Systems.
 - Verify the Unit Interface CAN harness connector in the pedestal is labeled **AXIS CAN 2**. On derrick models, this is a 3-pin DTM plug. On all other model types, this is a 2-pin DTM plug. On crane models, this will be in the subbase and could be labeled **Worldview Con** (refer to Figure 5).

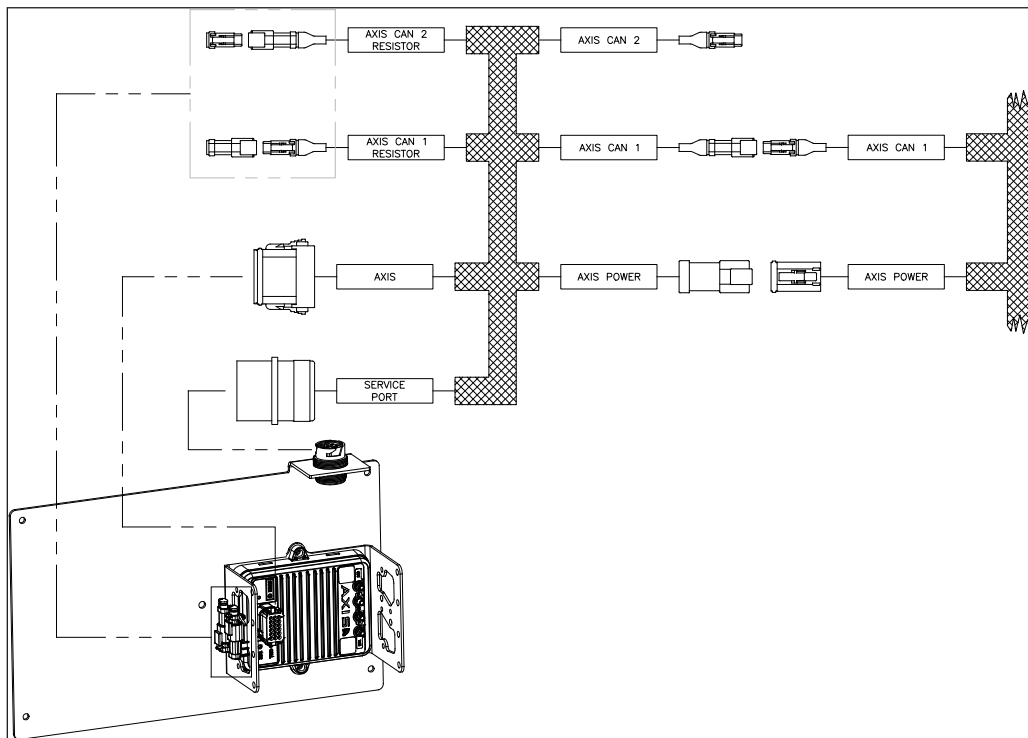
Figure 6 — JEMS Wiring Schematic

9. On JEMS units, make sure the TCU harness AXIS CAN 1 is connected to the CAN 1 plug on the JEMS harness inside the cab. Correct the wiring if it is not.

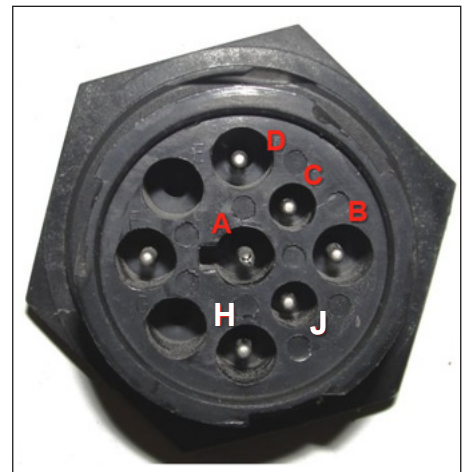
Figure 7 — CAN 2

13. Check the resistance at the service port on the AXIS hub CAN 2, which is pin H (CAN high) and pin J (CAN low). Refer to Figure 7 for pin locations.

- **0 Ω** - resistance is a short circuit.
 - Inspect the CAN bus for any visible signs of a short circuit (damaged insulation, exposed wiring).
 - Make sure there is no direct connection between the CAN high and CAN low lines.

- If the resistance is 50 to 70 Ω , go to the next bullet.
 - **50 to 70 Ω** - resistance is correct.
 - Verify all wiring is consistent: CAN low (green to green), CAN high (yellow to yellow).

- Proceed to step 17.
 - **110 to 130 Ω +** - resistance is incorrect.
 - Look for a loose missing resistor on the CAN bus. Each CAN bus will have two terminating resistors, one at each end of the bus.

- Correct the connections and check the resistance again.
 - If the resistance is not 50 to 70 Ω , contact Altec Technical Support for additional troubleshooting.

- Correct the connections and check the resistance again.
 - Still 110 to 130 Ω , proceed to step 14.
 - **140 Ω +**
 - Proceed to step 14.
14. Check the resistance on the wires below between the service port and AXIS hub connector. Correct resistance is 0 Ω to 10 Ω .
