Service Bulletin

Bulletin No.: 21-NA-054

Subject: Various Instrument Cluster Functional Concerns or DTC U0155 Set

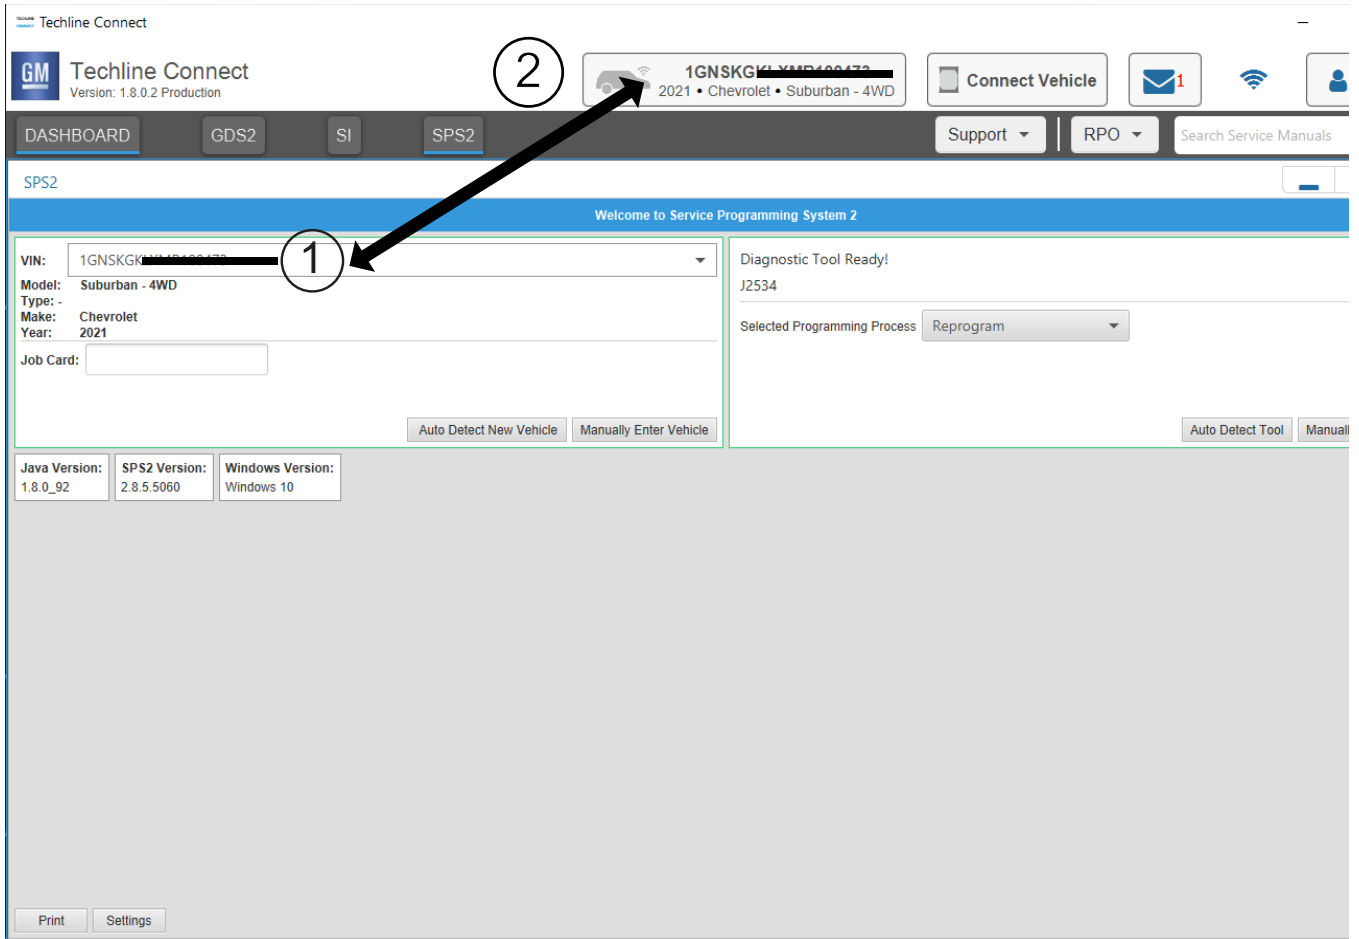
5743643

Caution: Be sure the VIN selected in the drop down menu (1) is the same as the vehicle connected (2) before beginning programming.

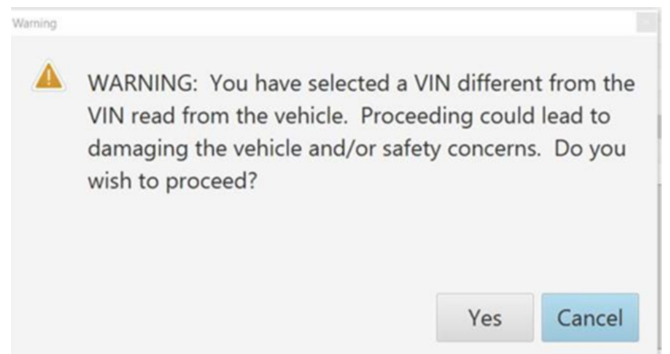
5877000

Important: If the vehicle VIN DOES NOT match, the message below will be shown.

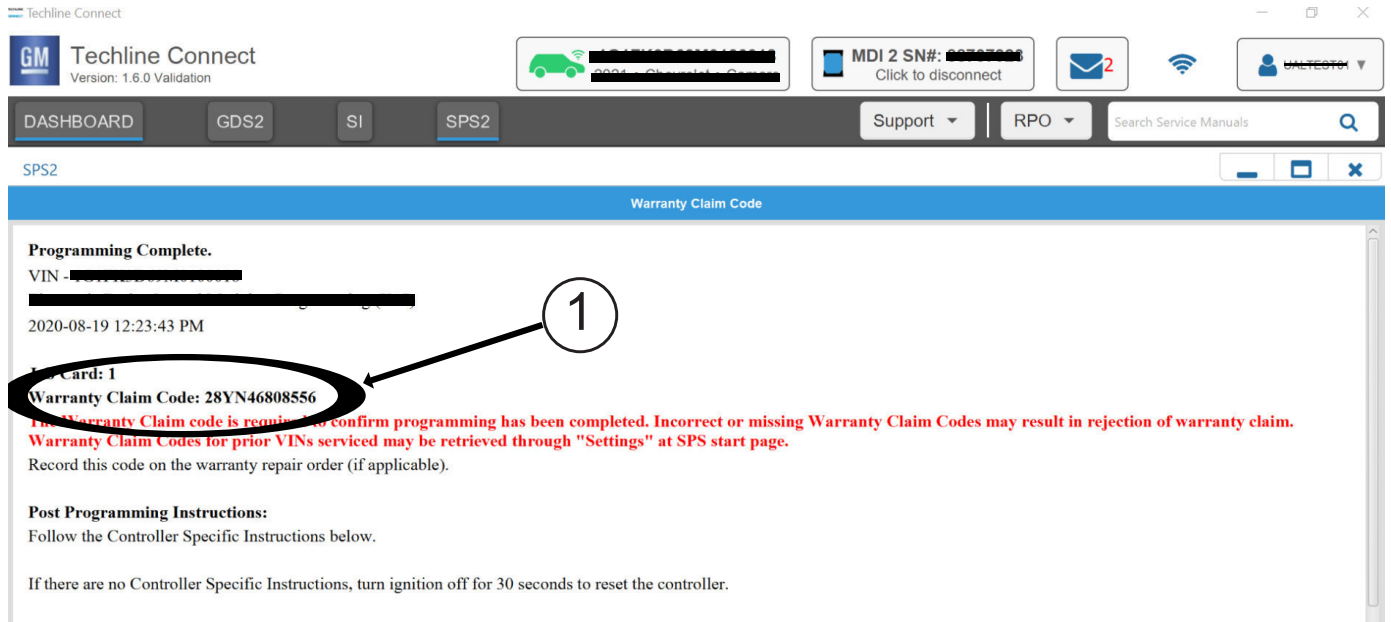
5644478

Note: The screenshot above is an example of module programming and may not be indicative of the specific module that is being programmed. Module selection and VIN information have been blacked out.

Important: To avoid warranty transaction rejections, you **MUST** record the warranty claim code provided on the SPS Warranty Claim Code (WCC) screen shown above on the job card. Refer to callout 1 above for the location of the WCC on the SPS screen.
