# Service Bulletin

Bulletin No.: 23-NA-115

**Subject:** Ticking, Tapping or Snapping Noise from Engine - 5.5L RPO LT6 Realign Camshaft Caps as Required

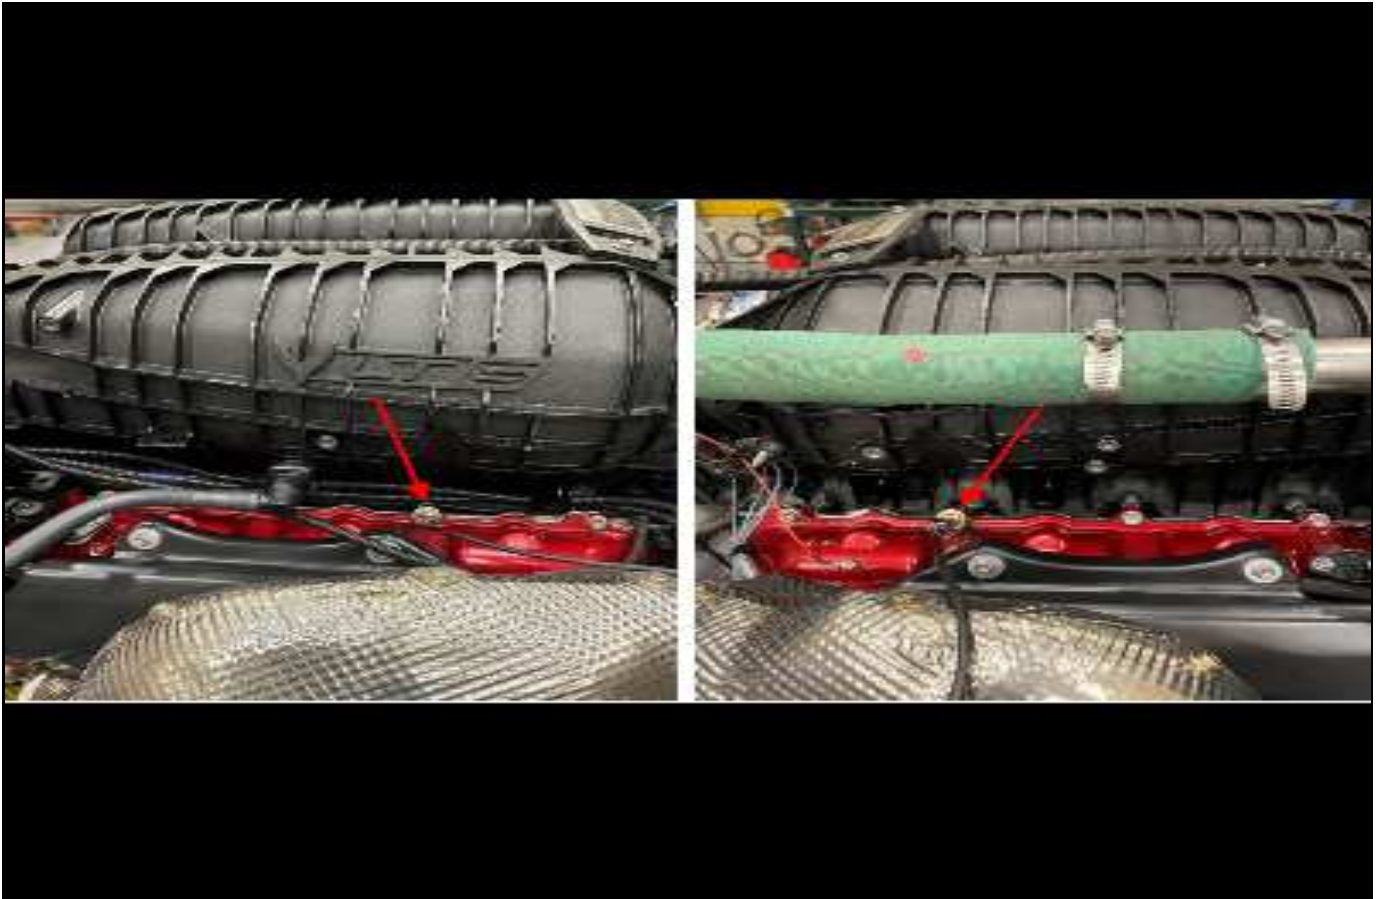
6374742

Place the accelerometer on the suspect bank.

⇒ With the suspect bank determined, prep/position the accelerometer so the X, Y, Z coordinate system (that's laser etched) is facing upwards before securing to the bolt head. After accelerometer is placed on bolt head, double check to ensure its centered and did not rotate on the bolt head. Doing so will ensure the best results.

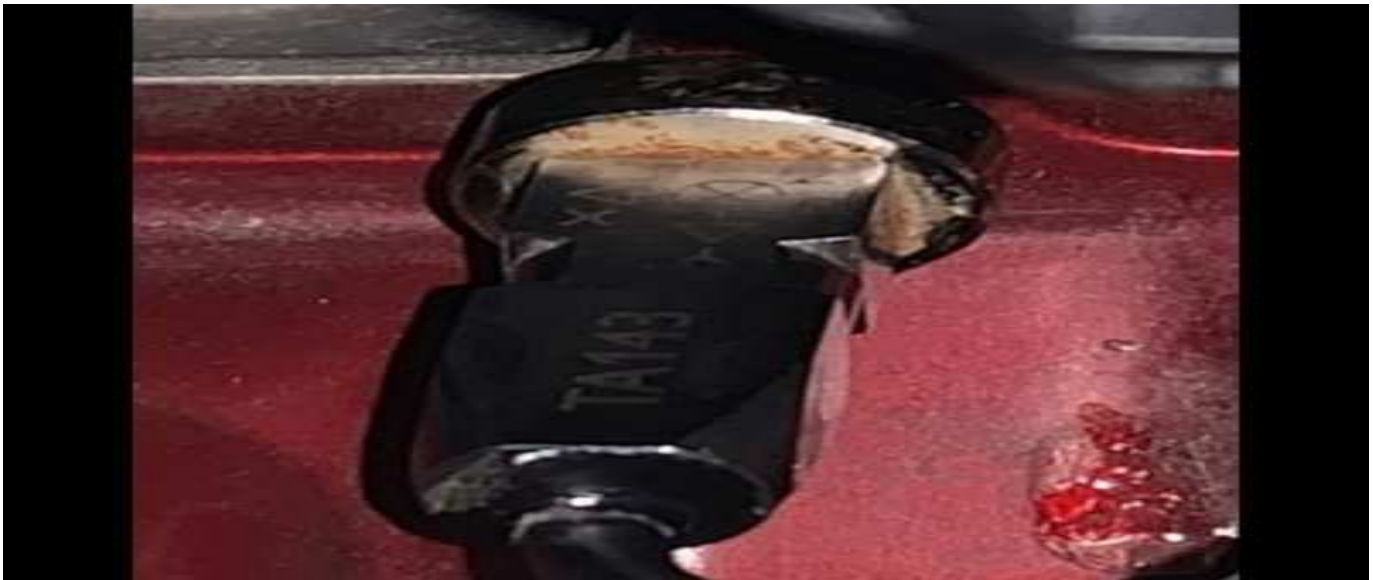
6374737

**Important:** Ensure accelerometer coordinates are facing up towards the intake.

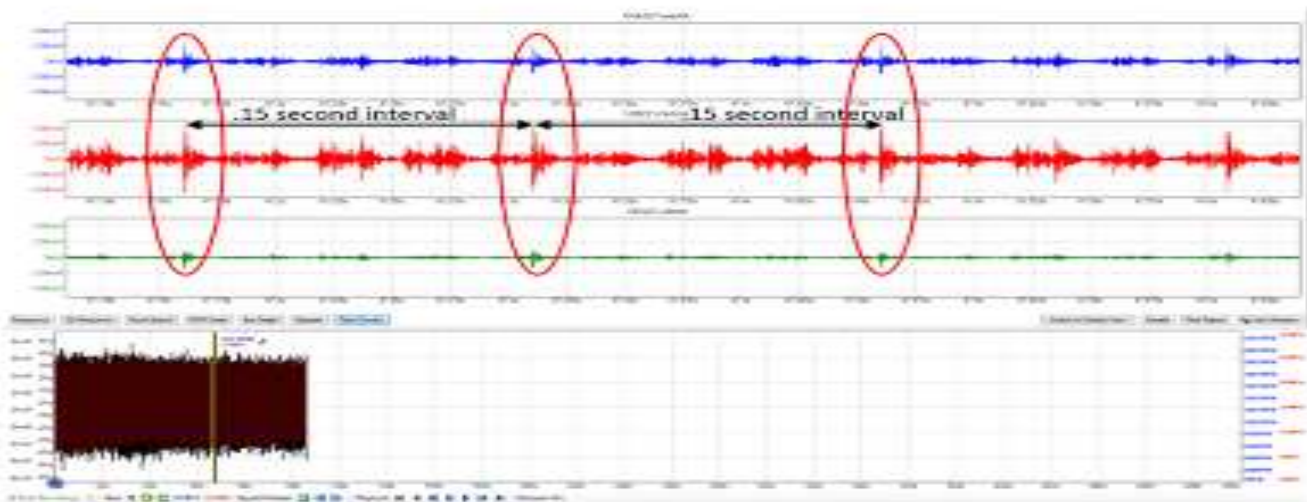
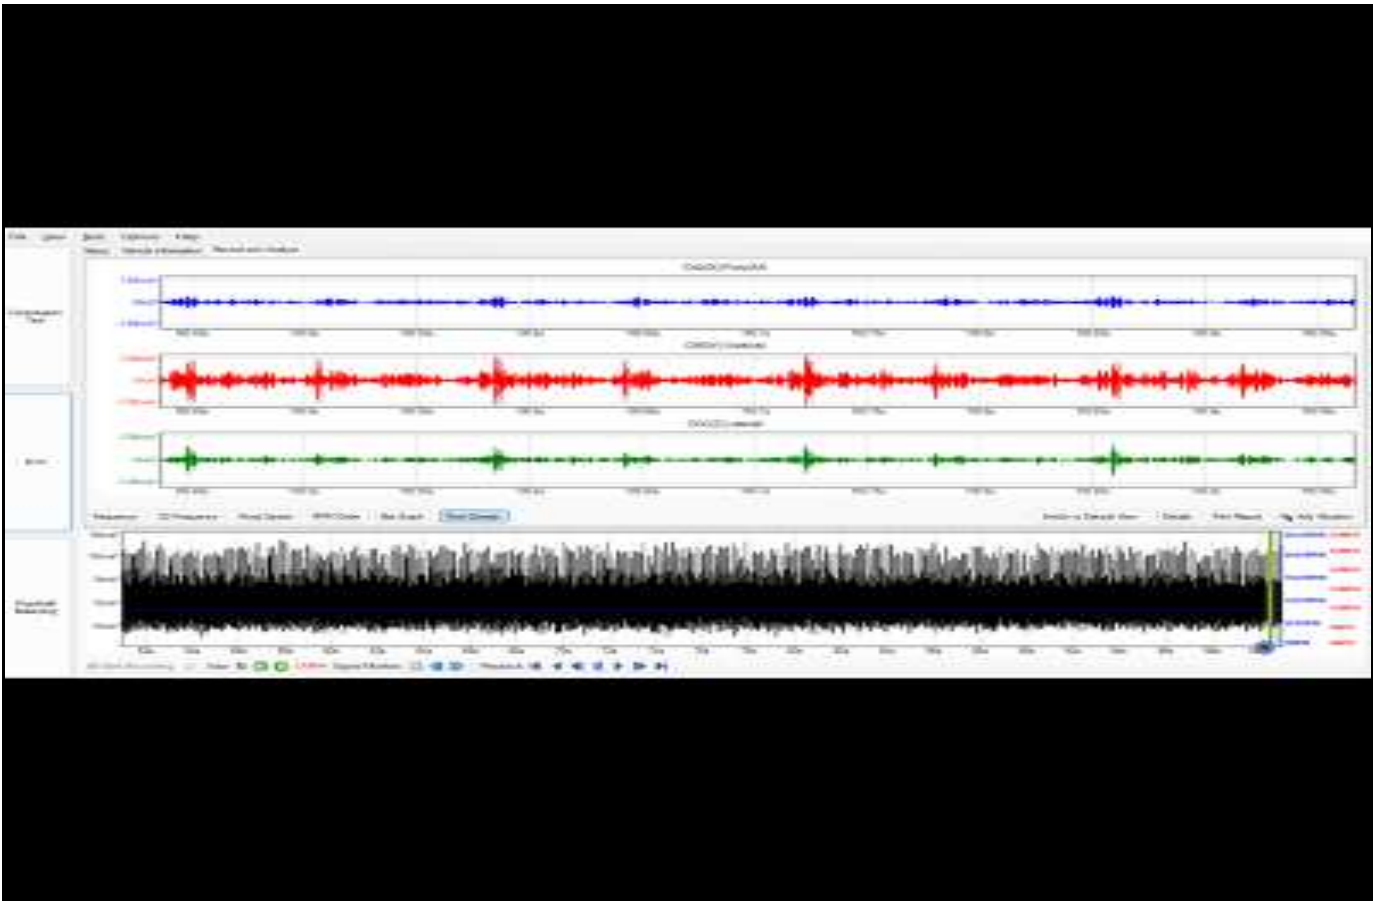
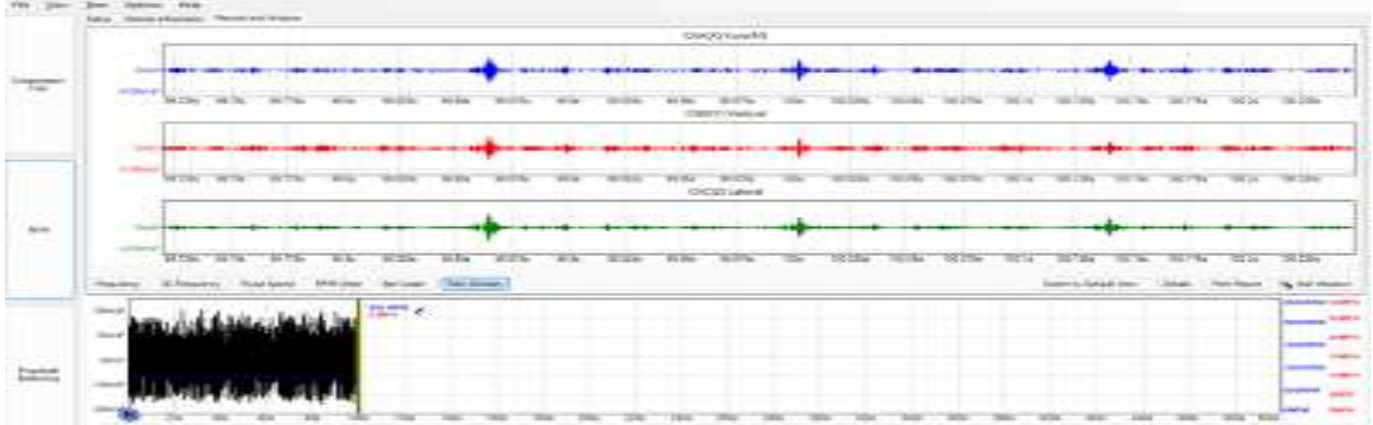
Examples of Tick:

- Right click in the time domain display and change the display mode to single.
- If scales on the left end for each channel are not ranging from -4 m/s<sup>2</sup> to 4 m/s<sup>2</sup>, right click in the time domain display and select "reset scale."
- Pull the yellow window cursors on the bottom in as close together as they will go.
- Look at the channel lines in the time domain window for ticks with a .15s gap between them.
  - ⇒ Compare to the examples below for an engine with a tick and an engine without a tick:

Once it is determined which bank the noise is coming from, it will be necessary to follow the service procedure below to adjust the camshaft cap torque.
