Service Bulletin

Bulletin No.: 13-08-116-001J

Subject: Aftermarket ALDL or DLC Interface Devices Causing Multiple Issues
Models: 2025 and Prior GM Passenger Cars and Trucks (including BrightDrop)
Attention: This bulletin also applies to any of the above models that may be Export from North America vehicles.

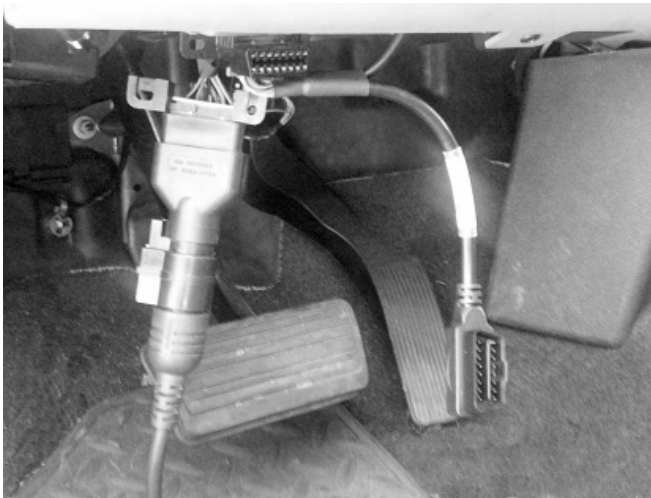
Device W/Secondary DLC Connector

This device has another DLC connector on it. The rest of the harness along with the device can be placed out of sight hidden from the technician, who may not notice the diagnostic connector is not in the factory location.
