Service Bulletin

Bulletin No.: 24-NA-079

Subject: Rear Door Not Unlocking

Brand:	Model:	Model Year:		VIN:		Engine:	Transmission:
		from	to	from	to		
Cadillac	XT4	2024	2024	-	-	All	All

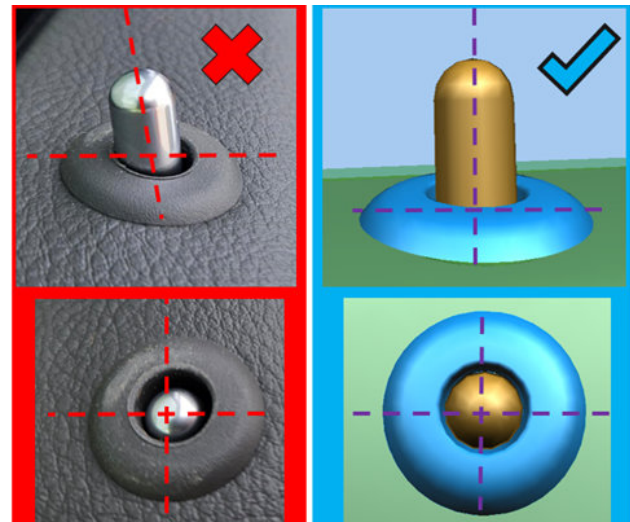
6625769

1. Confirm if the lock knob is not in the center of the bezel.
2. Remove door panel, refer to *Rear Side Door Trim Replacement* in SI.
3. Remove the lock knob bezel.

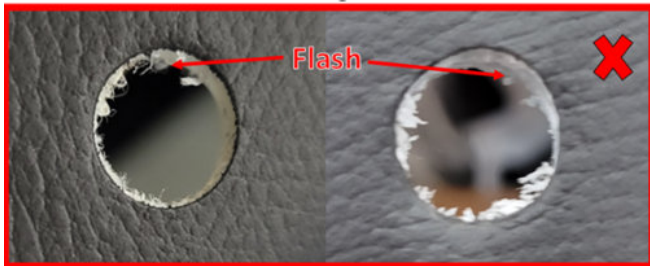
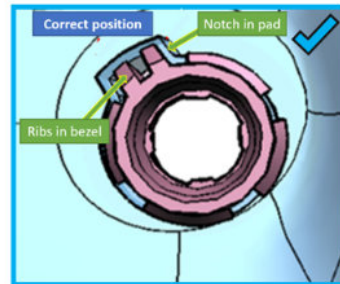
6625770

4. Inspect the door panel lock rod bezel ring opening for excessive door skin “flashing” (Illustrated Above). Use a sharp drill/cutter to remove any excessive door skin “flashing” without making the diameter of the door opening larger.
5. Install a new lock knob bezel.

- 5.1. Confirm installation is correct by looking through the bezel opening.
