**May 16, 2024**

## Recirculation Motor Noise

### AFFECTED VEHICLES

Year	Model	Trim Level	VIN Range
2023–24	Accord	ALL	1HGCV1***PA047963 thru 1HGCV1***RA039722
2023–24	Accord Hybrid	ALL	1HGCV2***PA053620 thru 1HGCV2***RA038450

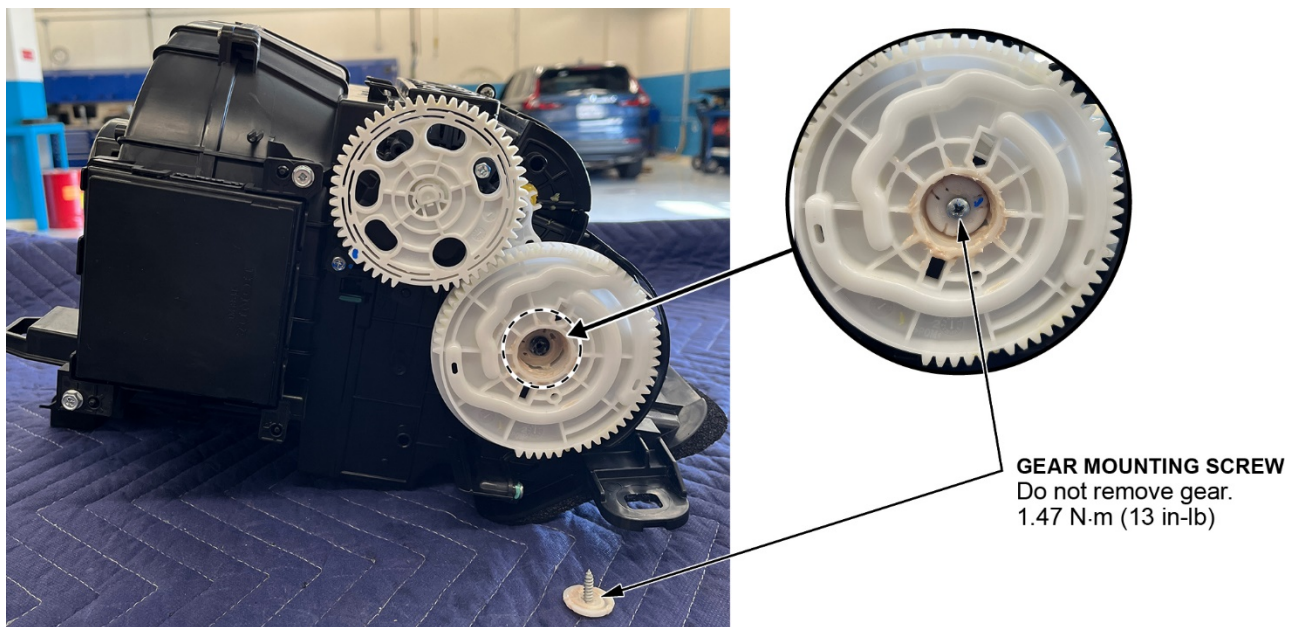
Not enough grease was applied to the recirculation motor/gear assembly.

14. Remove the recirculation control motor gear mounting screw and washer (**do not** remove the gear).
