Subject: REVISION: N242436241-02 – Customer Satisfaction Program  
Multiple Module Reprogramming  
Revised Service Procedure

Models: 2024 Chevrolet Blazer EV

## N242436241 Multiple Module Reprogramming

**Revision:** 02

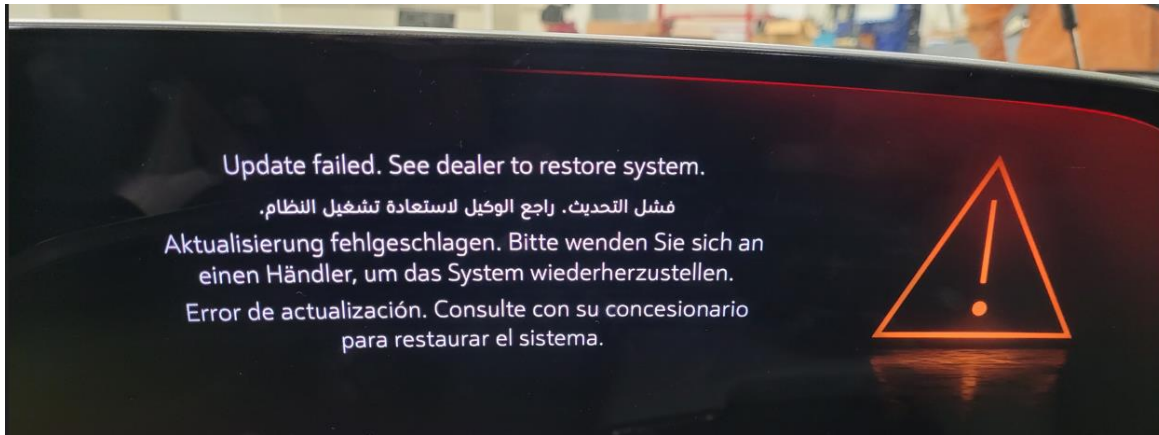
6554772

1. There is a chance for an error to be encountered during the USB update portion of the procedure right around 60% completed.
  - 1.1. This happens once the USB is in the vehicle and the progress bar can be seen on screen.
2. If the error occurs the screen will look like below

3. In this case pull the USB from the vehicle and reformat again as shown in step 7 under service procedure.
4. Access the Service Programming System (SPS) and follow the on-screen instructions.
5. On the SPS Supported Controllers screen, select A11 Radio – USB Copy/USB File Transfer.
6. Upon completion of the file transfer, properly eject the USB drive from the computer.
7. Connect the USB drive to the USB port in the vehicle.
  - 7.1. If the screen fails to show a progress bar once reinserted, pull out and reinsert again.
8. These steps should allow the progress bar to restart and complete successfully.
9. If you require further assistance or would like verbal instructions in addition to this part of the service procedure please contact Techline Customer Support Center 1-800-828-6860 for English or 1-800-503-3222 for French (Canadian) for assistance.
