Technical Service Bulletin

Subject: OIL SEEPAGE FROM AUTOMATIC TRANSMISSION (A/T) AT THERMO VALVE	Bulletin No.: 05-002/24
	Last Issued : 05/17/2024

2024 CX-90 (3.3L MHEV) with VINS lower than JM3KK*****155319 (produced before December 21, 2023)

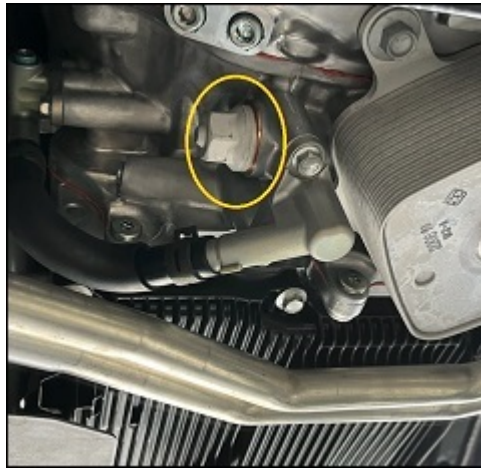
Some technicians may notice an oil seepage from the A/T at the thermo valve when the vehicle under covers are removed.

This is caused by insufficient tightening torque of the thermo valve. To eliminate this concern, the tightening torque of the thermo valve has been modified from 52-59 ft-lbs (70-80 N·m) to 63-71 ft-lbs (86-96 N·m).

1. Verify the concern.
2. Remove the thermo valve and replace the gasket with a new one.

b. Remove the thermo valve and the gasket.

c. Degrease the mounting area of the thermo valve.

d. Reinstall the thermo valve with a new gasket and torque to 63-71 ft-lbs (86-96 N·m).
