Technical Service Bulletin

Mazda North American Operations
Irvine, CA 92618-2922

Subject: CHECK ENGINE LIGHT ON WITH DTC P0524 OR P055F	Bulletin No.: 01-003/24
	Last Issued : 05/14/2024

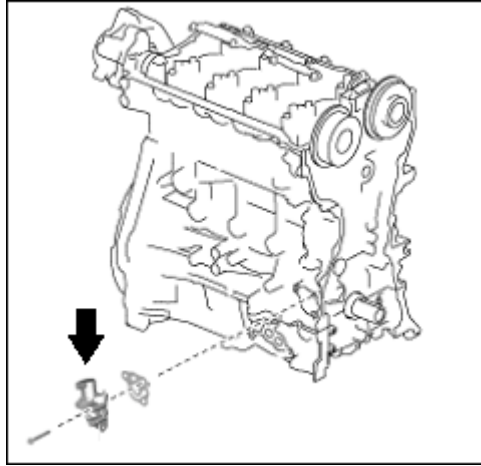
Some vehicles may have the check engine light on with DTC P0524:00 or P055F:00 stored in memory. Contamination in the engine oil may cause the engine oil solenoid valve to become stuck, resulting in improper operation of the oil pump

and improper oil pressure.

- DTC P0524:00 (Engine oil pressure too low)
- DTC P055F:00 (Engine oil pressure malfunction)

The control software of the PCM has been modified to eliminate this concern. In addition, the production process has been modified to reduce contamination in the engine oil solenoid valve, oil pump, spacer and oil filter.
