GROUP	MODEL
FUE	2017-2021MY Multiple Models 3.3L GDI Lambda II
NUMBER	DATE
067	May 2024

TECHNICAL SERVICE BULLETIN

HIGH-PRESSURE FUEL PUMP REPLACEMENT

This bulletin provides information associated with the 'Warranty Extension Program' (WTY034) to diagnose the 'Malfunction Indicator Lamp' (MIL) accompanied by DTC P0088 and, if necessary, replace the high-pressure fuel pump on vehicles listed below.

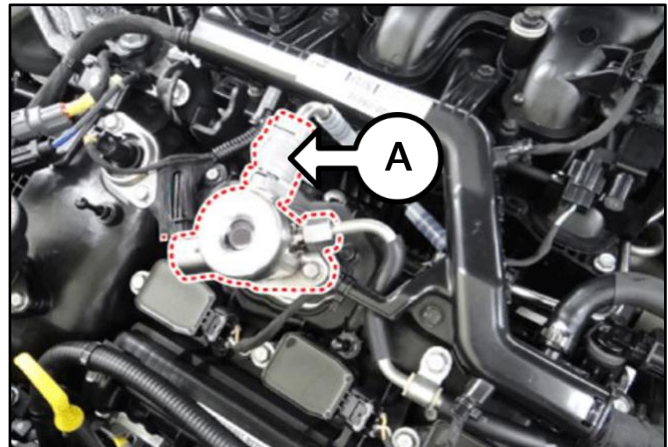
The fuel control valve (FCV) plunger in the vehicle's high-pressure fuel pump may wear unevenly, and, over time, become stuck in the open position. If this condition occurs, the customer may experience rough running, engine hesitation, and/or illumination of the MIL. In rare cases, the engine may shut off while the vehicle is at a stop, although it can be immediately restarted (after shifting into Neutral or Park). The warranty coverage for repairs related to the high-pressure fuel pump will be extended from 5 years / 60,000 miles to 15 years / 180,000 miles, whichever comes first, starting from the date the vehicle was first put into service. Follow the procedure outlined in this publication to inspect the vehicle and check for DTC P0088 and, if necessary, replace the high-pressure fuel pump and related parts on the applicable vehicle.

2. Release the residual pressure in the fuel line by referring to "Engine Control / Fuel System → Fuel Delivery System → Release Residual Pressure in Fuel Line" in the applicable Shop Manual on KGIS.
3. Replace the High-Pressure Fuel Pump (HPFP) (A) by referring to "Engine Control / Fuel System → Fuel Delivery System → High Pressure Fuel Pump → Repair procedures" in the applicable Shop Manual on KGIS.

Tightening torque for bolts:
9.4 - 10.9 lb.ft (12.8 - 14.7 N.m)

Note: DO NOT reuse HPFP bolts or high-pressure fuel pipe. Refer to [VID020](#) for HPFP and Line Installation.
