Service Bulletin

Bulletin No.: 20-NA-136

Subject: Diagnostic Tips for DTCs Set at a Low Mileage for 9T65 Transmissions
Attention: The 9T65 Transmission Replacement Pilot Has Ended.

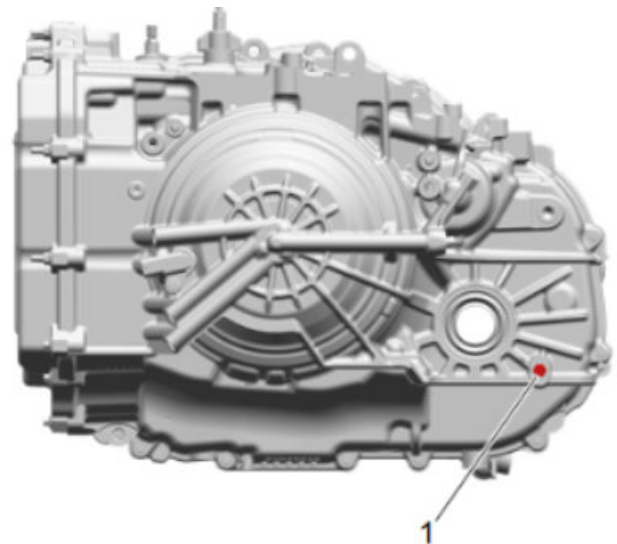
6. While the vehicle is idling, remove the oil level set plug (1). Allow any fluid to drain:

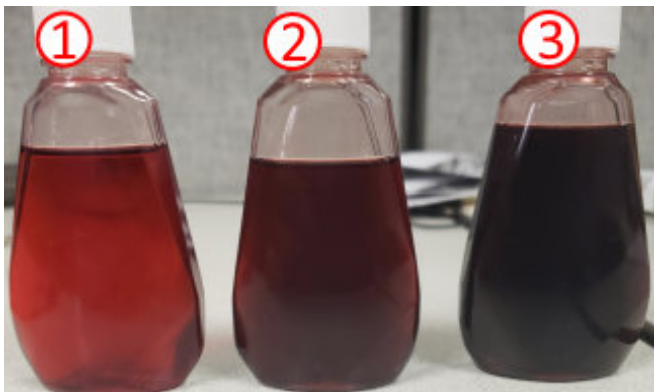
5840393

- 8.1. Inspect the fluid color.
- The fluid should be red or dark brown.
 - It should be transparent so that objects or writing can be seen through it. Sample #1 is an example of acceptable fluid. Sample #2 is an example of very dark fluid. Sample #3 is an example of black fluid.
 - In addition to checking the fluid color and transparency, the fluid should be checked for an odor of burnt fluid. If the fluid is very dark, black, or has a burnt odor it would indicate clutch damage has occurred internally in the transmission and it would need to be removed from the vehicle and investigated.
- 8.2. Inspect the fluid for excessive metal particles or other debris.
- A small amount of “friction” material is a “normal” condition.
 - A small amount of “metal” from the manufacturing process is a “normal” condition. This is observed as fine silver streaks floating in the fluid.

- If large pieces and/or metal pieces are noted in the fluid, record on the repair order and it would indicate damage has occurred internally in the transmission and it would need to be removed from the vehicle and investigated.
 - Fluid that is cloudy or milky or appears to be contaminated with water indicates engine coolant or water contamination. Refer to the latest version of Corporate Service Bulletin Number 08-07-30-035 for testing and, if confirmed, find the source of the coolant/water and repair then follow SI document for “Engine Coolant/Water in Transmission” for proper transmission repair.
- 8.3. Inspect for external leaks. Refer to *Fluid Leak Diagnosis*.
- If fluid level and condition are ok, proceed to next step.
